# **FIRE TYPE TEST REPORT**

## **FR 6289**

### **FIRE RESISTANCE TEST OF A RESENE CONSTRUCTION LOAD-BEARING INTER-TENANCY WALL SYSTEM**

Resene Construction Ltd.  
5 Venture Place  
Middleton  
Christchurch, 8024  
New Zealand

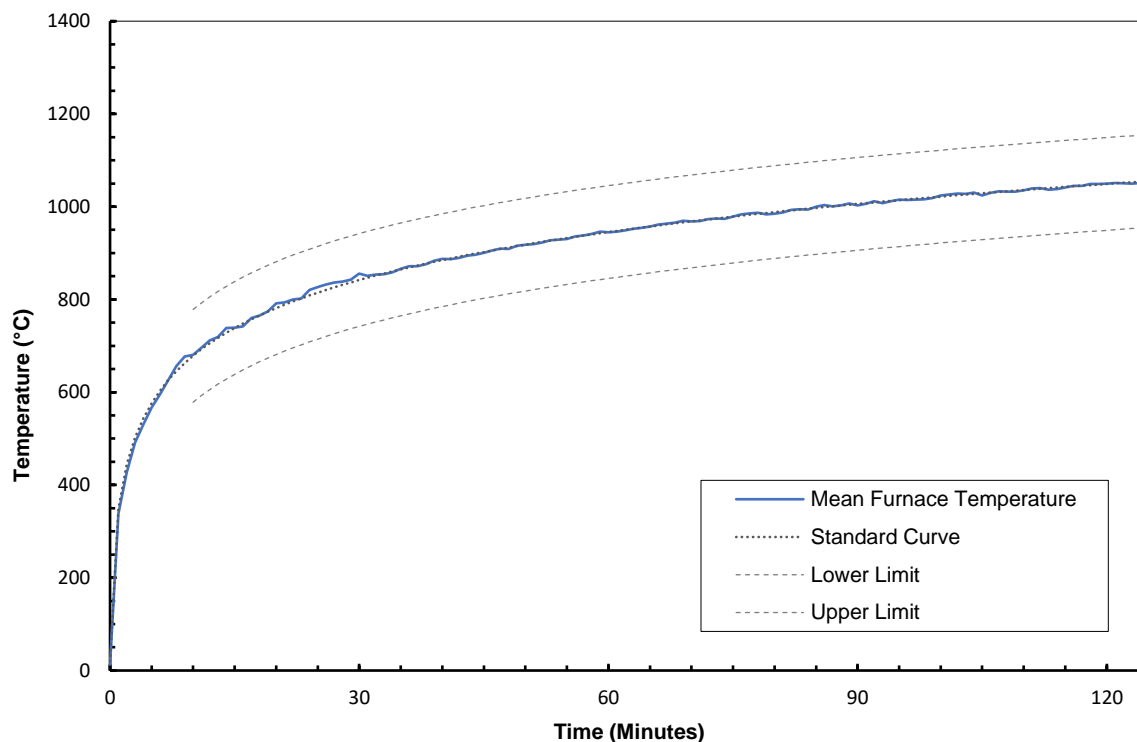
Figure 3: Furnace Temperature

Figure 3 shows the furnace temperature curve and the permitted upper and lower limits in accordance with AS 1530.4-2014.

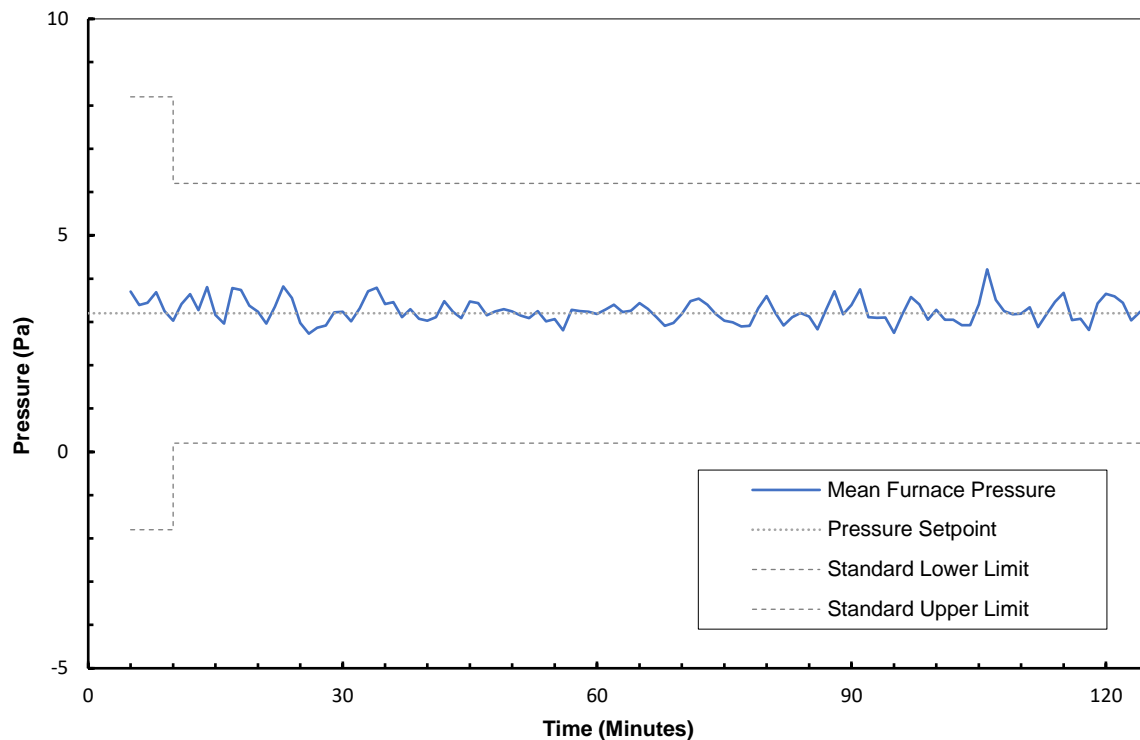
**Figure 5: Furnace Pressure**

The differential pressure of the furnace above the laboratory atmosphere was controlled to be 0 Pa at 500 mm above the notional floor which corresponds to 3.2 Pa at the pressure probe in the furnace. The differential pressure was monitored using a micromanometer connected to a computer controlled data logging system which recorded the pressure at 15 second intervals. Figure 5 shows the furnace pressure variation with time.

The furnace pressure met the requirements of the standard for the duration of the 125 minute test.

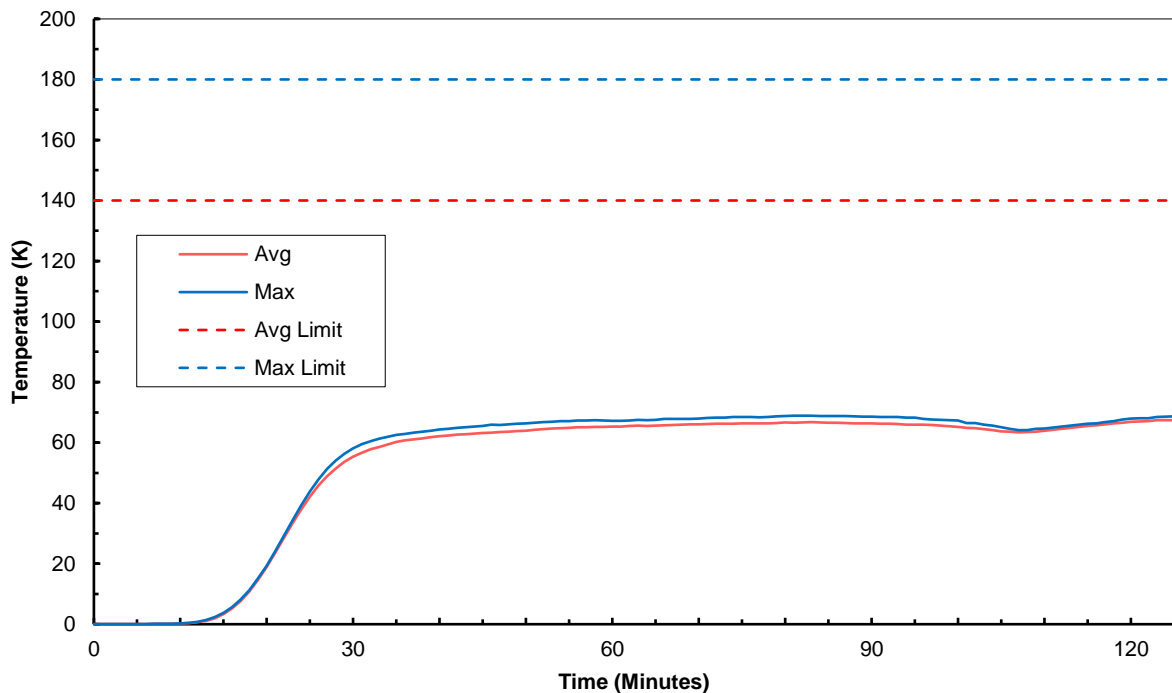
Figure 7: Unexposed face of the wall temperature rise

The temperature rise measured on the unexposed face of the wall did not exceed either the maximum or the average temperature rise insulation failure criteria for the duration of the 125 minute test. A graph of the mean and maximum temperature rise of the unexposed face of the wall is shown in Figure 7.

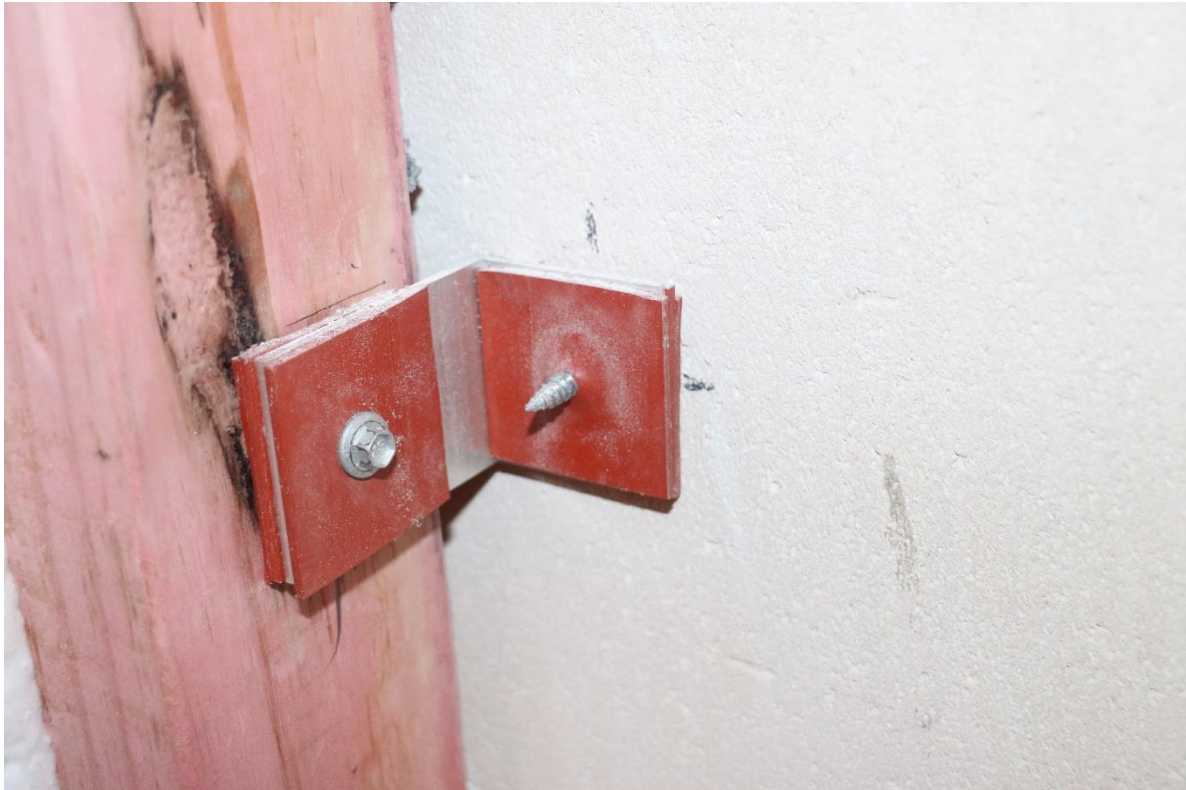
Photo 1: Integra AAC Panel fixing brackets.

A 25 mm gap was left between the panels and the framing. 12-11 x 45 mm Timber Roofing Type 17 hex head screws with seals were used to fix the 75 mm x 50 mm face of the bracket to the framing, as shown in Photo 1.

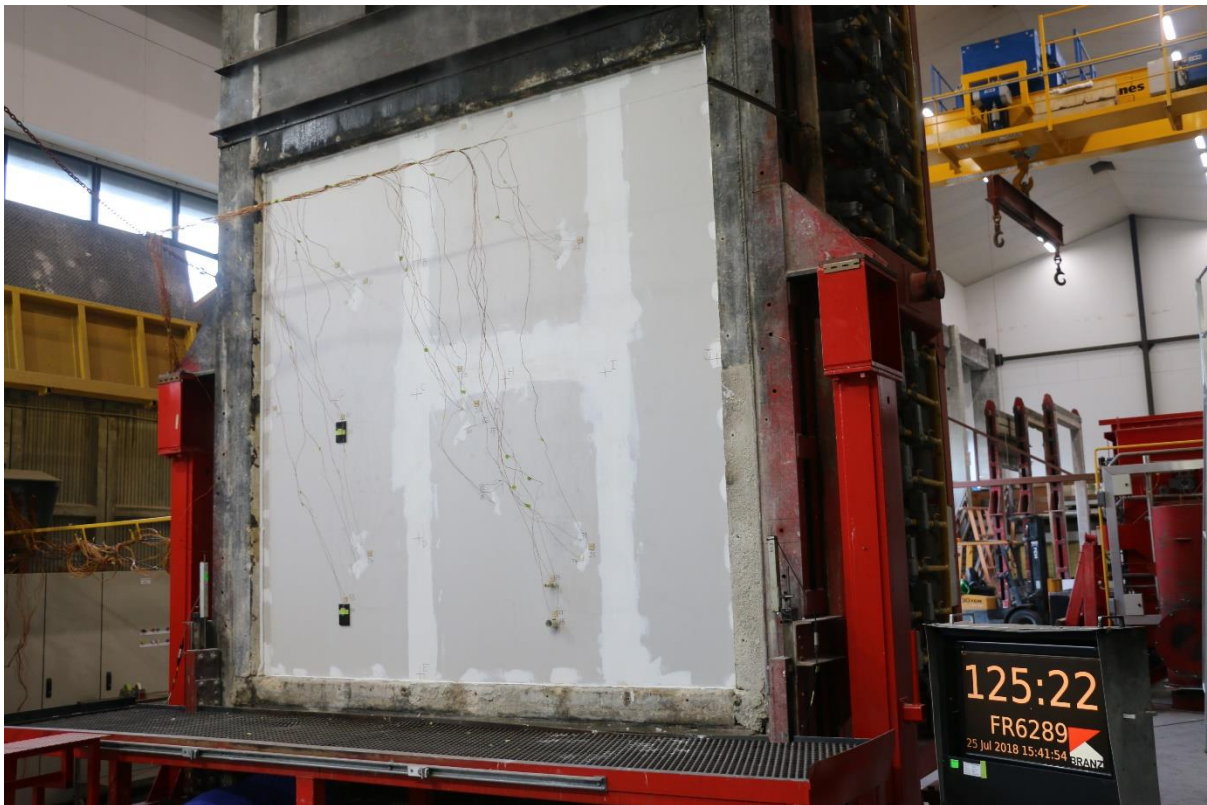
**Photo 4: The unexposed face of the wall after 125 minutes**

The wall did not fail any of the integrity criteria for the duration of the 125 minute test.

None of the service penetrations failed the integrity criteria for the duration of the 125 minute test.
