Report No. 22-04

Testing of 'Kaycan', Eco clad horizontal bevel back weatherboard cladding on cavity, Class-2 details in accordance with E2/VM1

Project: Kaycan - Eco clad horizontal

Test Schedule Water penetration to NZ Building Code, E2/VM1, Class 2

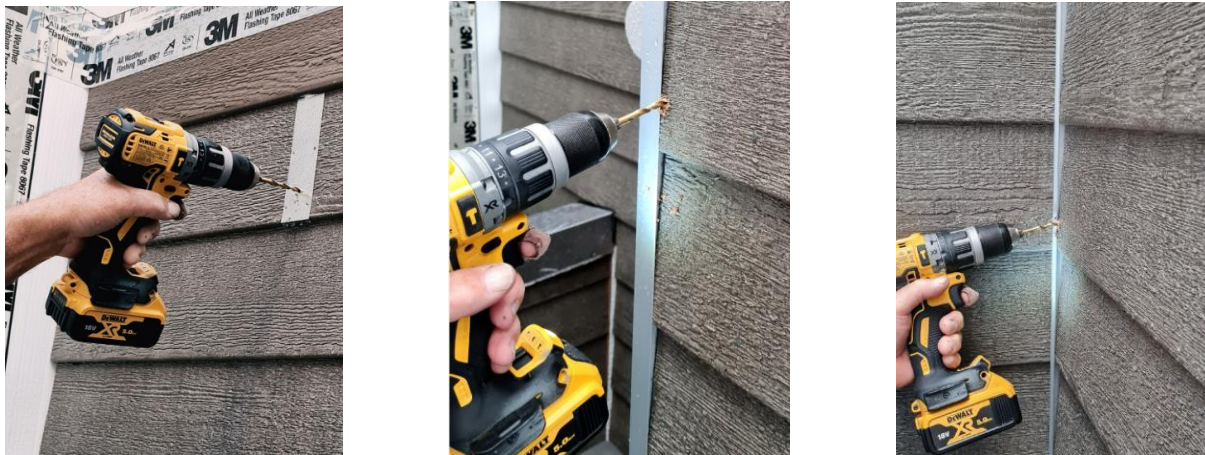
Figure 3: Holes of 6mm diameter drilled in the horizontal jointer, vertical jointer and an internal corner

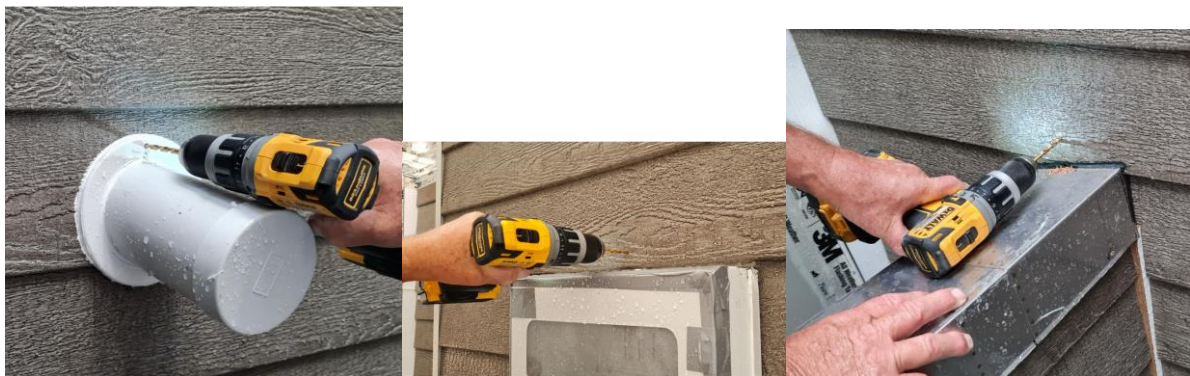
Figure 4: Holes of 6 mm diameter drilled above the pipe penetration, meterbox and balustrade/parapet capping

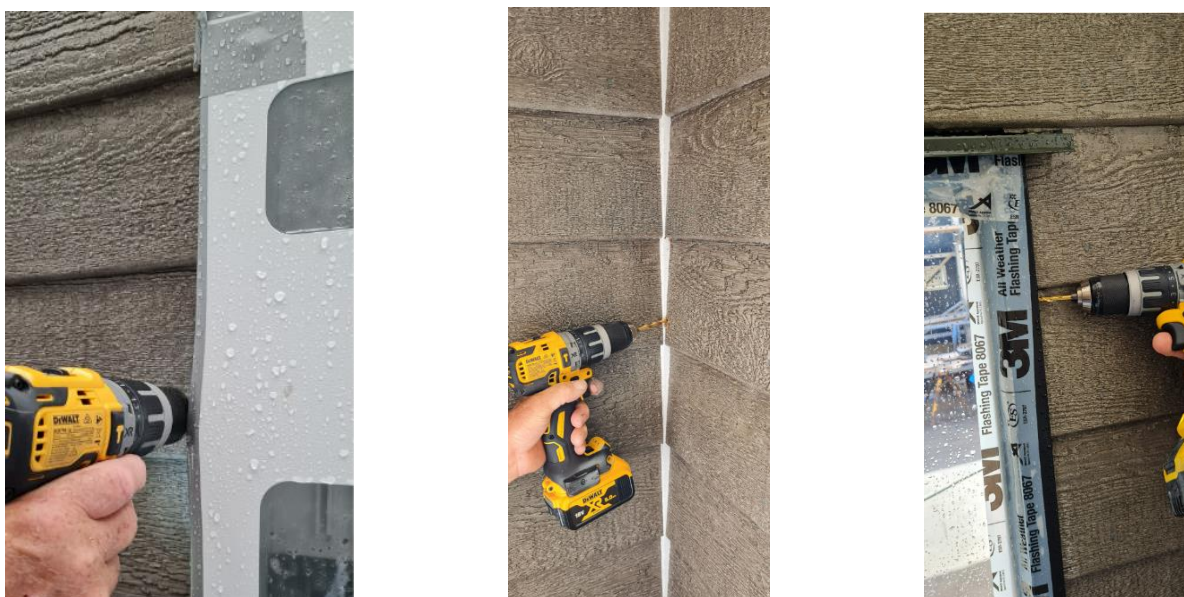
Figure 5: Holes of 6 mm diameter drilled through the meterbox jamb, the internal corner and the window jamb
