## **Report R/2017/01:**

### **Exterior Exposure Series – Kapo Board - G/D/15/1080**

#### **EXTERIOR EXPOSURE TESTING – KAPO BOARD**

10<sup>th</sup> January 2017

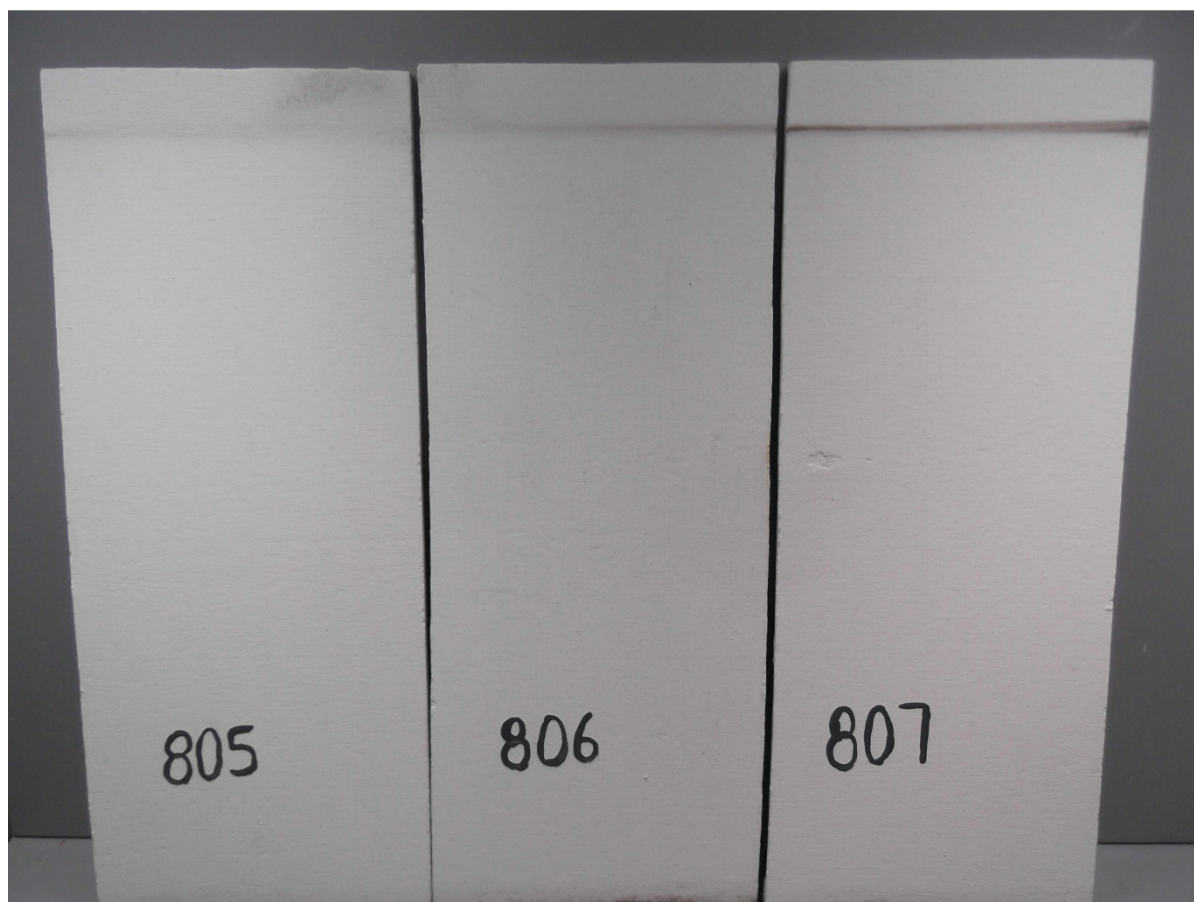
**Panels 805 – 807 after 20 months exposure:**

All boards associated with Exposure Series G/D/15/1080 are in good condition. There is some minor dirt collection but otherwise after 20 months exposure the boards and coating systems appear to be performing well. There is no obvious flaking, chalking, or signs of cracking. It was observed that on the edge of board 806 that there was some yellow discolouration. It was not clear whether this discolouration originated from the substrate.
