Tensile Adhesion Strength Test

Tech Coatings contracted New Zealand Corrosion Services to conduct tensile adhesion strength tests of FBL-100 Intumescent Coating System on the following samples:

INSPECTION REPORT No: **TCL PFP 001-01**

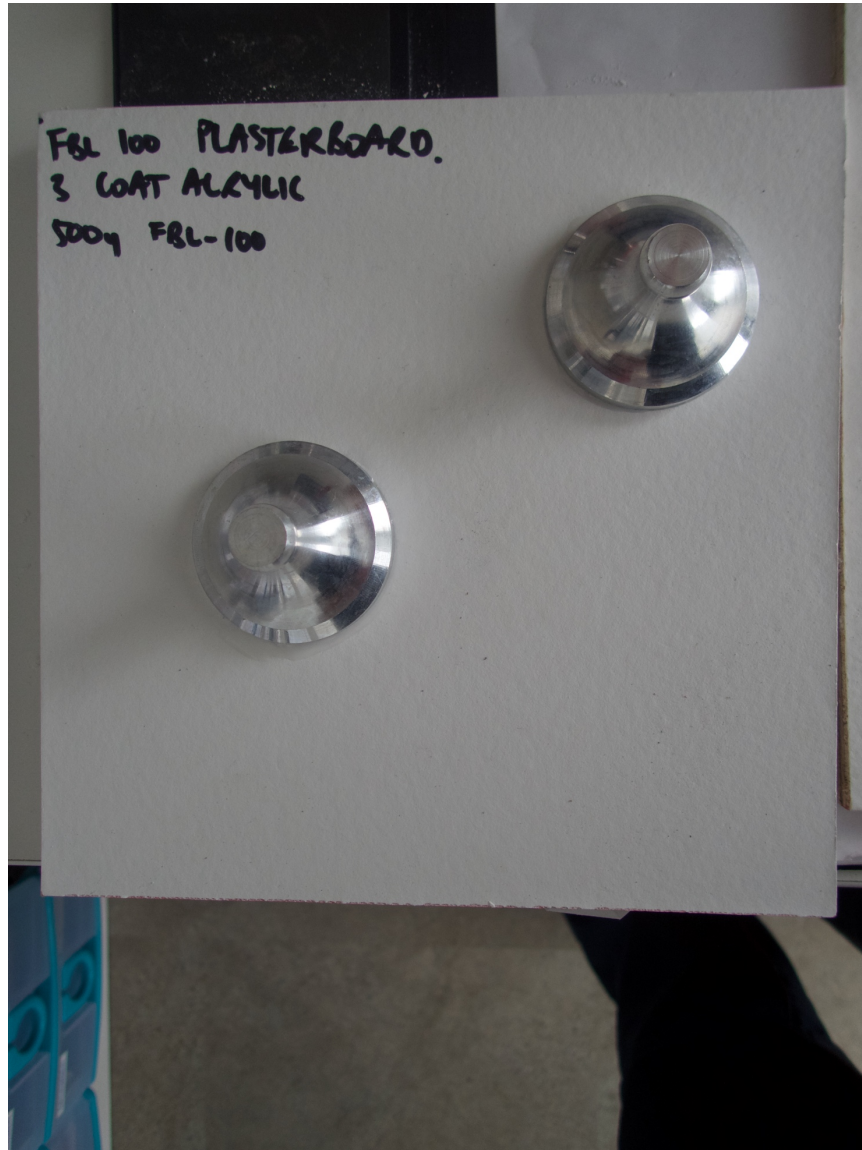
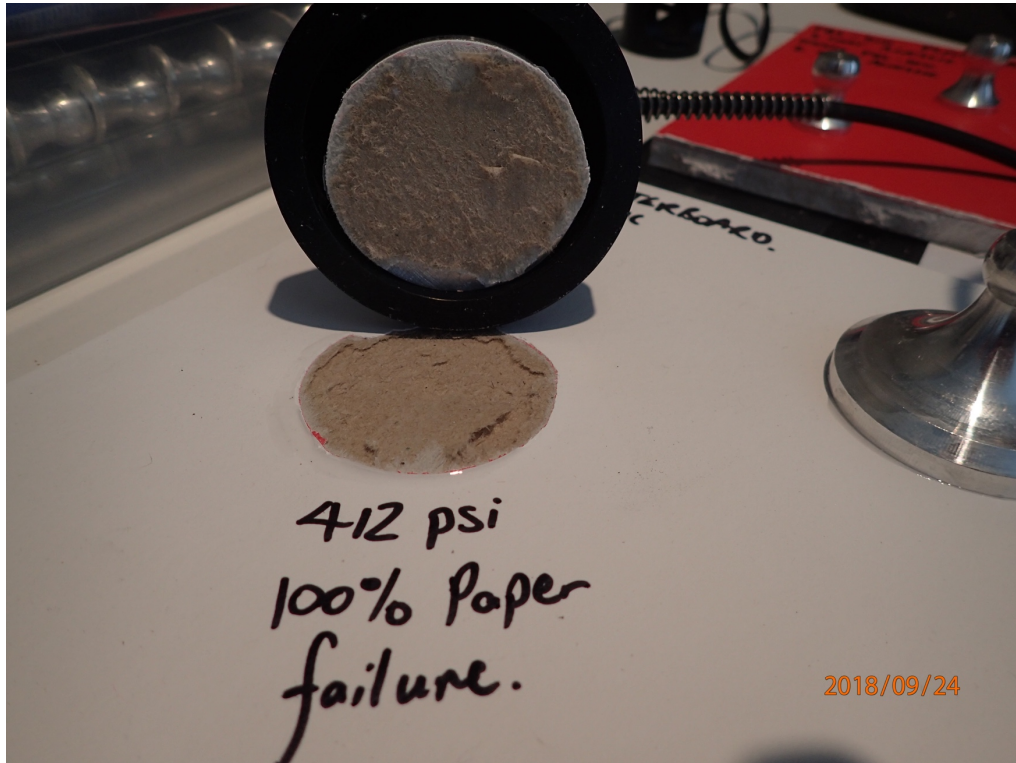
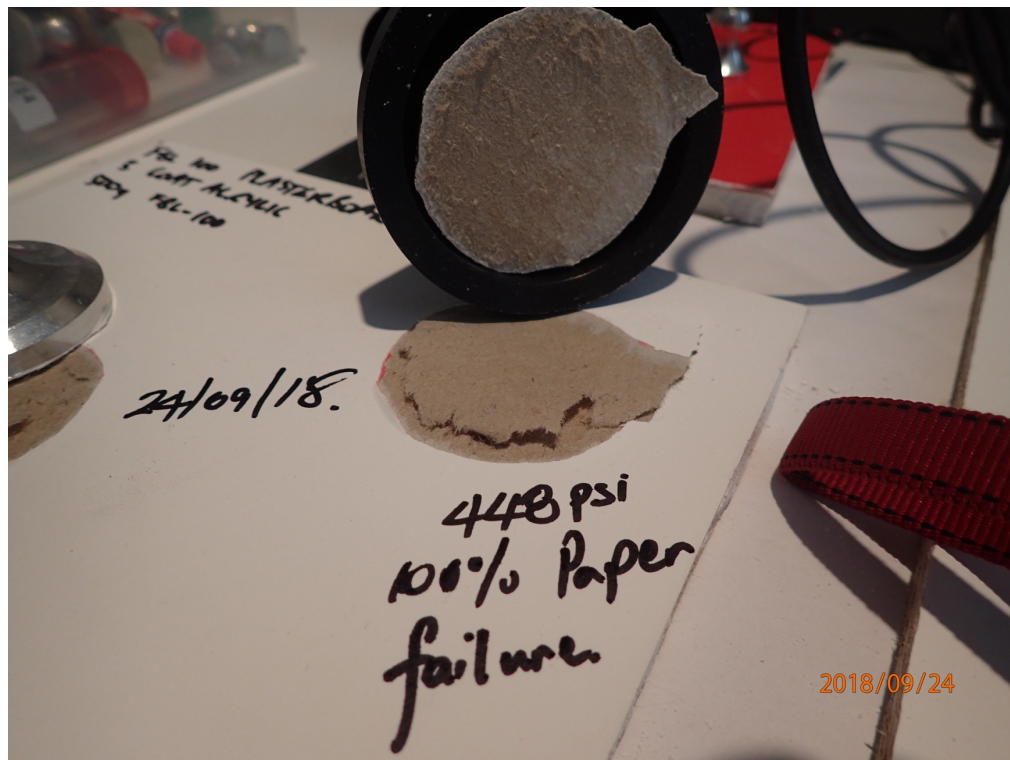
Rating	%	psi	Comment
1.	A	100% Substrate failure (Paper)	412	Acceptable
2.	A	100% Substrate failure (Paper)	448	Acceptable

Comments: 13mm Gib standard plasterboard. FBL-100 ICS applied directly to the plasterboard. No top coat.

Adhesion of the ICS to the paper failed at 412psi.

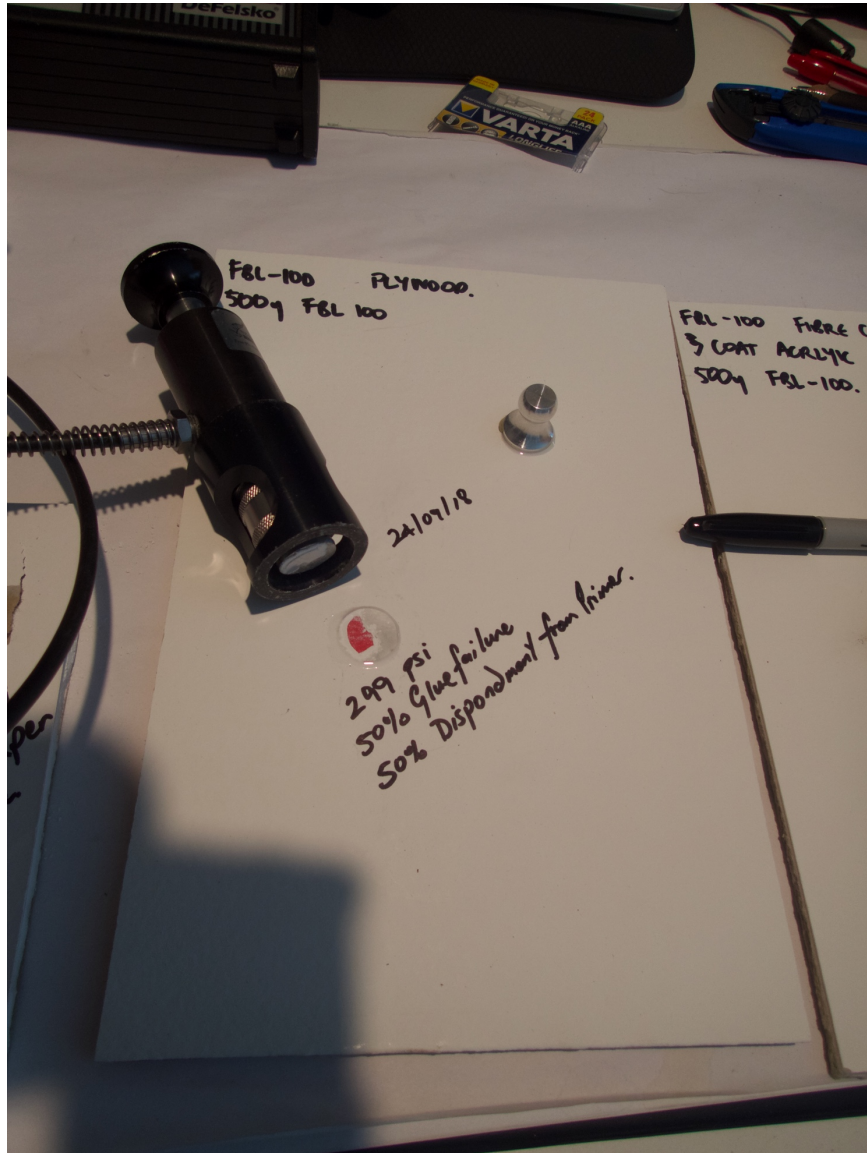
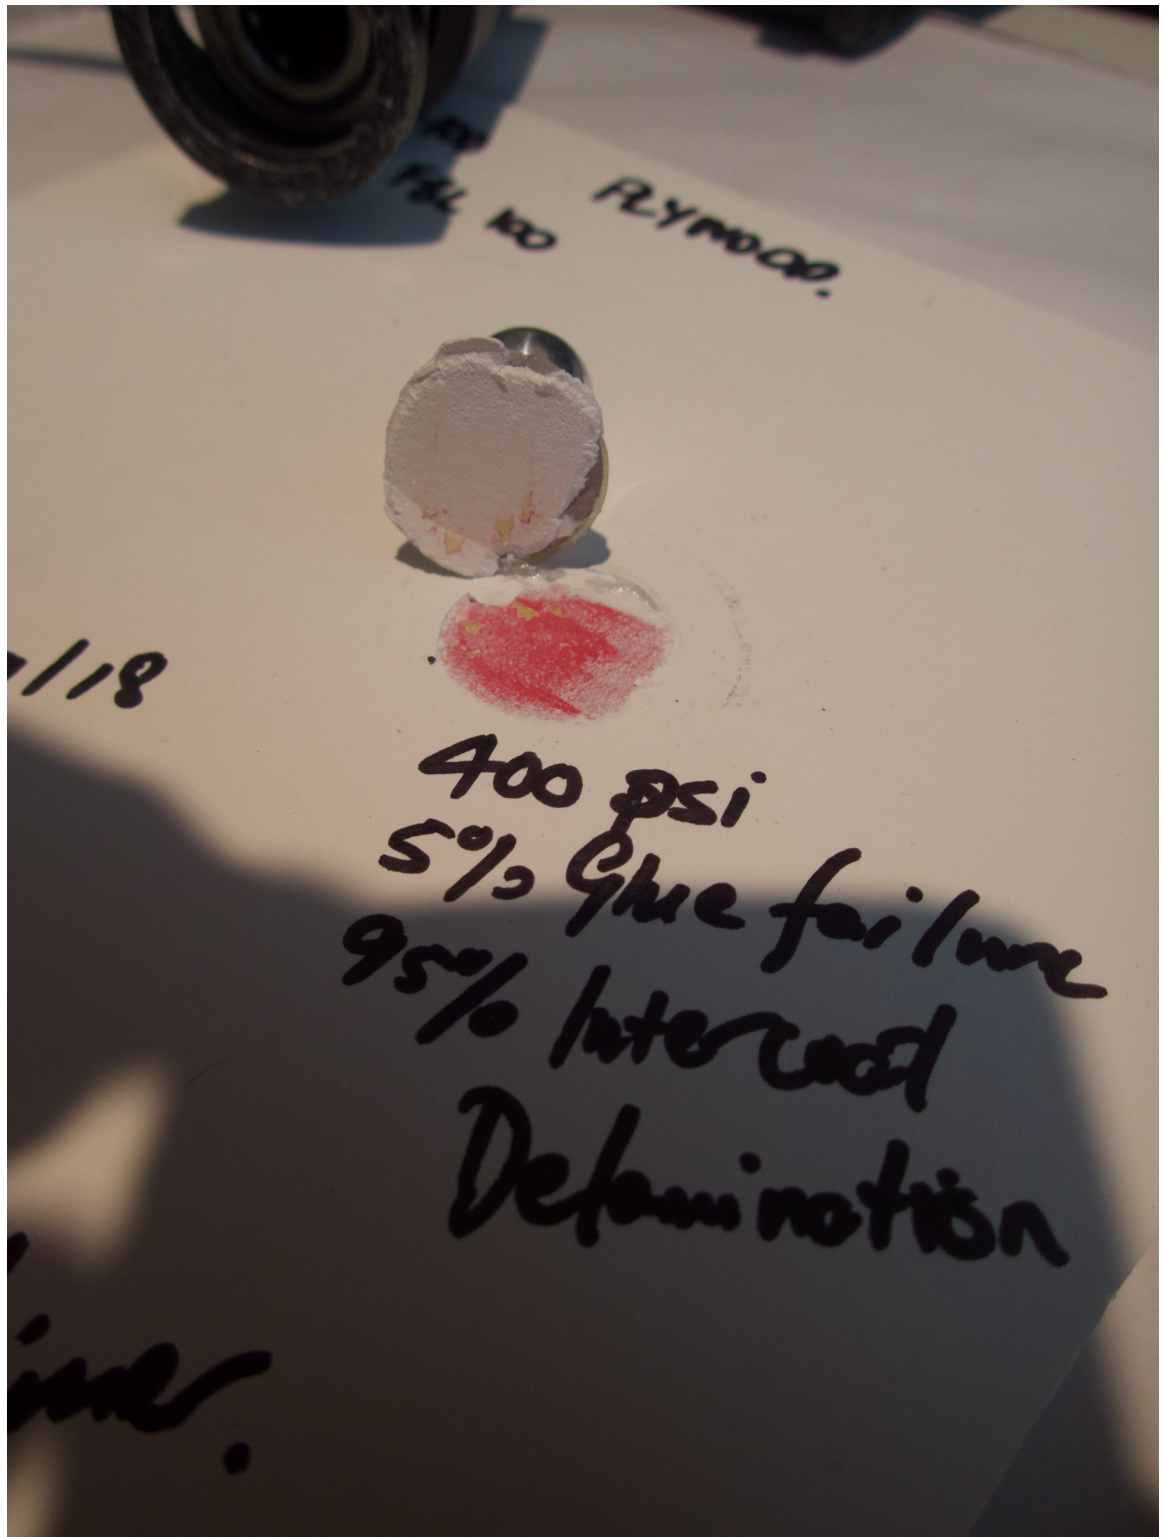
Rating	%	psi	Comment
1.	Y/Z-B/C	50% Adhesive 50% Intercoat Disbondment	299	Acceptable just
2.	Y/Z-B/C	5% adhesive, 95% Intercoat Disbondment	400	Acceptable just

Comments: FBL-100 ICS was applied over a pre-painted surface. The pre-painted surface was a 3-coat water-borne enamel system. No top coat

Adhesion of the ICS to the red under coat was poor and should be looked at.

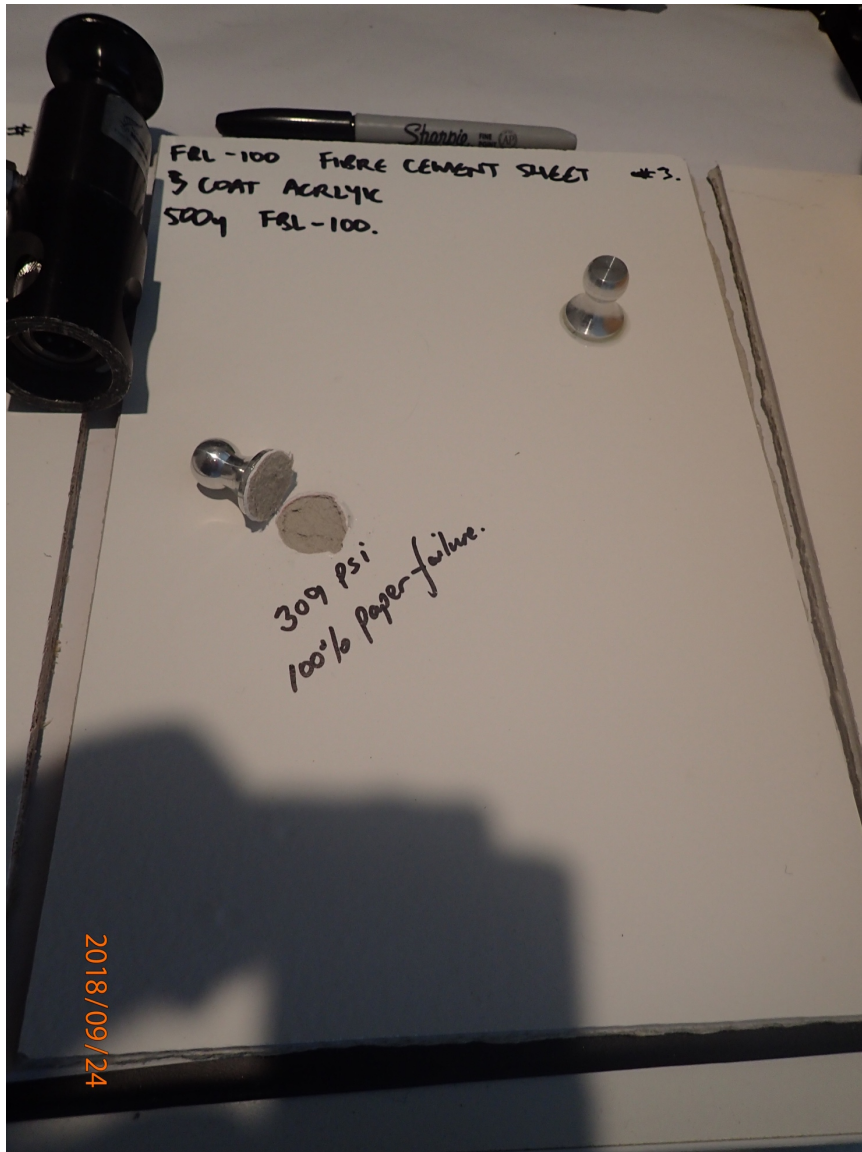
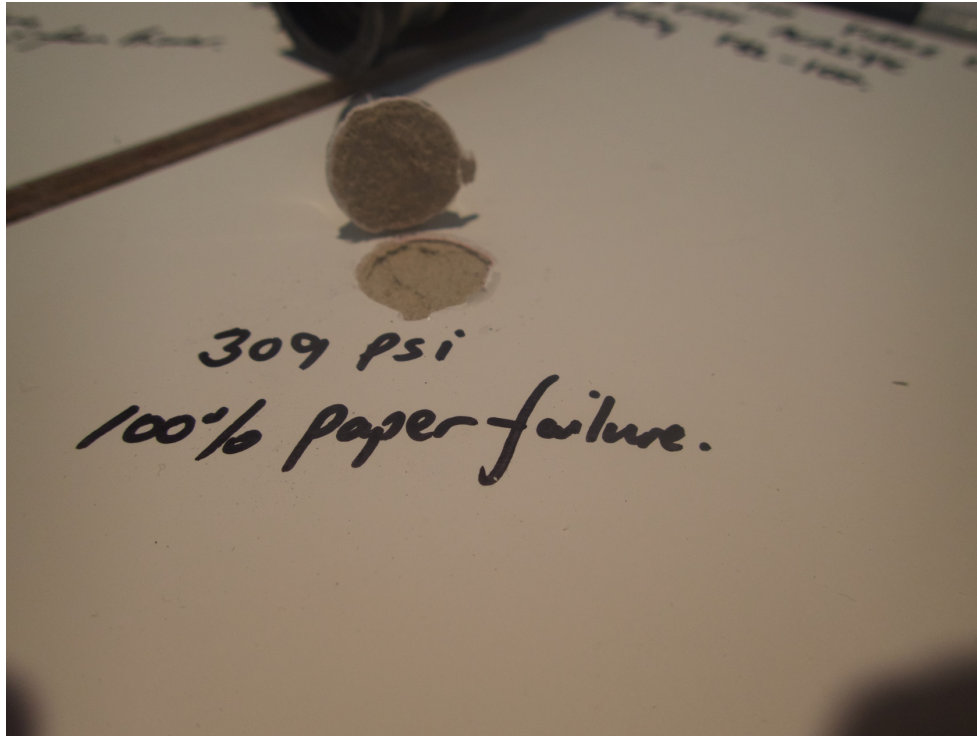
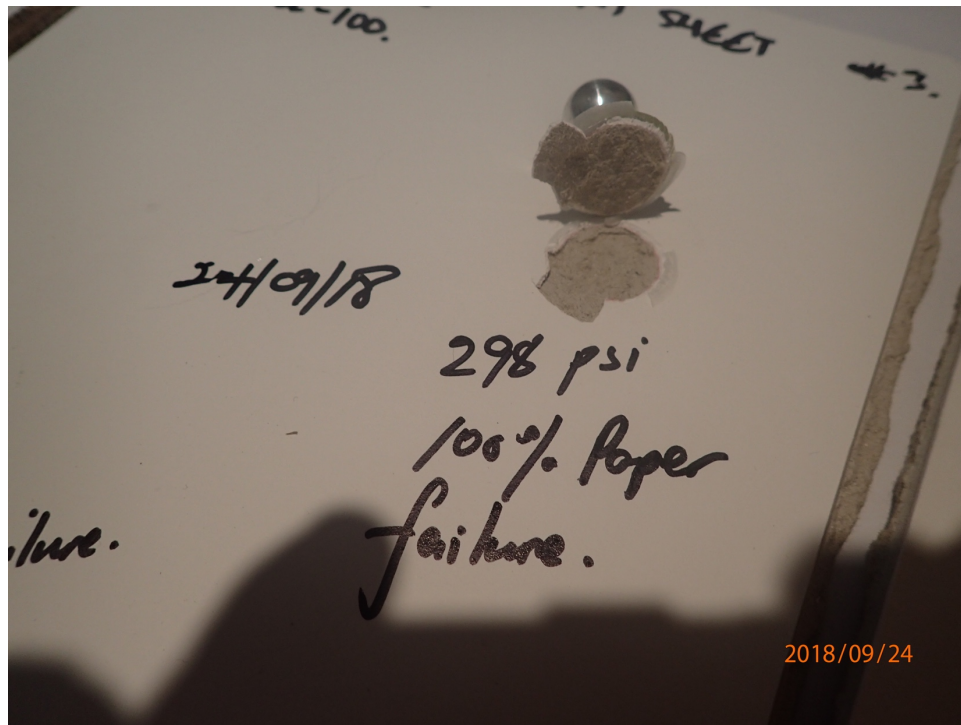
Rating	%	psi	Comment
1.	A	100% substrate failure	309	Acceptable just
2.	A	100% substrate failure	298	Acceptable just

Comments: 6mm Villaboard Fibre Cement Sheet. FBL-100 was applied over a pre-painted surface. The pre-painted surface was a 3-coat water-borne enamel system. No top coat

Adhesion of the ICS to Fibre Cement Sheet was excellent, the FCS failed cohesively.

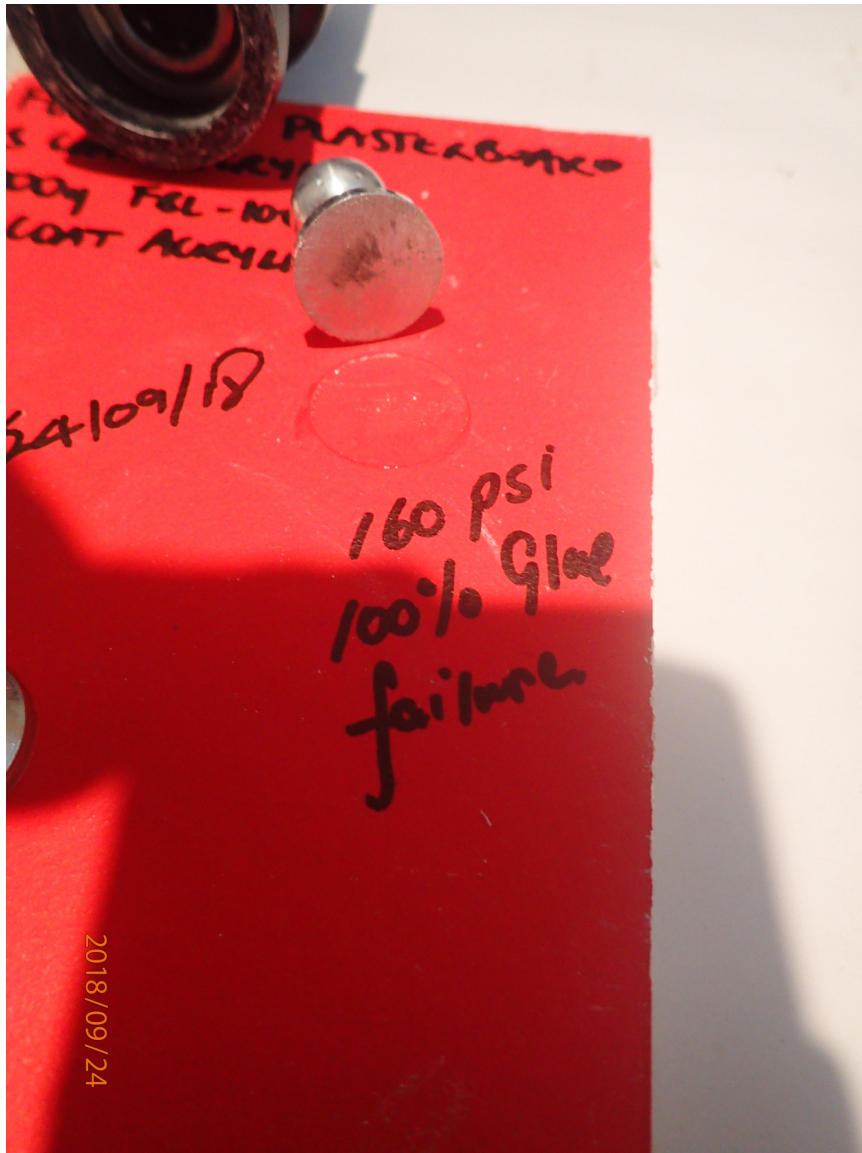
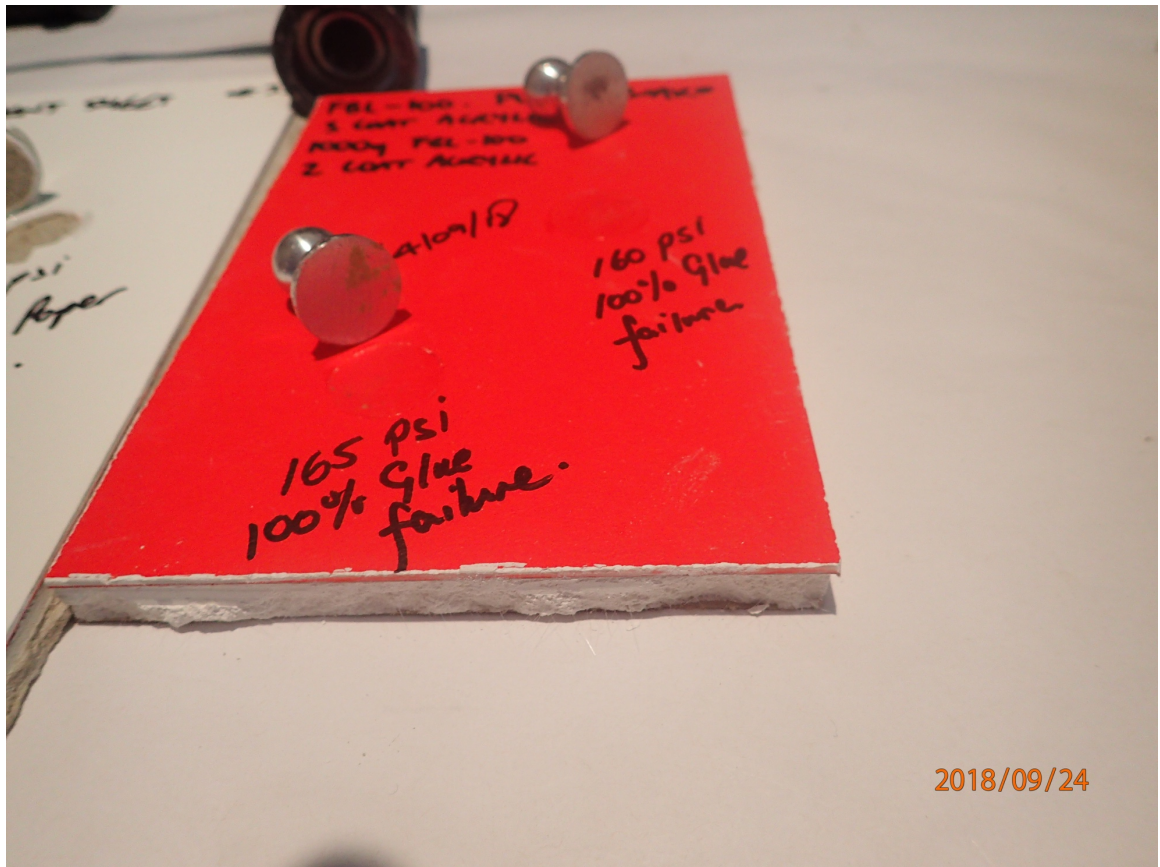
Rating	%	psi	Comment
1.	Y/Z	100% substrate failure	160	Failed
2.	Y/Z	100% substrate failure	168	Failed

Comments: 13mm GIB Standard plasterboard. FBL-100 ICS was applied over a pre-painted surface. The pre-painted surface was a 3-coat water-borne enamel system. FBL-100 was then top coated with 2 coats of a water-borne enamel.

Adhesion to the red top coat failed. Adhesion compromised, unsure why.
