TECHNICAL ADVICE NOTE

TOPIC: Efflorescence

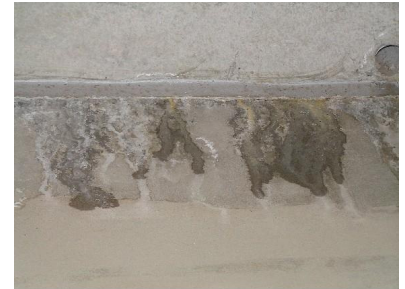
Efflorescence appears as a white deposit of mineral salts on face of concrete walls and/or floors. Efflorescence usually appears in underground car park areas and other subfloor areas. Efflorescence is caused by moisture ingress. As the moisture enters and moves through the wall or floor, it dissolves mineral salts present in the cement. This **mineral salt solution** eventually finds its way to the surface of the concrete. As the water evaporates, it leaves behind a white deposit of mineral salts on the surface.

Efflorescence on concrete floor

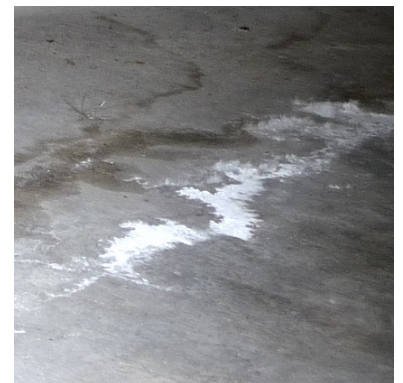
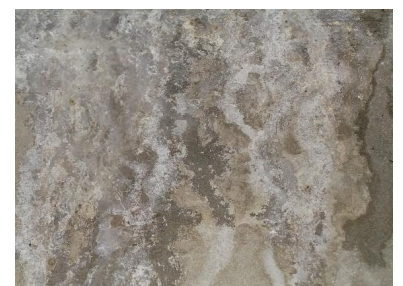
Efflorescence on concrete.
