COMMERCIAL RIBLINE ROOFING PENETRATION FLASHING WATERSHED TO UNDER RIDGE (Notched)

DETAIL NO. CRRO18A
 DATE DRAWN 10/03/12
 FILE REFERENCE R1-CRRO18A.DWG

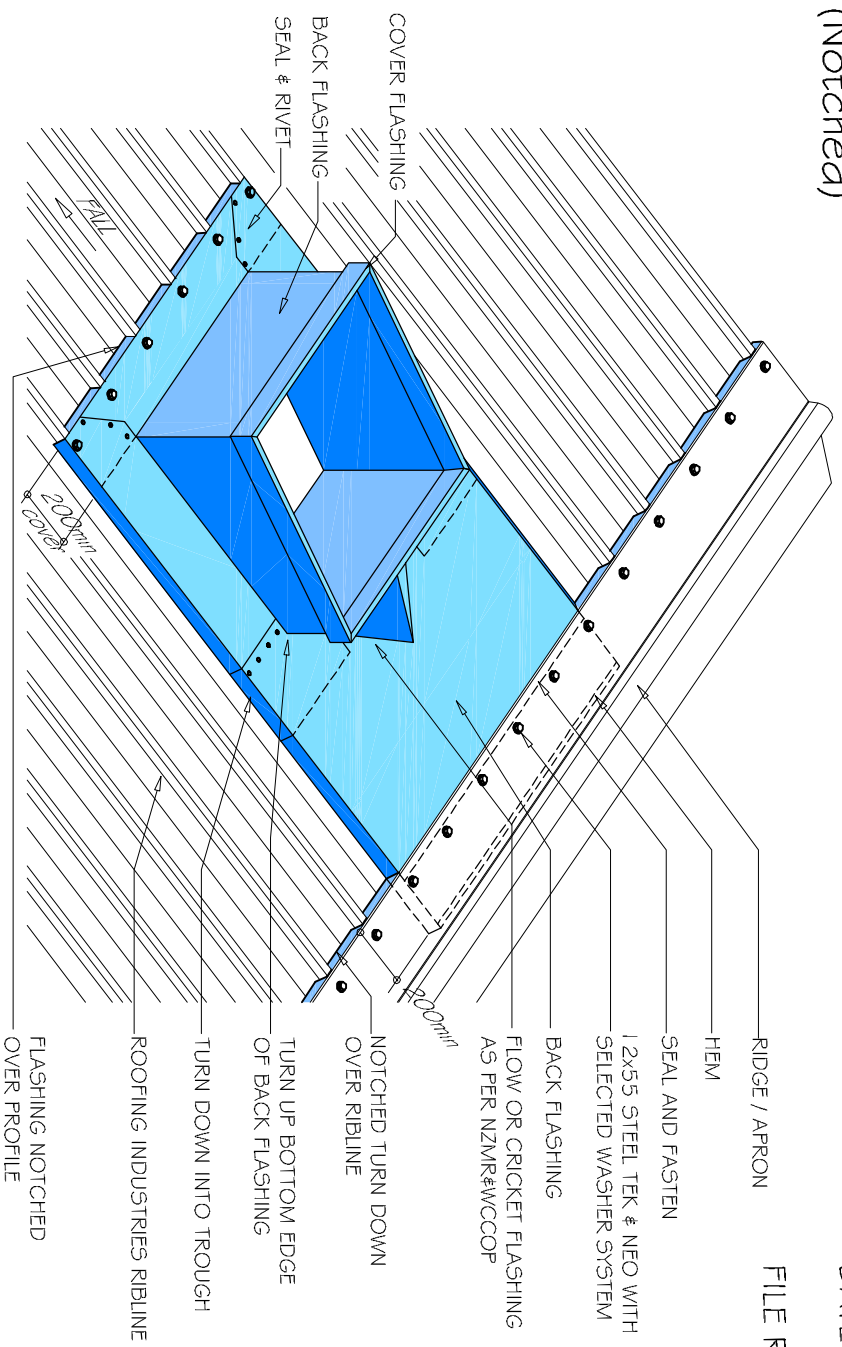
NOTE:
 (1) ADDITIONAL SUPPORT FRAMING MAYBE REQUIRED WHEN PENETRATION EXCEEDS 200mm THROUGH ROOF.
 (2) REFER TO SECTION 6 OF NZMRM CODE OF PRACTICE FOR CATCHMENT AREA LIMITATIONS.
