# No. 1446144.6

SAMPLE DESCRIPTION:  
LVT Aspect range flooring plank samples fixed to a clear Perspex base using:  
- Uzin 888 Cementitious feather finish and absorbent mat used to prepare Perspex to receive plank.  
- KE 66 wet-set dispersion-based (hard set).

## ISO 4760:2022(E) - LAMINATE FLOORING – TOPICAL MOISTURE RESISTANCE – ASSEMBLED JOINT (MODIFIED)

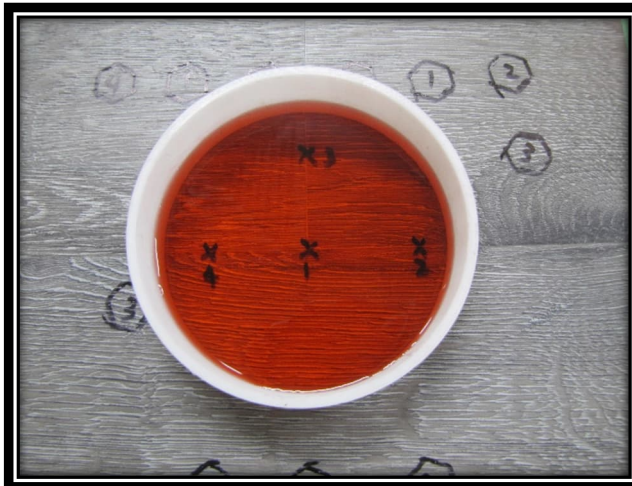
24 Hrs with Water

100 mls of dye solution was applied onto the sample surface. It was poured into a cylinder 100mm diameter placed in the centre of the sample at the "T joint." Sealant was used at the plank/cylinder interface to avoid leakage.

The underside of the sample was inspected through the clear Perspex to enable detection of any dye penetration through the sample.

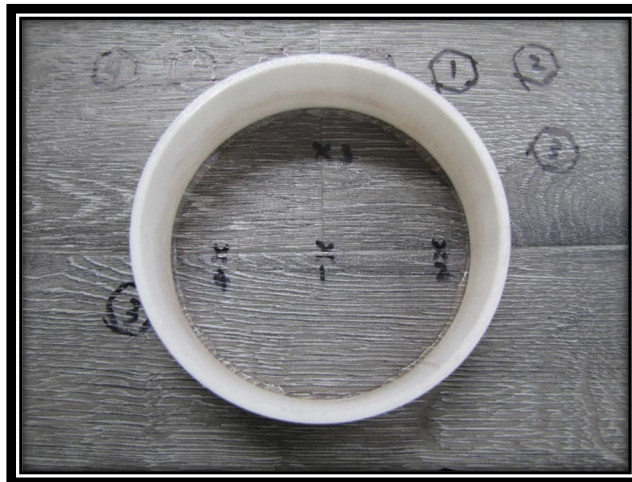
Recovered Swell

Wet Swell			Recovered Swell		
	Specimen 1	Specimen 2	Specimen 3	Specimen 1	Specimen 2	Specimen 3
Qualitative Ratings (individual results):	1	1	1	1	1	1

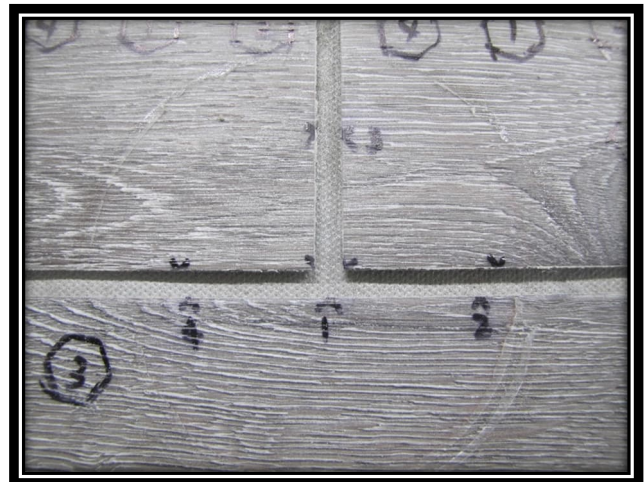
Recovered Swell (Disassembled)

Disassembly Observations:	Specimen 1	Specimen 2	Specimen 3
Migration of water along the upper surface:	No	No	No
Migration of water to the underside:	No	No	No
