# The Research.

NZ Foam set out to get the facts on the costs to insulate a home with different product options available on the New Zealand market. First, we got plans drawn up for a typical new build home with four bedrooms, two bathrooms, and an attached garage by our friends at Fusion Homes.

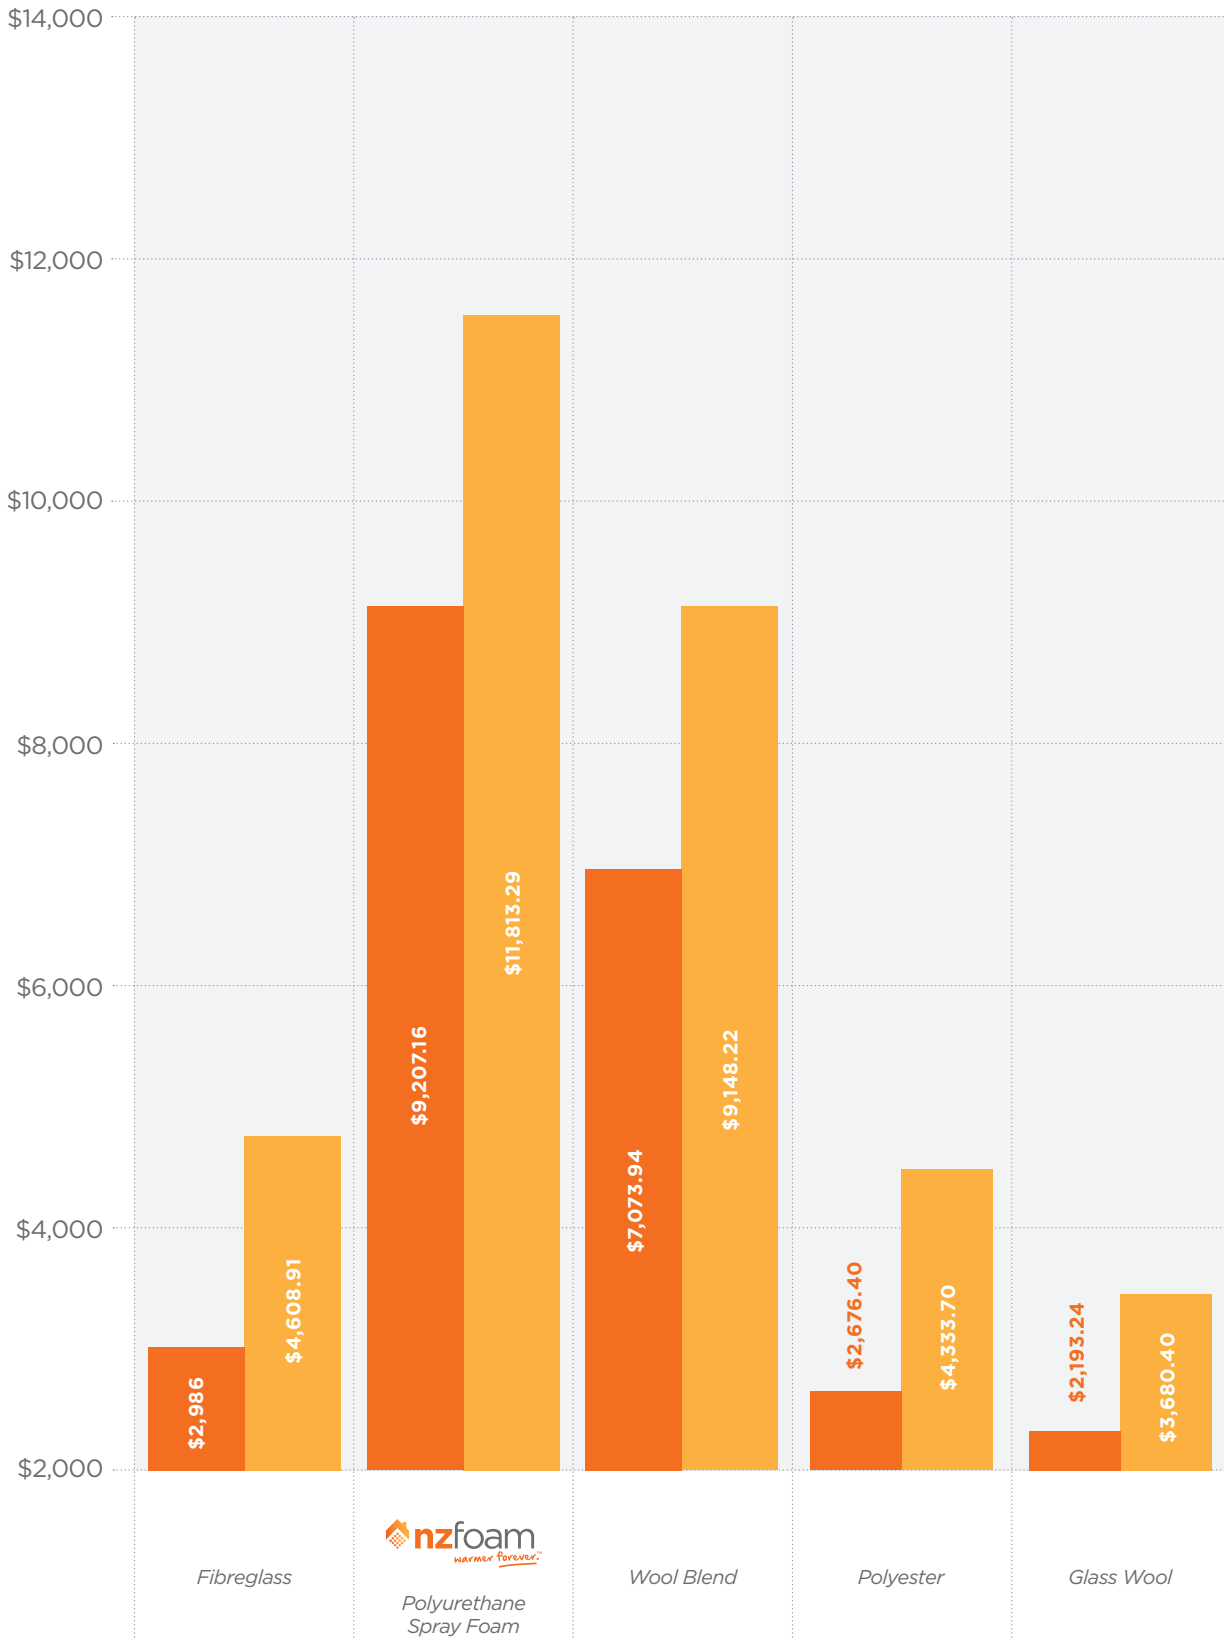
# Price Comparison Graph

**BASIC:** Built to Code - R-2.8 Walls / R-3.6 Ceilings     **UPGRADE:** R-3.6 Walls / R-5.0 Ceilings

Polyurethane Spray Foam	<b>\$9,207.16</b>	<b>\$11,813.29</b>
most popular choice in New Zealand & our main competitor <b>Fibreglass</b>	<b>\$2,986.00</b>	<b>\$4,608.91</b>
<b>Wool Blend</b>	<b>\$7,073.94</b>	<b>\$9,148.22</b>
<b>Glass Wool</b>	<b>\$2,193.24</b>	<b>\$3,680.40</b>
<b>Polyester</b>	<b>\$2,676.40</b>	<b>\$4,333.70</b>

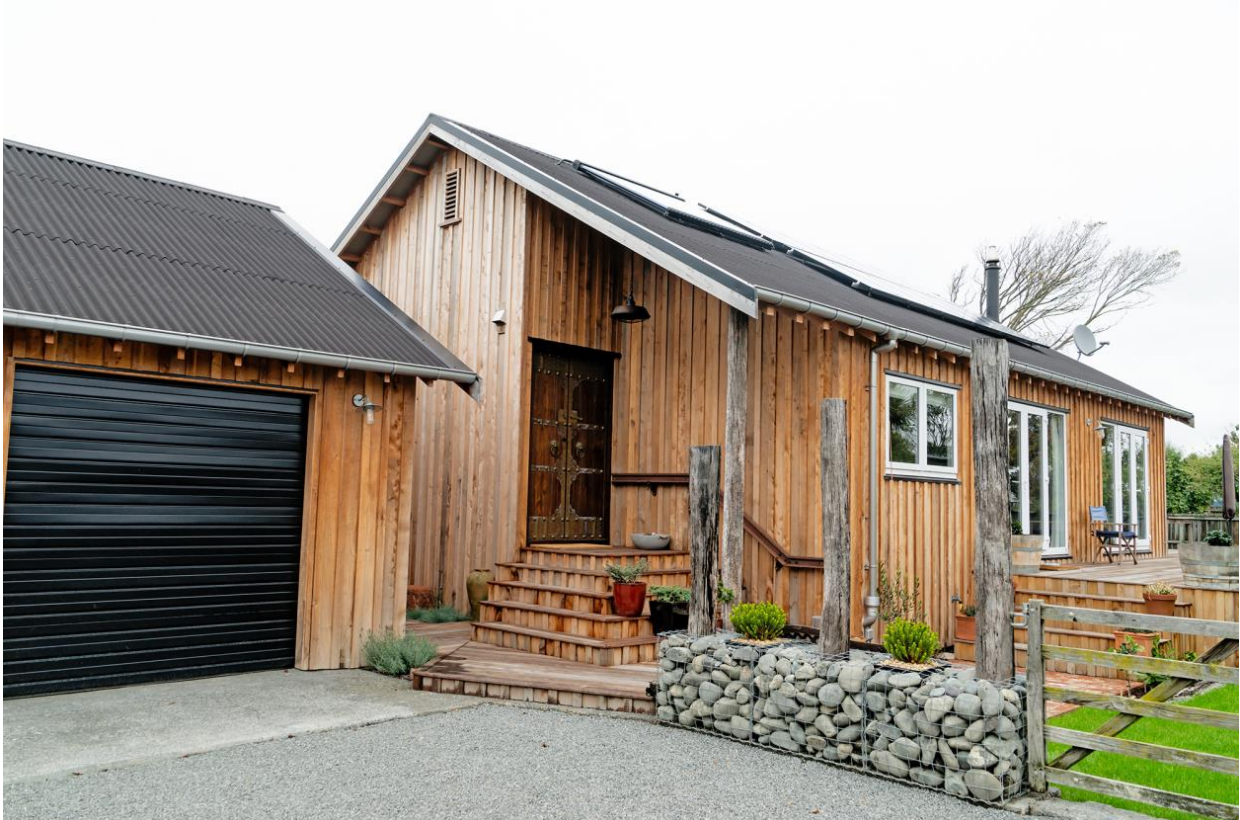
An award-winning family home is creating a buzz, simply because of **NZ Foam** insulation, a product improving the comfort levels and affordability standards for new builds.

**NZ Foam** is the main reason this consistently warm Christchurch abode, built by Fusion Homes, achieved the Lifestyle Award in the Sustainability category in the Canterbury Master Build Awards 2017. This spray-on insulation enabled the home to exceed the minimum government R-value requirements.

What is an R value? This is the official measurement of how well insulated walls can resist heat flow. The government minimum recommendation for R Values is 3.6 for ceilings and 2.4 for 90mm walls. The **NZ Foam** system, in this instance, measured R Values as 5.1 in the ceiling and 3.6 in the walls. There is no need to increase the thickness of the walls to achieve high results. A minimal 70mm layer of foam creates an R Value of 3.13.

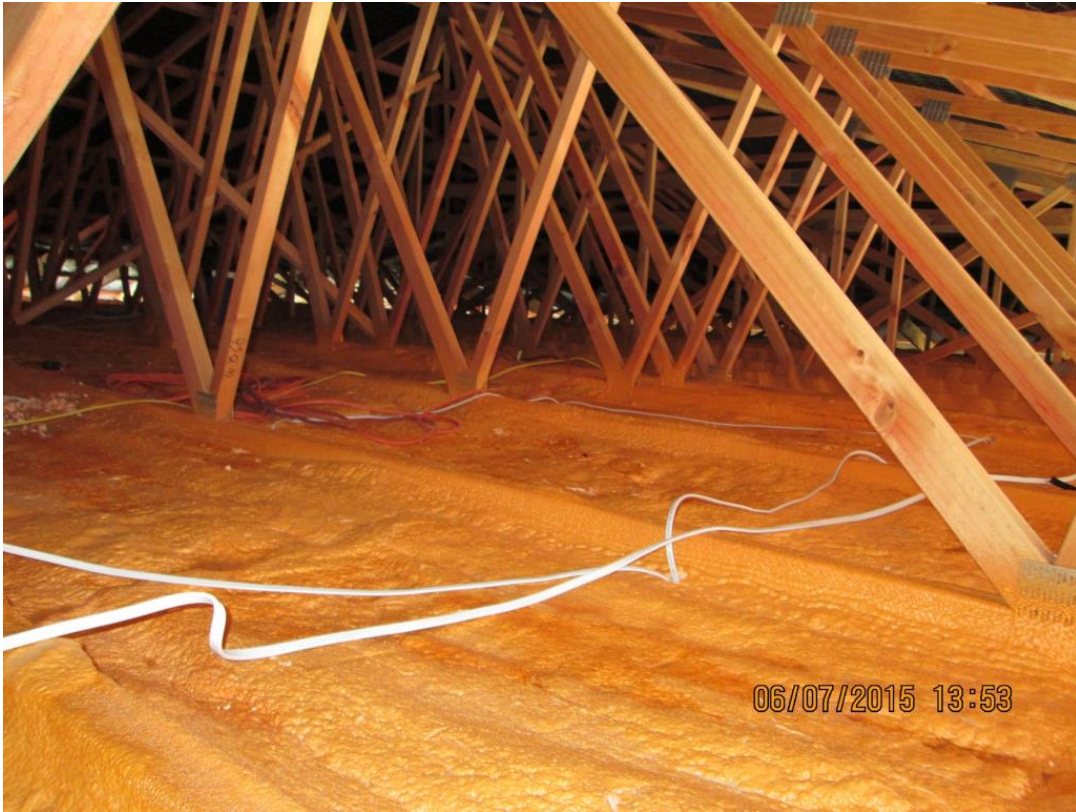
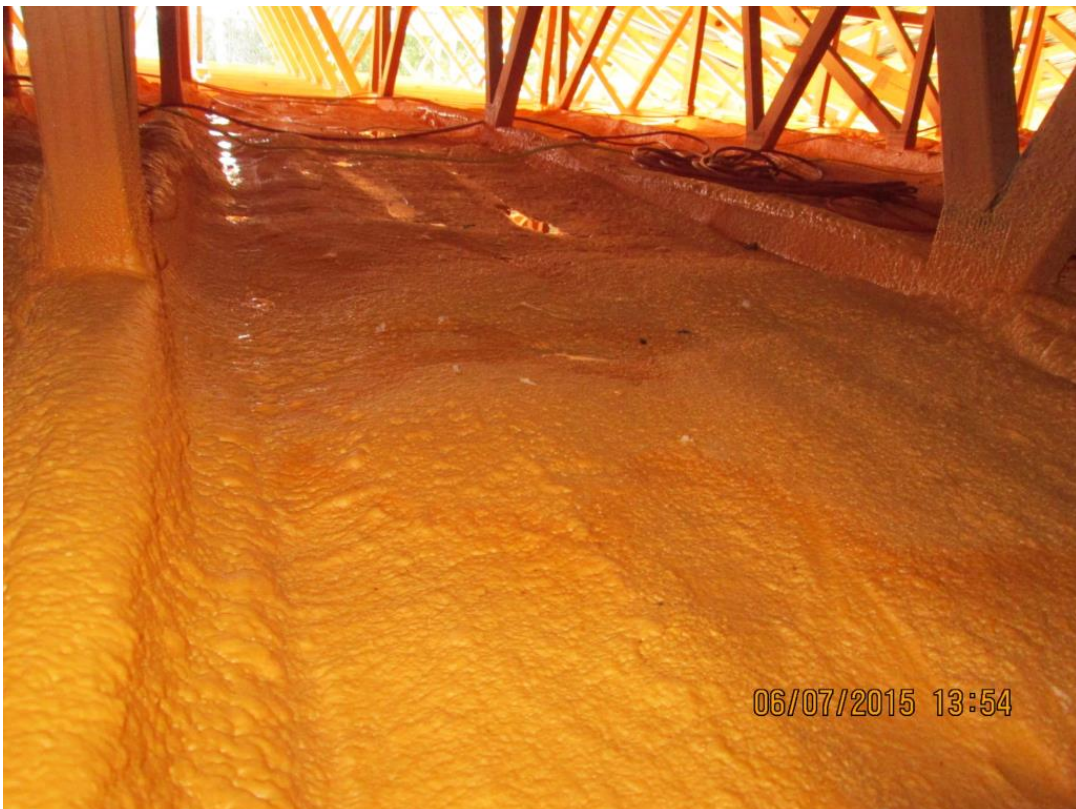
Foam on ceilings

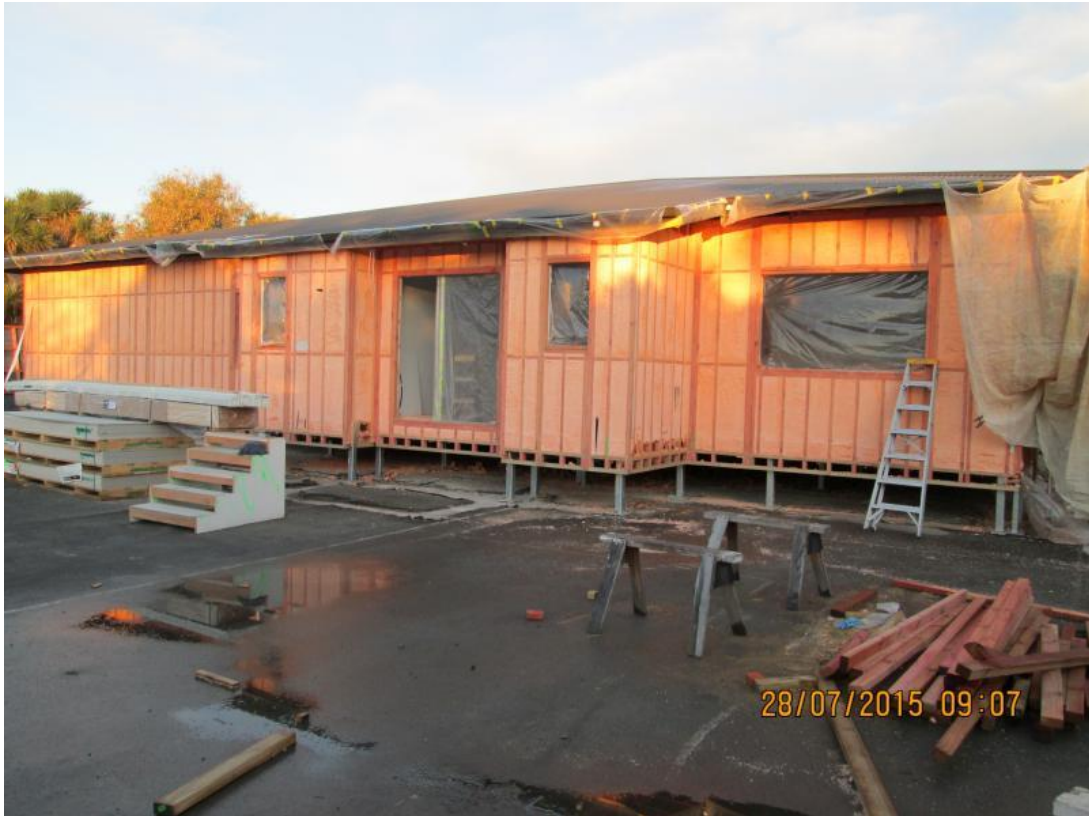
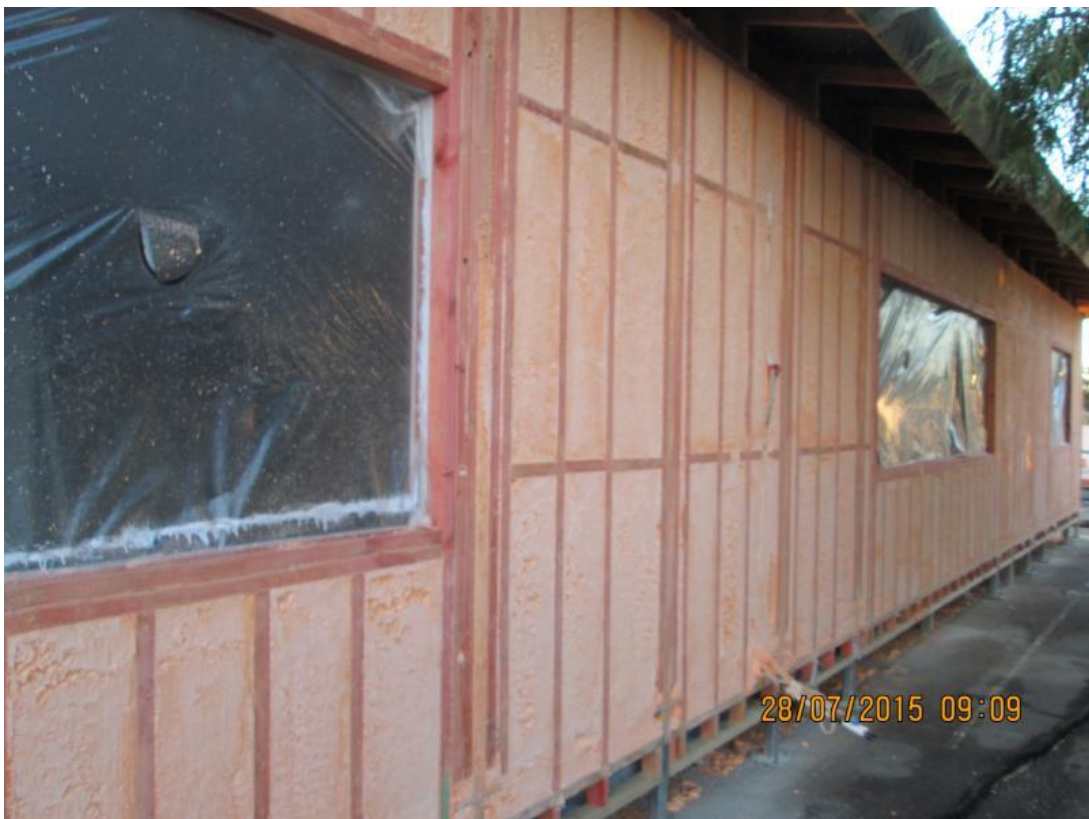
Foam on walls
