STRUCTURES TEST REPORT

ST1234-001-02

FACE LOAD TESTING OF NU-WALL CLADDING USING ALUMINIUM BATTENS

Aluminium Product Brands New Zealand Limited
750B Great South Road
Penrose
Auckland 1061

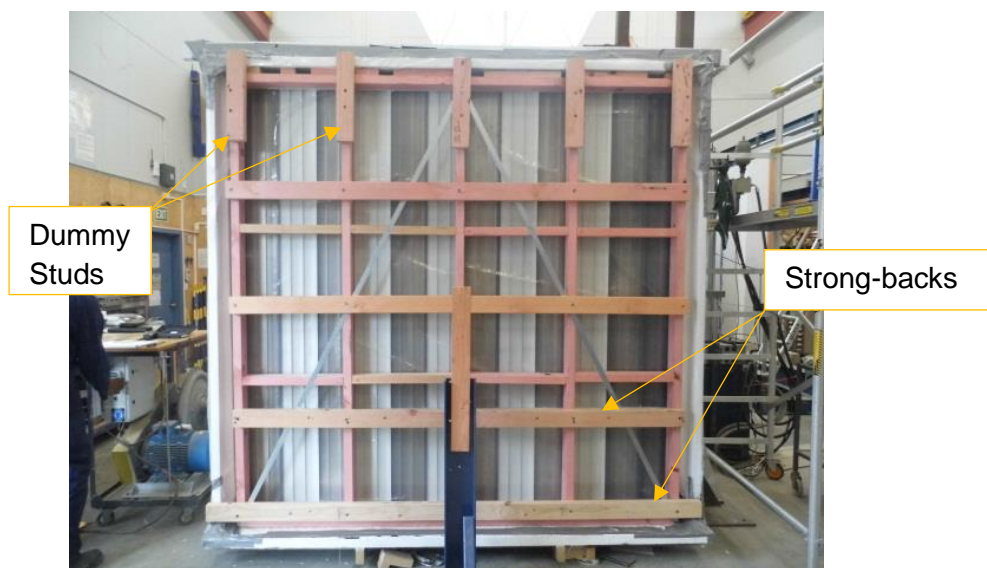
Figure 3. Initial test set up of first three tested specimens shown in pressure box

All specimens were secured in an upright position within the front opening of an airtight pressure chamber with the NuWall exterior cladding positioned on the inside of the pressure box, as shown in Figure 3. The top and bottom plates were securely fixed to the perimeter of the chamber with Tek screws with additional dummy studs sharing the load at the top of the specimen. The sides of the specimens were not fixed to the chamber but were sealed all around using the polythene sheet and adhesive tape to create a seal and allow the specimens to be pressurised uniformly.

Strong-backs were included at bottom plate and at three locations to strengthen the frame. These strong-backs were horizontally orientated 90 mm x 45 mm SG8 timber members that were screwed to the plates and studs as shown in Figure 3 for the first three specimens.

The test procedure used for face load testing is based on AS 4040.2:1992 [1]. The specimens were tested under negative pressure applied to the chamber shown in Figure 3 and Figure 4, corresponding to wind “suction” on a wall. The pressure was applied to the first three specimens with an initial level of 2.0 kPa and then in increasing steps of 0.2 kPa. The pressure was applied to the fourth and fifth specimens with an initial level of 3.0 kPa and then in increasing steps of 0.2 kPa. Each pressure step was held for one minute then released back to zero for 15 seconds before the next level of pressure was applied to the specimen. The maximum pressure resisted by the specimen was the greatest pressure that could be resisted for one minute.

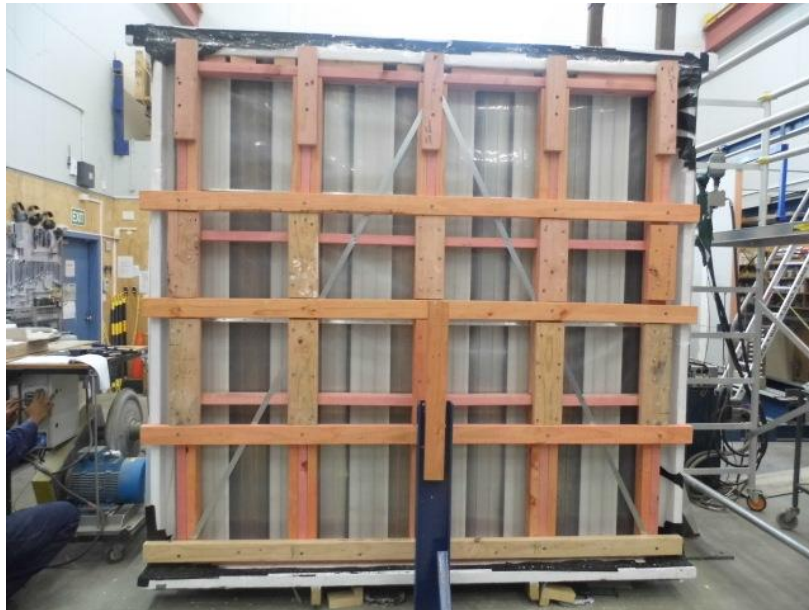
Figure 4. Augmented test set up of first three tested specimens with additional timber and extended strong-backs

Initially these strong-backs did not extend past the width of the specimens so that the specimens could deflect inward during testing. Because the timber frames failed prematurely starting with the first specimen tested, additional timber was added to the frames and the strong-backs were extended to restrain the specimens from excessive deflections as shown in Figure 4. Similar reinforcing was used for the first three specimens tested. Because the fourth and fifth specimens included doubled studs and 140 mm deep framing, it was not necessary to reinforce the frame, but the same strong-back configuration was used. These modifications were not considered to prejudice the conclusions reached in this report as the tests were intended to test the cladding and cladding fixings and not the framing.

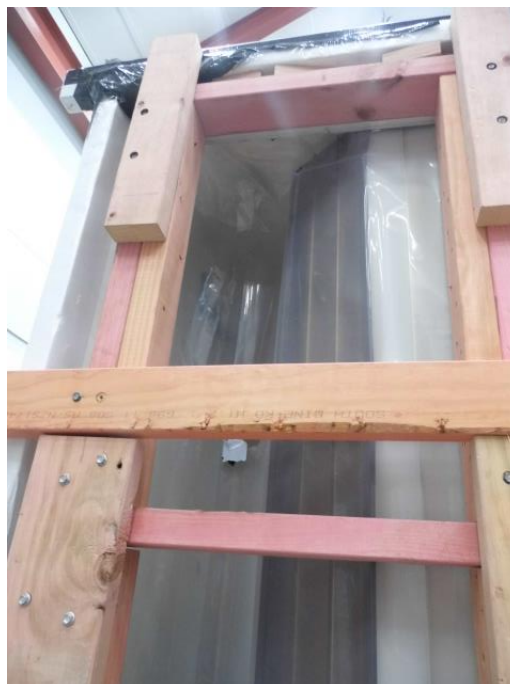
Figure 5. Typical failure of first three specimens starting with first board

The first three face load specimens behaved in a similar manner to one another. Because the framing was only 90 mm deep and included significantly sized knots there were premature failures of the framing. At the lower pressure levels these framing failures did not create perforations in the cladding and therefore the testing was continued once the frames were reinforced and strong-backs extended as described in Section 3.2 of this report. Final failures of the first three specimens were primarily due to peeling away of the aluminium cladding starting with the first board that was located using the Nu-Wall NC232F locator brackets as seen in Figure 5. Failures of the framing leading up to the cladding failures made it difficult to determine the exact initiation of failures but it was assumed there was some contribution from the first board cladding fixings and the framing failures.
