## **WARM ROOF RETROFIT INSULATION & WATERPROOFING SOLUTION – VIKING GROUP HEAD OFFICE ADMINISTRATION**

**CHALLENGE: THE ADMINISTRATION BLOCK AT VIKING GROUP'S HEAD OFFICE IN OTARA HAD AN OLD STEEL ROOF (APPROXIMATELY 450M<sup>2</sup>) WITH MINIMAL SLOPE WHICH HAD BEEN LEAKING FOR DECADES.**

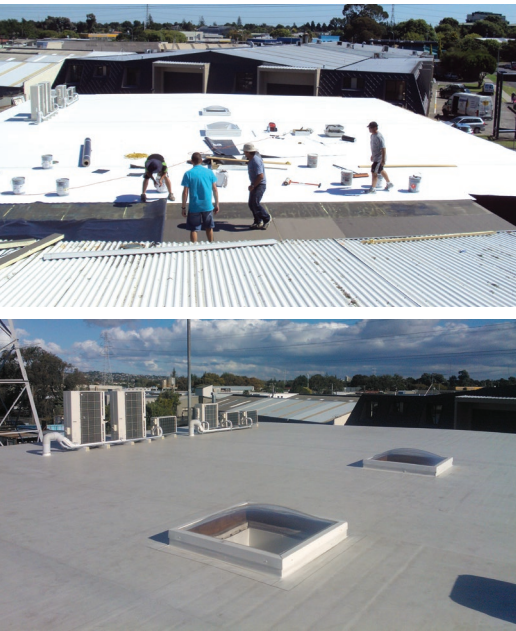
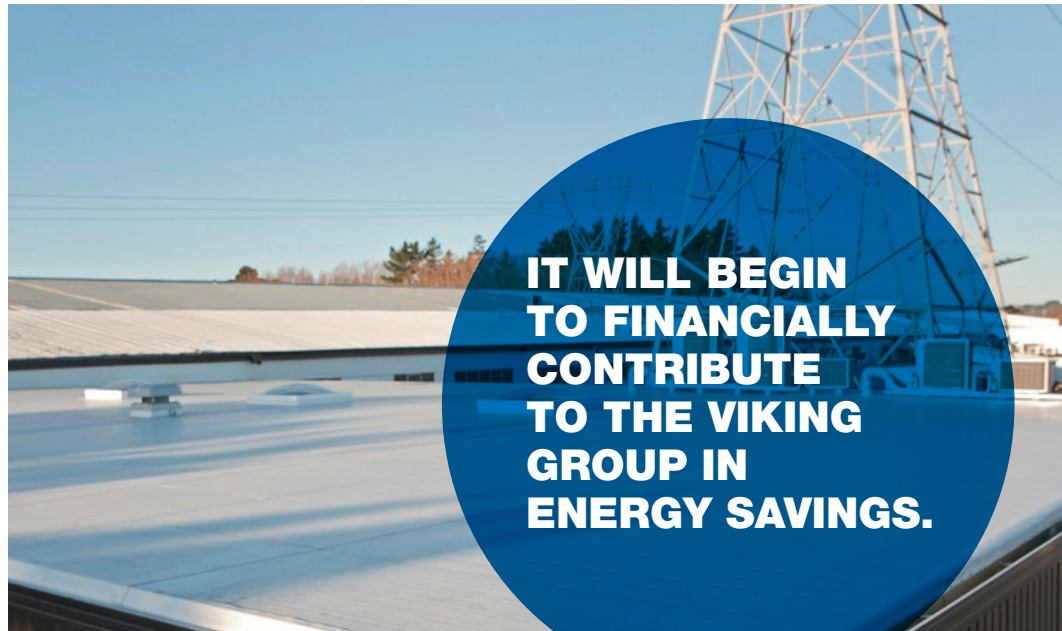
The roof had been patched over the years but the time had come for a full replacement. The traditional method would normally have been to:

Rather than remove the existing steel roof, the Warm Roof was installed on top, negating the need for protection of the interior.

Having water-blasted the roof and removed old vents, skylights and other penetrations that would become redundant, the team began the installation process.

First, they cut 50mm thick polyisocyanurate insulation panels (R-value= R-1.1 per 25mm

thick) into 180mm wide strips and adhered them inside every second tray of the existing Brownbuilt steel roof profile (using Carlisle's F.A.S.T. 2-part polyurethane adhesive system applied with a specialised battery-powered caulking gun).

This covered 50% of the existing roof, whilst providing a sound base on which to install a second full layer of 63mm polyisocyanurate - also applied using F.A.S.T. adhesive. (a warm roof must provide 100% insulation cover where physically possible to be effective and classified as a proper warm roof).
