## **TE KUITI POST OFFICE - KING COUNTRY**

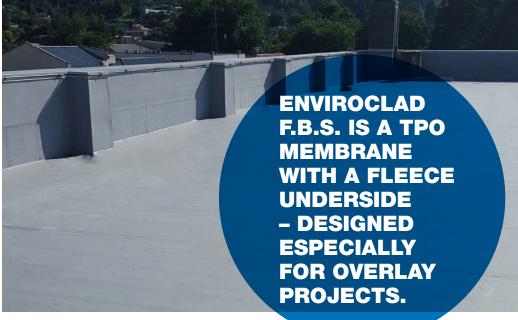
CHALLENGE: THE 60 YEAR-OLD TE KUITI POST OFFICE BUILDING HAD AN 850M2 FLAT ROOF, CLAD WITH A VERY OLD TORCH-ON MEMBRANE THAT WAS LEAKING. IN MANY AREAS, THE MEMBRANE HAD CRACKED OR LIFTED FROM THE ROOF COMPLETELY. PAST REPAIR EFFORTS WERE EVIDENT IN THE FORM OF LIQUID FIBREGLASS PATCHES IN SOME AREAS, AND TORCHON MEMBRANE PATCHES IN OTHERS. THE AREAS OF LIQUID FIBREGLASS HAD WRINKLED AND BUBBLED INDICATING THAT WATER HAD TRACKED UNDERNEATH.

To begin with, the roof was stripped back to the bare concrete wherever practical. Sections

of the existing membrane that were too tough to remove were left in place, seeing they had proven to be well bonded already. The concrete substrate was then moisture tested to decipher the extent of any water ingress. As some moisture had found its way into the concrete, a drying period was necessary to allow the trapped moisture to evaporate. Some grinding and levelling of parts of the 60 year-old concrete was also required.

Once the substrate was prepared and dry, the Enviroclad F.B.S. membrane was adhered to it. This was exactly the kind of situation this 3.6m wide, heat-weldable, fleece-backed TPO membrane was designed for, as its underside was able to forgive most of the unorthodox substrate comprising of bare concrete and stubborn old bitumen, by providing a surprisingly flat membrane surface. Maximum bond to this aged-surface was achieved through the use of Viking's specialised Dual-Cartridge F.A.S.T.

expanding polyurethane adhesive system; the wind uplift resistance of which rivals mechanical fastening.
