# COMMERCIAL CORRUGATE ROOFING CABLE ENTRY PENETRATION FLASHING

Detail Number: RI-CCR020A

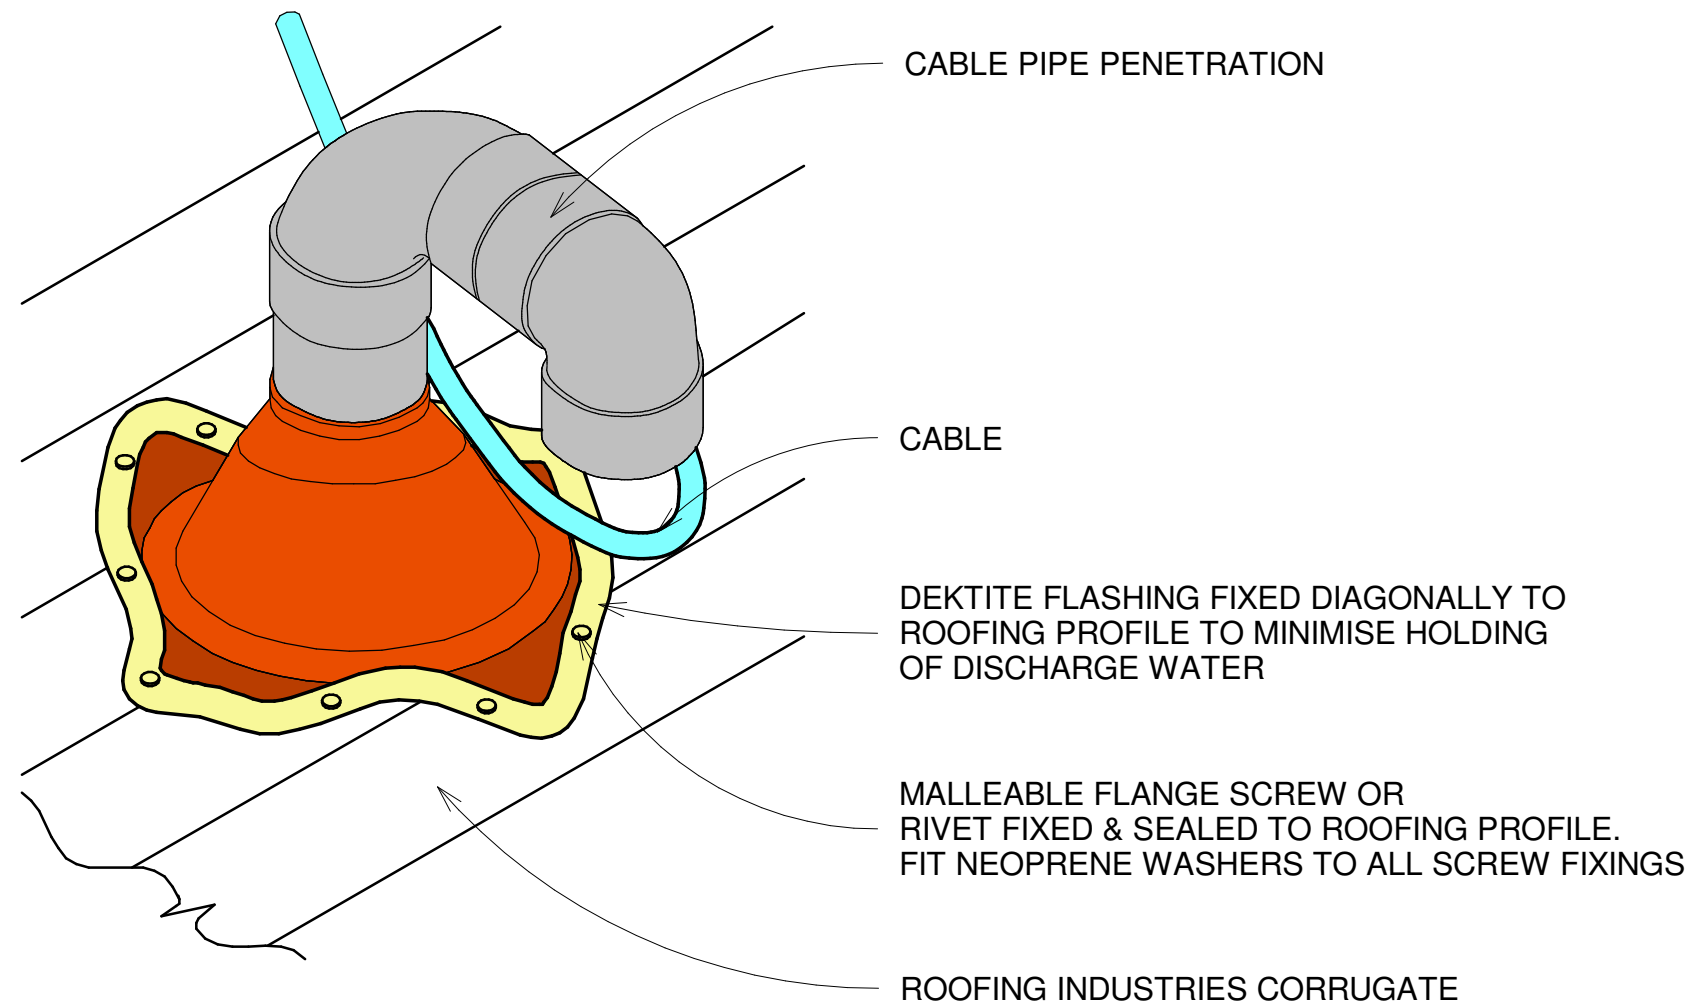
1. FOR PIPES UP TO 85mm DIAMETER.
2. MAX ROOF PITCH FOR THIS FLASHING 45°, MIN PITCH 8°
3. INSTALL ADJACENT TO PURLIN FOR SUPPORT WHERE POSSIBLE, NO PANS TO ENTRAP WATER.
