## COMMERCIAL CORRUGATE ROOFING 175 BOX GUTTER DETAIL (External Bracket)

## Detail Number: RI-CCR031B Date drawn: 01/08/2019 Scale: 1:5@ A4

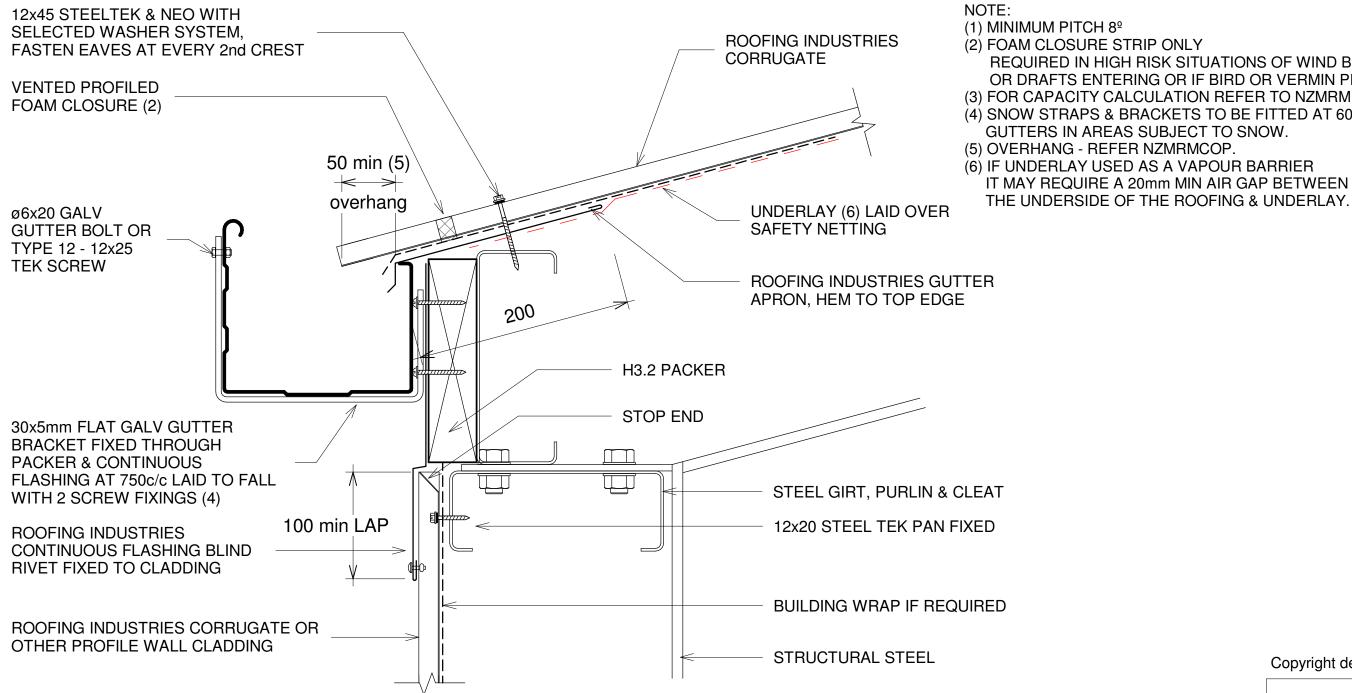
REQUIRED IN HIGH RISK SITUATIONS OF WIND BLOWN MOISTURE OR DRAFTS ENTERING OR IF BIRD OR VERMIN PROOFING IS REQUIRED. (3) FOR CAPACITY CALCULATION REFER TO NZMRM CODE OF PRACTICE. (4) SNOW STRAPS & BRACKETS TO BE FITTED AT 600c/c TOP OF ALL
