FIRE TYPE TEST REPORT

FR12976-001

FIRE RESISTANCE TEST OF A LOADBEARING 36 MM THICK METRA PANEL WALL SYSTEM IN ACCORDANCE WITH AS 1530.4:2014

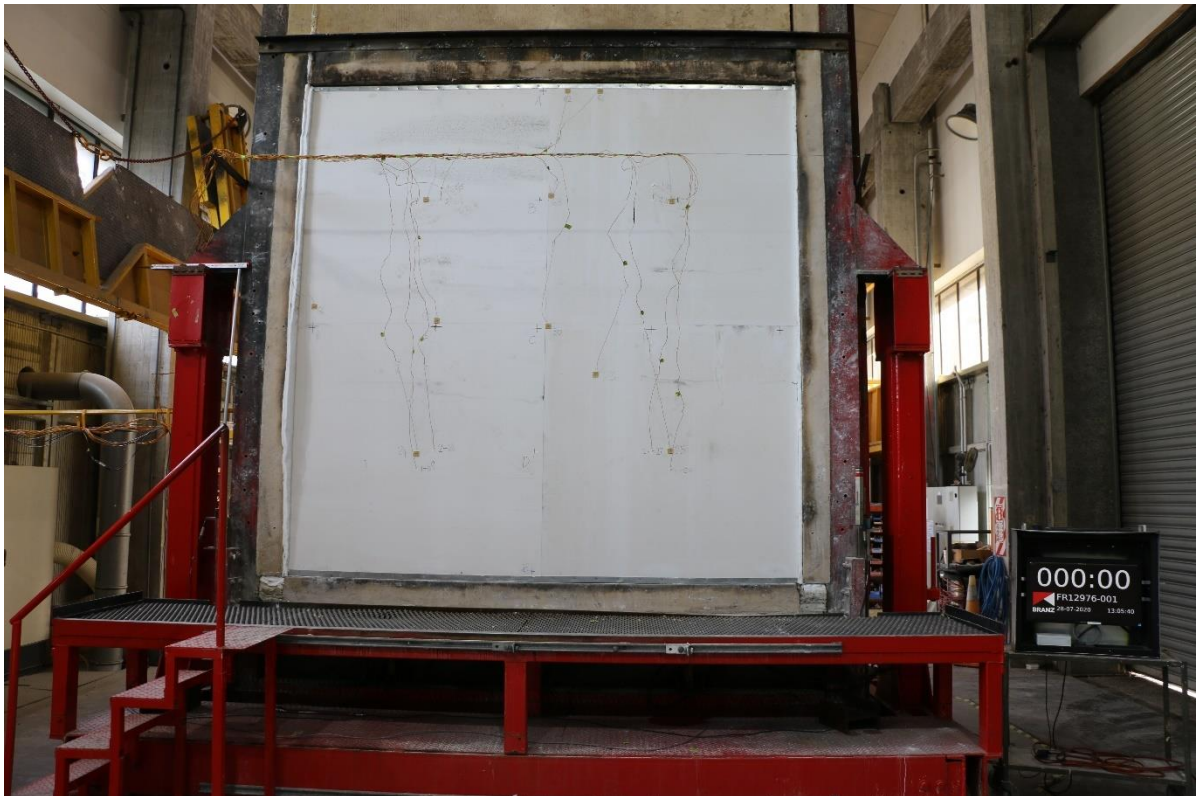
Photo 1: The Unexposed Face of the Specimen Prior to Testing

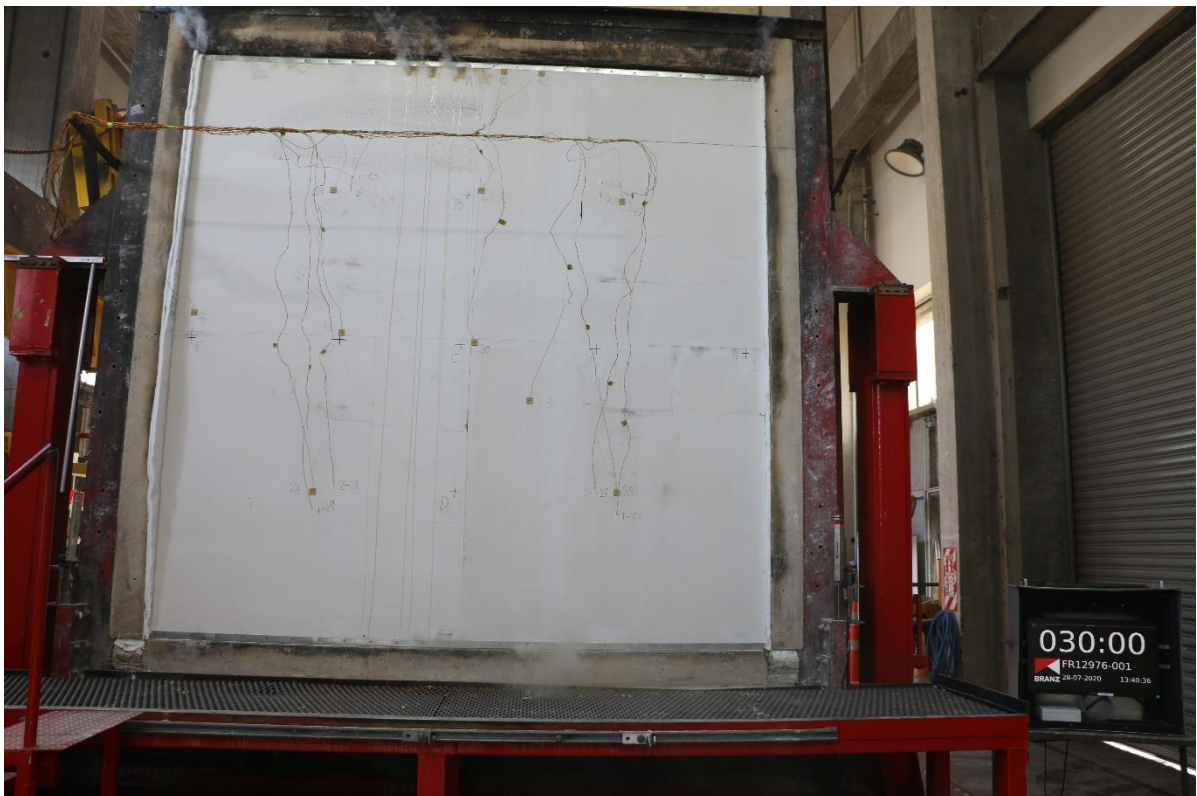
Photo 2: The Unexposed Face of the Specimen After a Duration of 30 Minutes

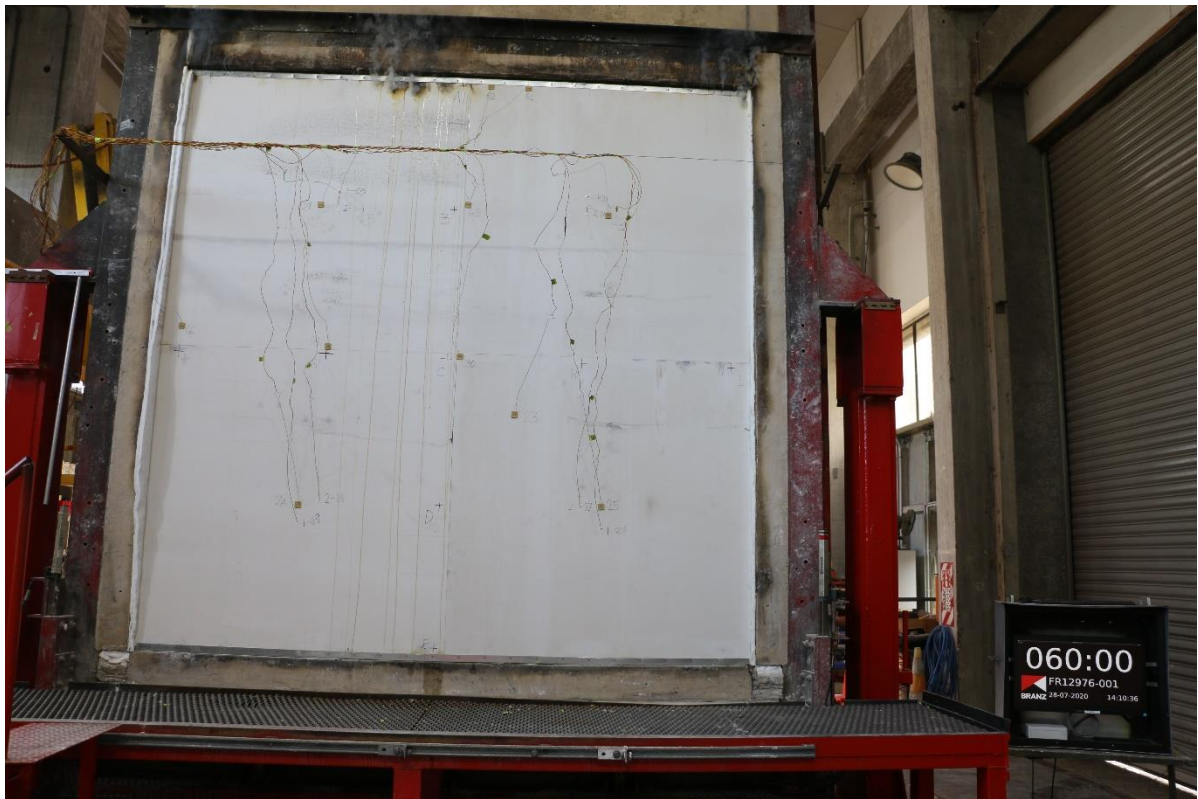
Photo 3: The Unexposed Face of the Specimen After a Duration of 60 Minutes

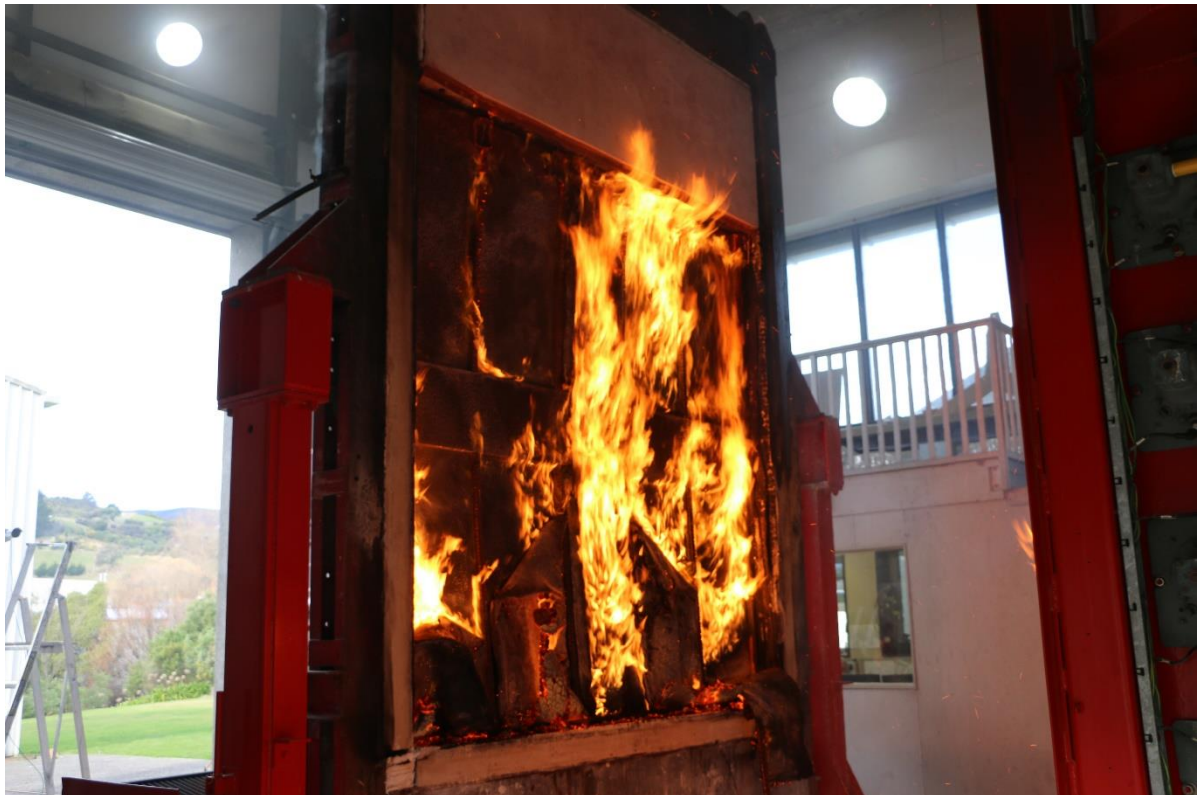
Photo 4: The Exposed Face of the Specimen Immediately After Testing
