## **Test Report**

**Test Number PF19022**

**Fire resistance test for wall timber  
penetrations**

**Test method AS 1530.4:2014**

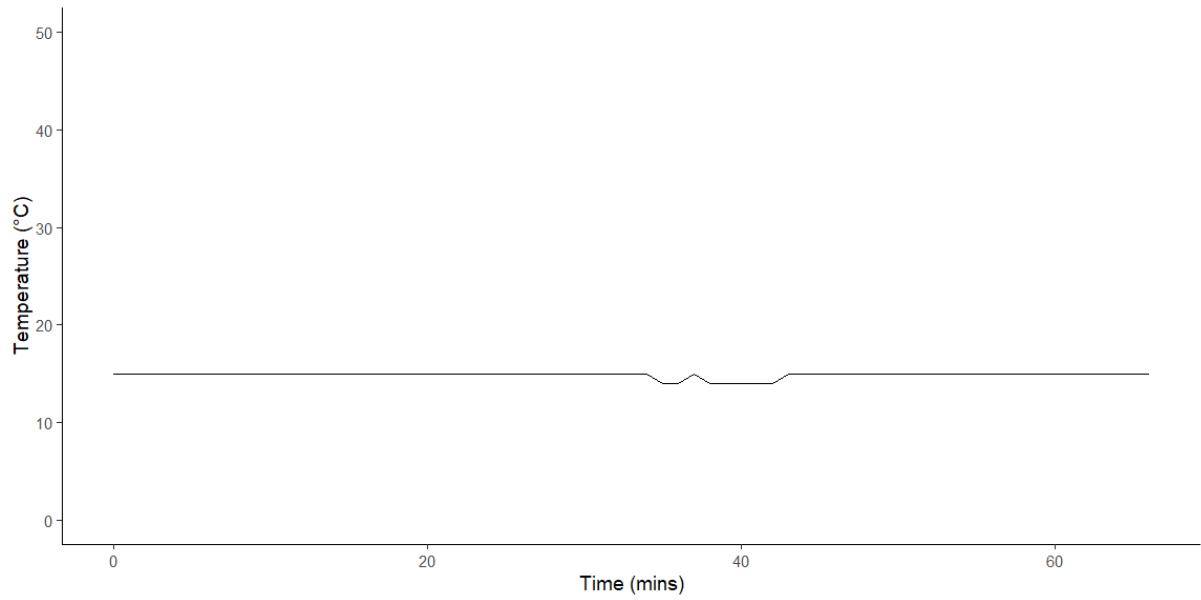
Ambient Temperature:

The ambient temperature of the test area at the commencement of the test was 15°C.

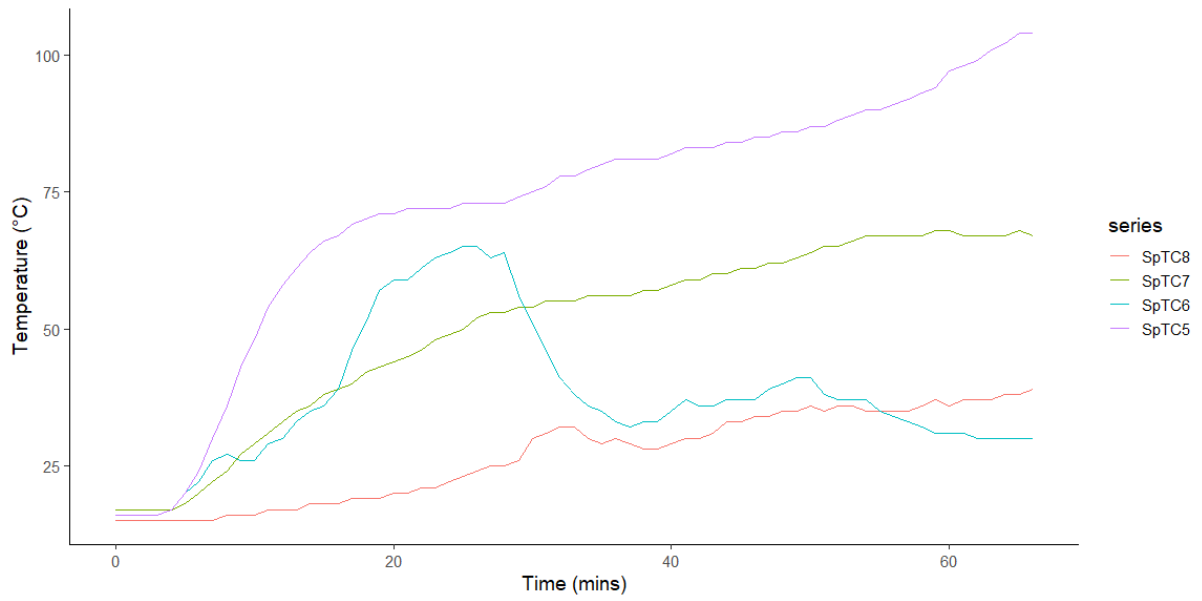
**Specimen 1 Thermocouple Temperature Readings**

Structural adequacy	66
Integrity	66
Insulation	66

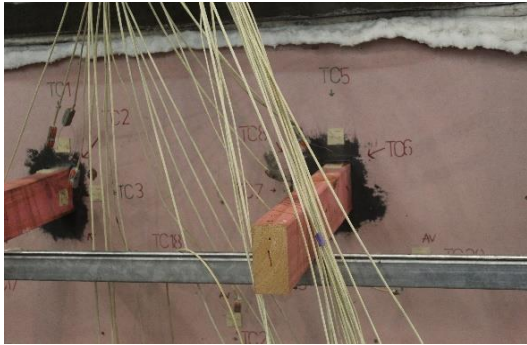
20-30 min – unexposed face

Time Minutes	Test Face	Observations
1	U	Smoke release at specimens 3 and 4
2	U	Smoke release specimen 2
5	U	Smoke release specimen 1
6	E	Paper falling off plasterboard
7	E	All timbers now burning
9	E	Ply now burning
10	E	Paper now completely burnt off plasterboard, gypsum holding together
13	U	Small smoke release now from all specimens
16	E	Ply started charring
19	U	Heavy smoke release from specimen 3 and 4
21	E	All specimens now fully burnt and exposed ends charring
25	U	Heavy smoke release to specimen 3
26	NA	Minimal smoke release to specimens 1,2 and 4
34	E	Ply and timber have fallen off specimen 3
36	E	Timber fallen off specimen 1
39	E	Timber fallen off specimen 2
42	U	Excess smoke releases all specimens
50	E	Timber fallen off specimen 4
55	E	Plasterboard starting to crack
66	NA	Test stopped
69	NA	The unexposed face shows the initial signs of charring against the plasterboard
