Test Report

Test Number PF19056

**Fire resistance test for Concrete Midfloor
(25mm timber infill topped with 75mm thick
reinforced concrete) with 1000 μ m of FBL-100
intumescent coating**

Test method AS 1530.4:2014

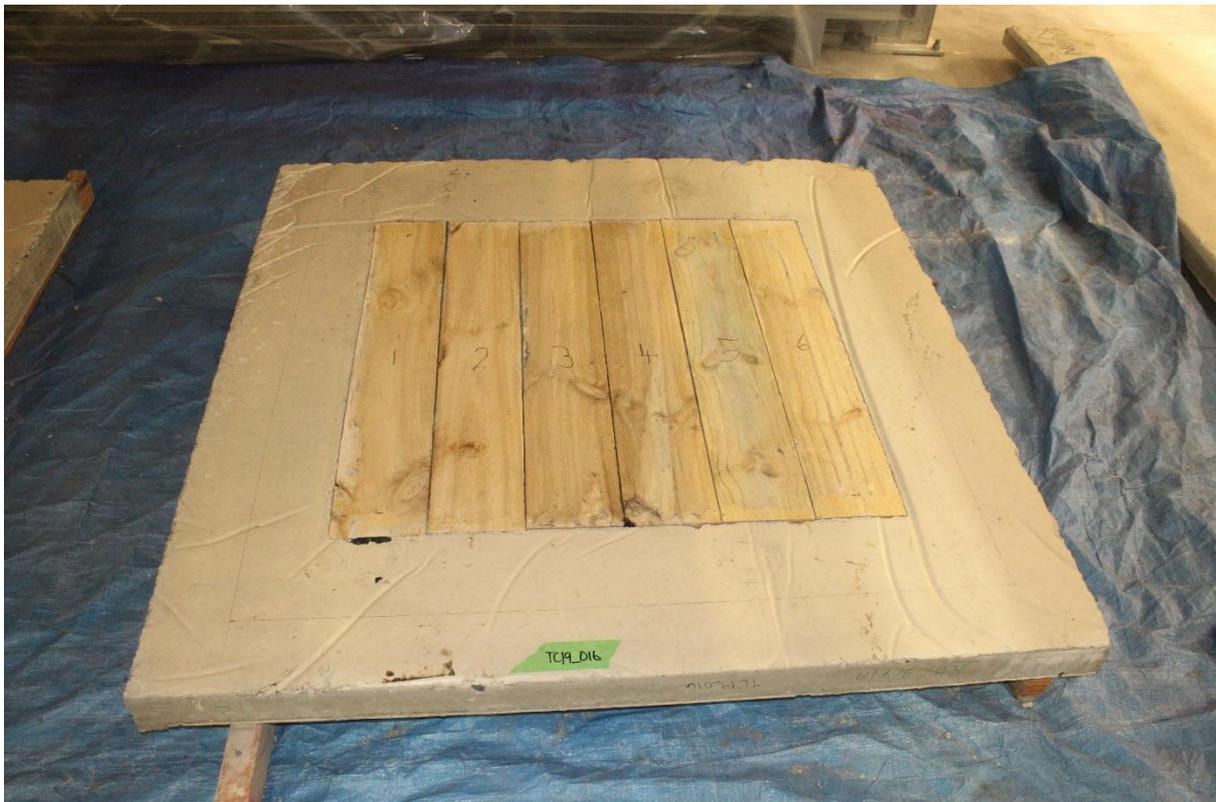
Design overview:

Concrete Midfloor consisting of 155mm x 25mm rough sawn radiata pine timber infill topped with 75mm thick reinforced concrete. Concrete slab with timber infill was done by laboratory.

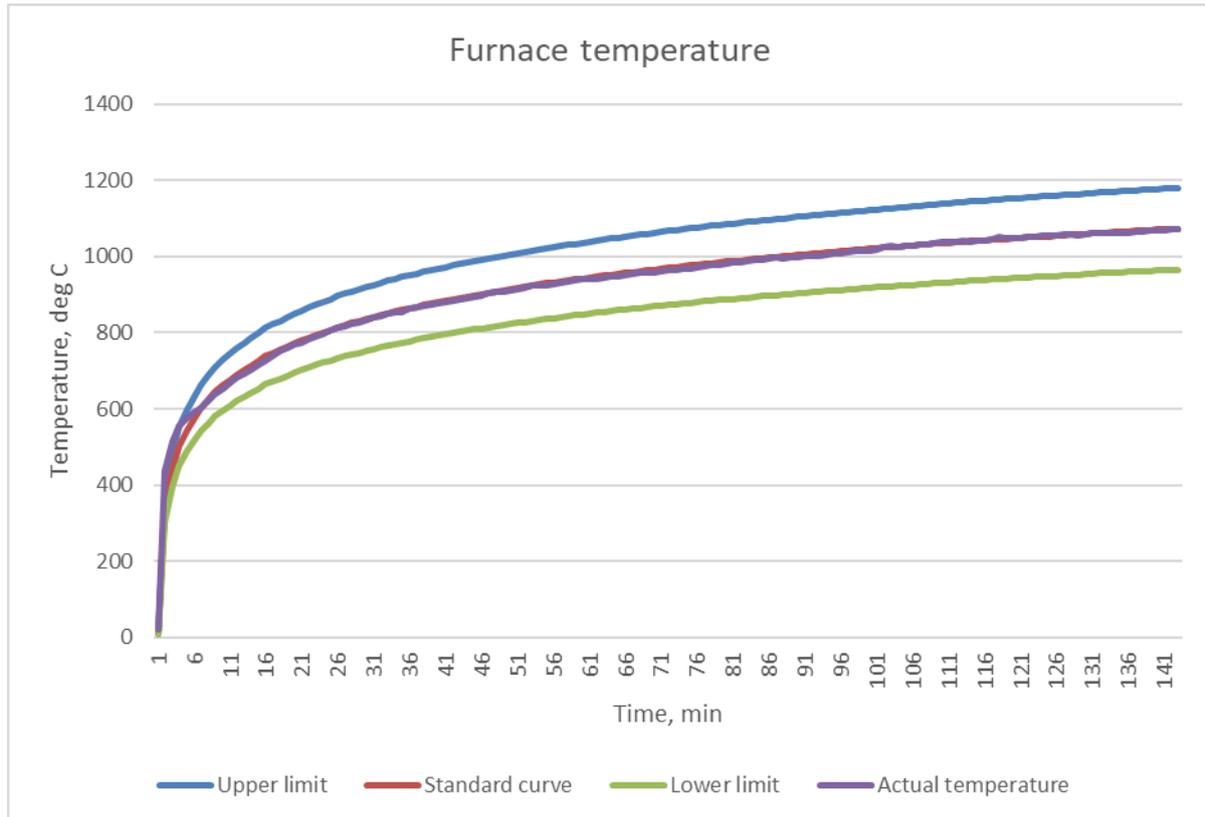
Furnace Temperature

The furnace was controlled to follow the temperature/time relationship specified in AS 1530.4-2014 as closely as possible.

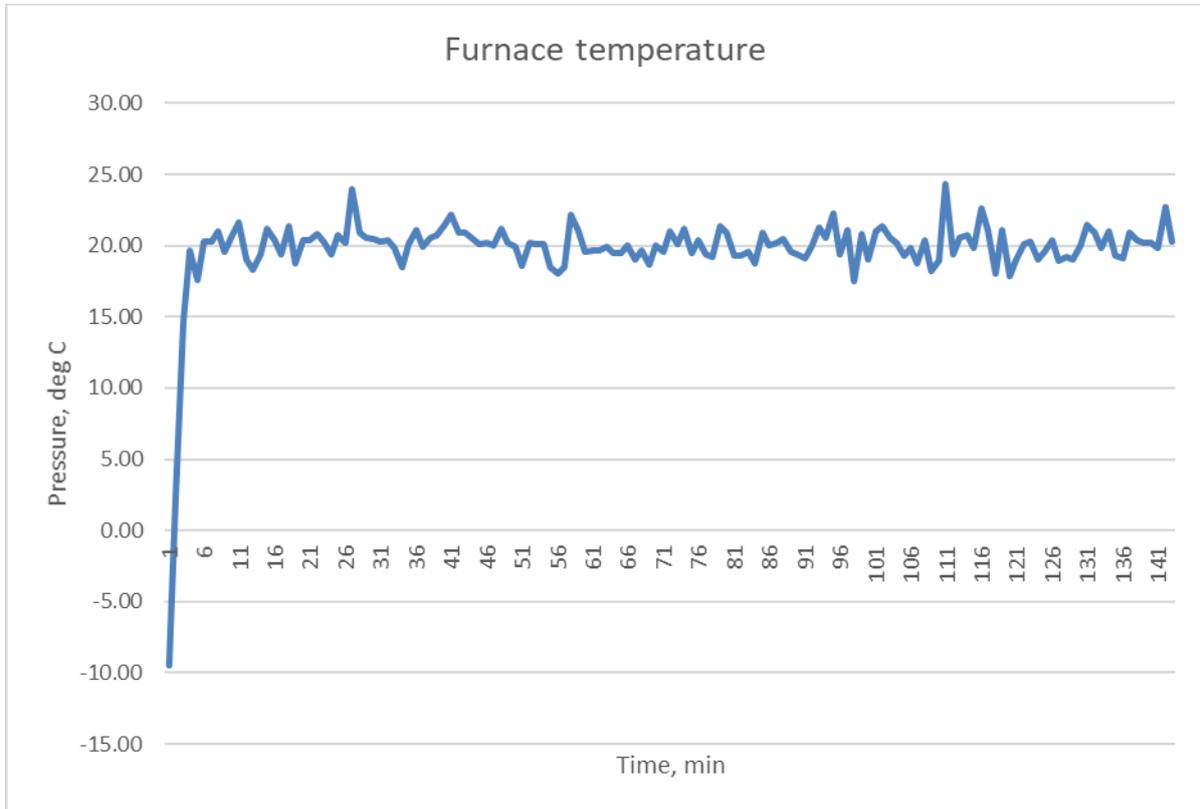
Pressure Readings

After the first 10 minutes of the test the furnace pressure was maintained at 20 ± 3 Pa with respect to atmosphere. Probe was located 100mm below furnace top and set to 20 pascals.

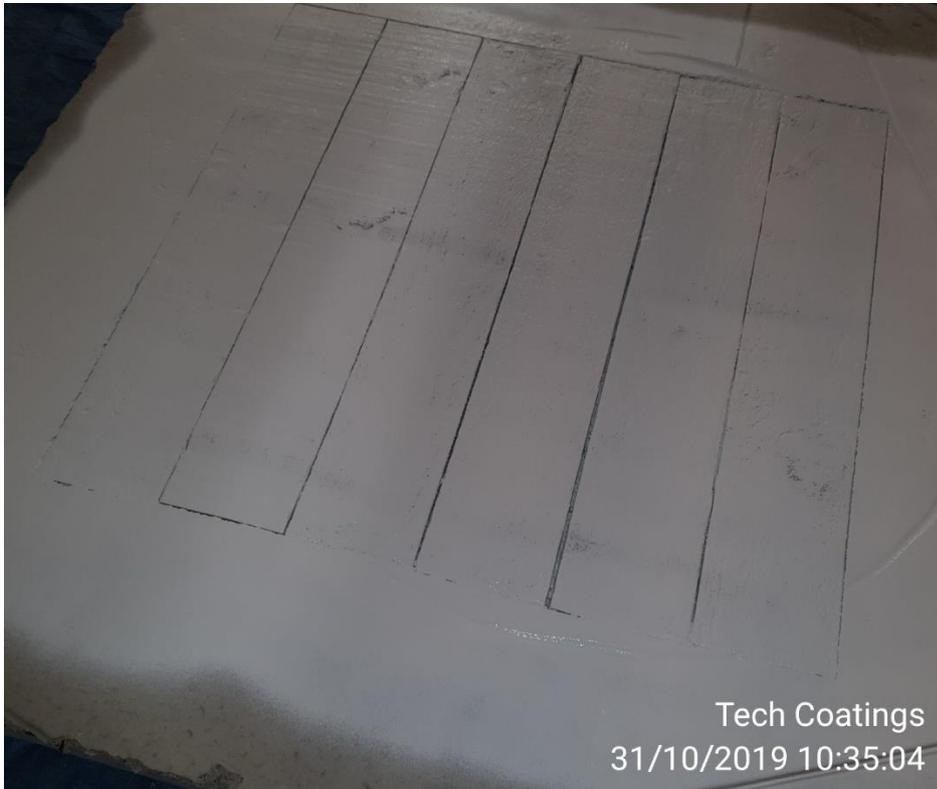
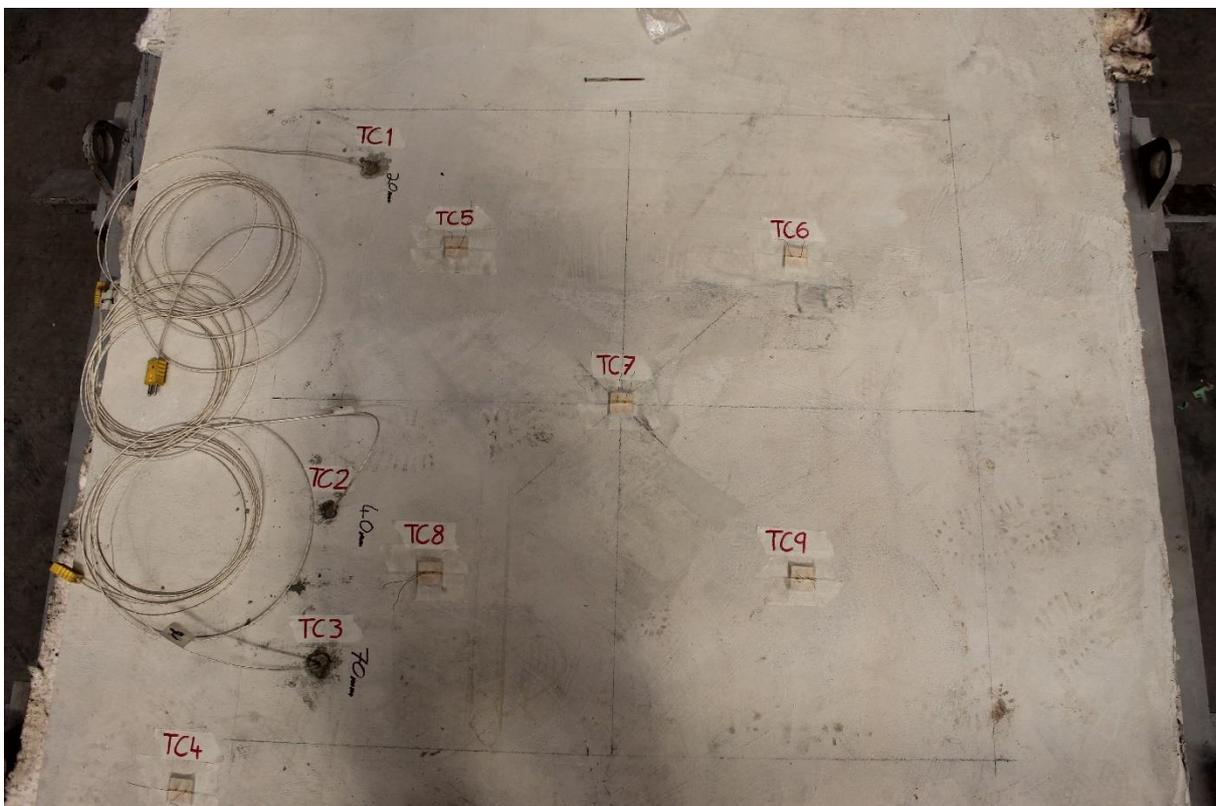
Test Specimens details

The separating element has been constructed with a 1.45m x 1.45m x 75mm concrete topping on a 900mm² bed of 150 x 25 rs h3.2 timber infills.

The slab has been cast with vibrated 30mpa structural concrete to a depth of 75mm above the timber infill and 100mm depth to the entire perimeter of 150mm wide thus encapsulating the timber infills with concrete leaving a flush joint on the exposed side between timber infill and concrete. D12 reinforcing bars have been installed on 20mm plastic chairs leaving top reinforcement cover of 31mm concrete. The slab has been trowelled to a smooth finish.

FBL-100 was applied to the test specimen at a nominal DFT of 1000µm. Coating was provided by Client. Application was performed by Client according to Client internal procedures in two layer. Second layer was applied after first dried. Direction of spraying of second layer was 90 deg to direction of the first layer, no additional application for timber joints.

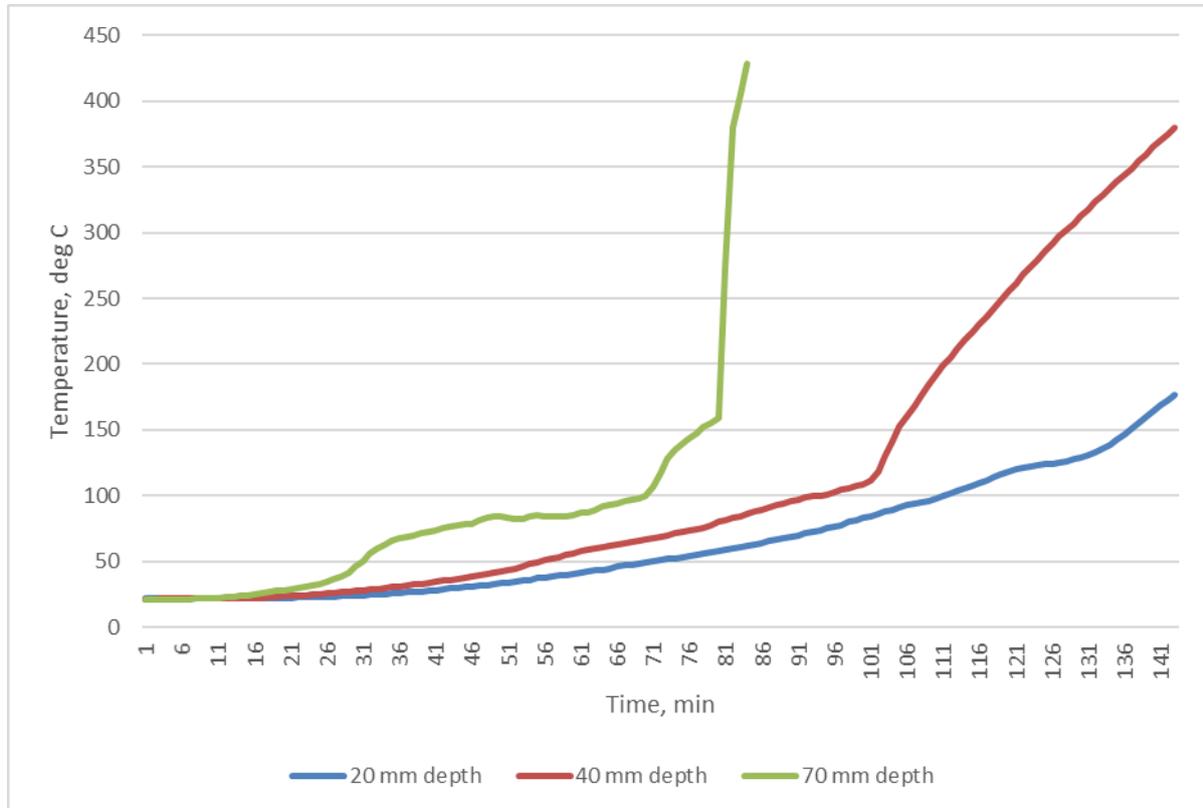
Slab thickness temperature gradient (for Client research purpose only, not a failure criteria)
