TEST REPORT

SLIP RESISTANCE CLASSIFICATION OF NEW PEDESTRIAN SURFACE MATERIALS

AS/NZS.4586:2004
Appendix A - Wet Pendulum Testing
Appendix B - Dry Friction Testing

Residential Mighty Oak

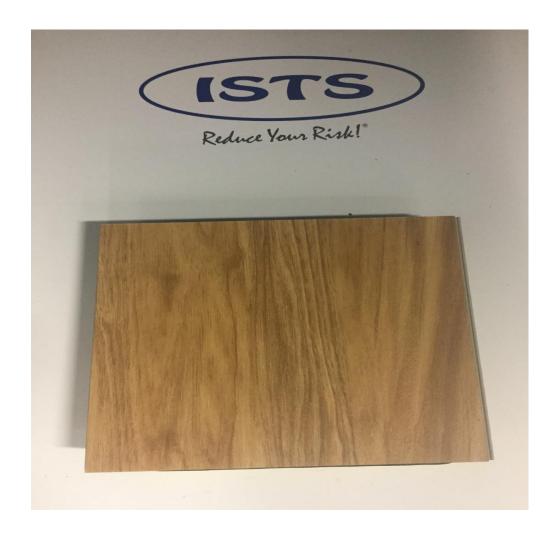
TEST PRODUCT IMAGE

Product Description: Residential Mighty Oak
