Tensile Adhesion Strength Test

Tech Coatings contracted New Zealand Corrosion Services to conduct tensile adhesion strength tests of FBL-100 Intumescent Coating System on the following samples:

INSPECTION REPORT No: **TCL PFP 001-01**

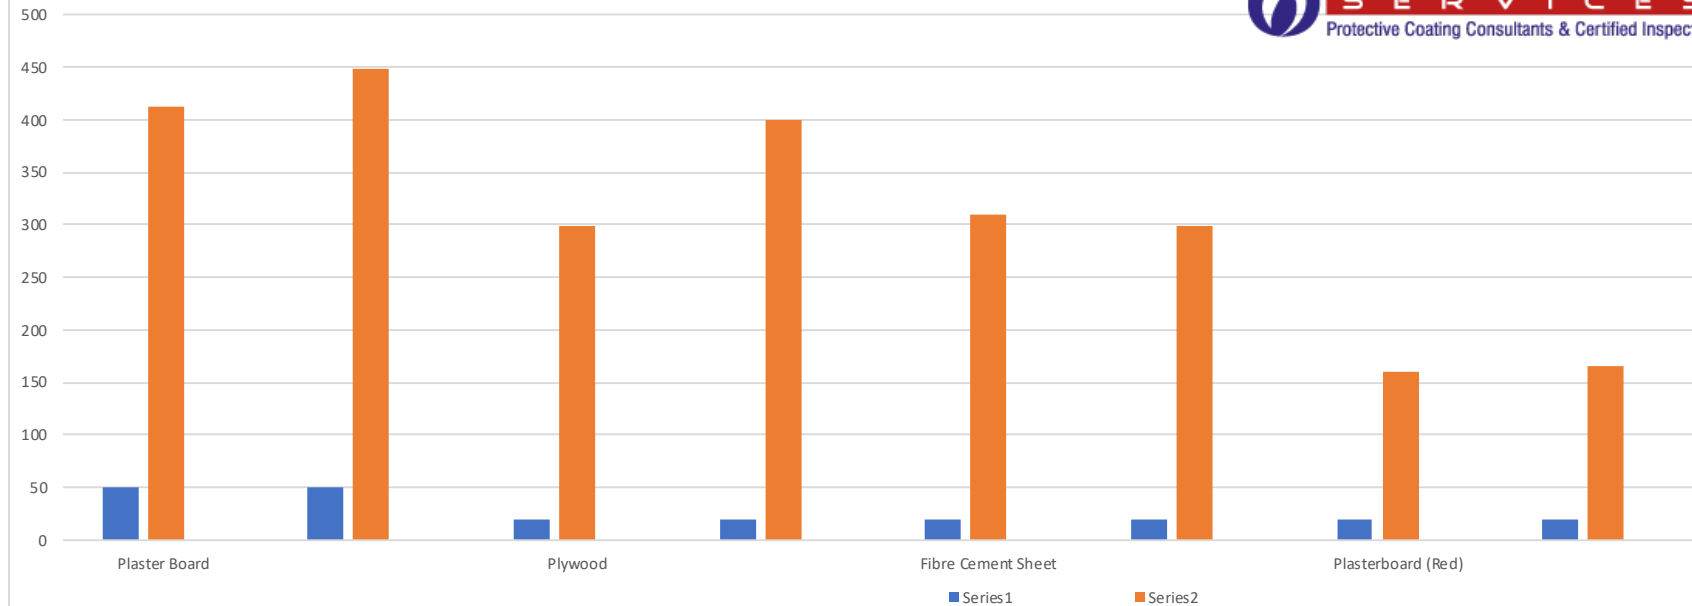
FBL-100 Adhesion Chart

Substrate Material	Dollie Size (mm)	Pull Off (PSI)	Failure	Comment
Plaster Board	50	412	100% Paper failure	Good result
	50	448	100% Paper failure	Good result
Plywood	20	299	50% glue failure 50% disbondment from red primer	Adhesion to red primer appear to have been compromised
	20	400	5% glue failure 95% disbondment from red primer	Adhesion to red primer appear to have been compromised
Fibre Cement Sheet	20	309	100% Paper failure	Good result
	20	298	100% Paper failure	Good result
Plasterboard (Red)	20	160	100% glue failure	Adhesion to this red appears to be compromised, unsure why
	20	165	100% glue failure	Adhesion to this red appears to be compromised, unsure why
