LUXURY VINYL TILE (LVT) WET ROOMS WATERSPLASH INSTALLATION SYSTEM ALTERNATIVE SOLUTION

- E3/AS1 BUILDING CODE- INTERNAL MOISTURE FOR FINISHES TO FLOORS: BATHROOMS

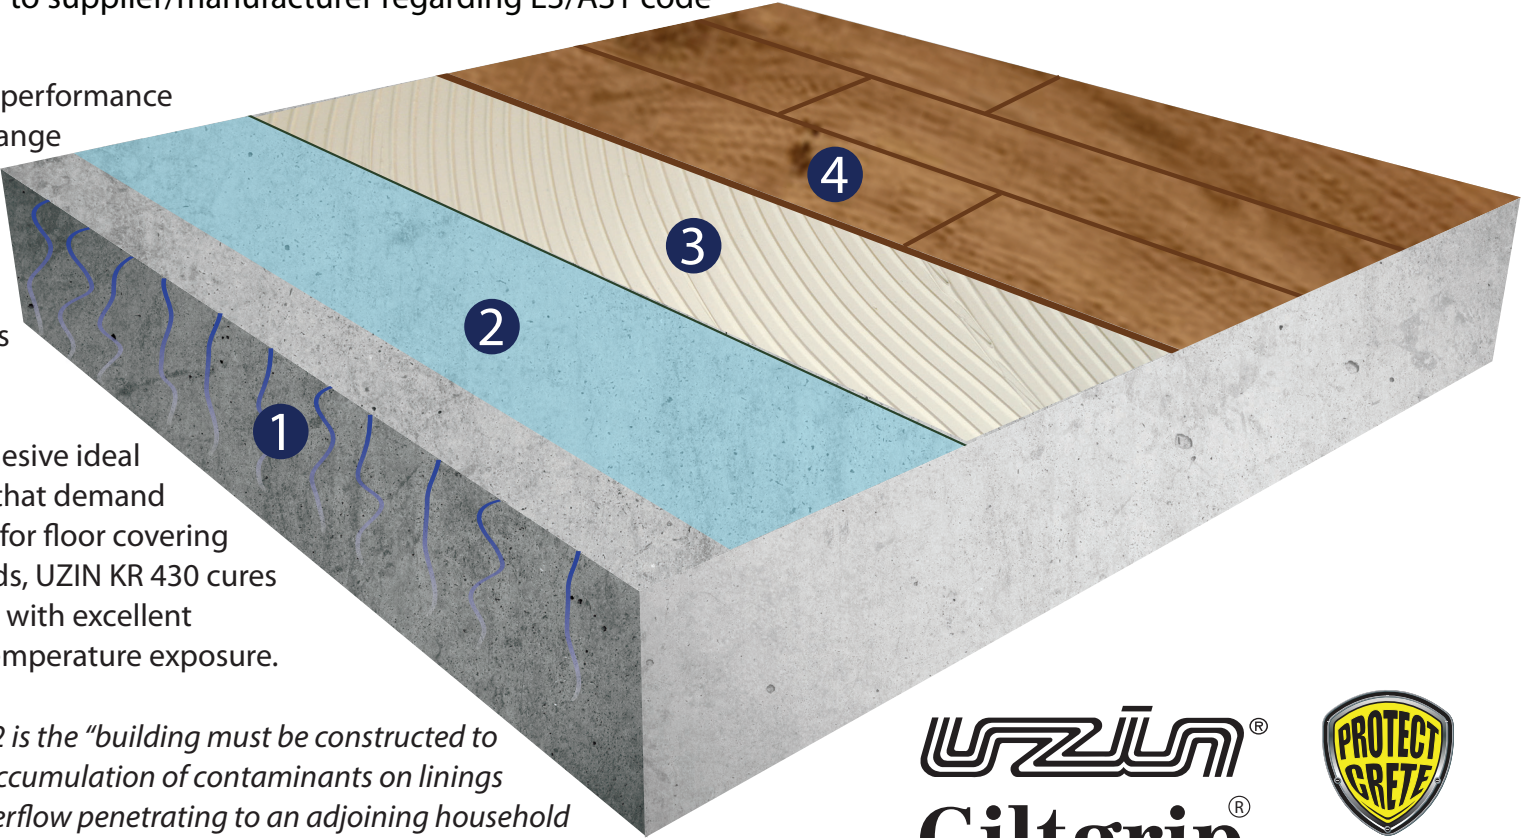
- 1 Concrete substrate treated with Protect Crete Densi-Proof (Optional.)
- 2 Subfloor Preparation Systems (Optional site specific as required.)
Subfloor primed with Uzin PE280 (Non-porous) or Uzin PE520 (Porous)
OPTION 1.) Uzin NC160 or NC170 Levelling Compound
OPTION 2.) Uzin NC888 feather Finish
- 3 **ADHESIVE OPTION 1:** UZIN KE68T 1- Component Hybrid Adhesive
ADHESIVE OPTION 2: UZIN KR430 2-Part Urethane Adhesive
- 4 Luxury Vinyl Tile (LVT) as Specified: Refer to supplier/manufacturer regarding E3/AS1 code compliance.
