# E3 Alternative Solution Flamingo

Substantiation for specifying Flamingo engineered oak flooring in rooms containing sanitary fixtures and sanitary appliances, as an Alternative Solution to E3/AS1.

| DOCUMENT | VW-E3-FL-001 · version 3.1 |
| APPLIES TO | Flamingo — 15 mm engineered board, tongue and groove, full-spread adhesive, glue-down, oil finish |

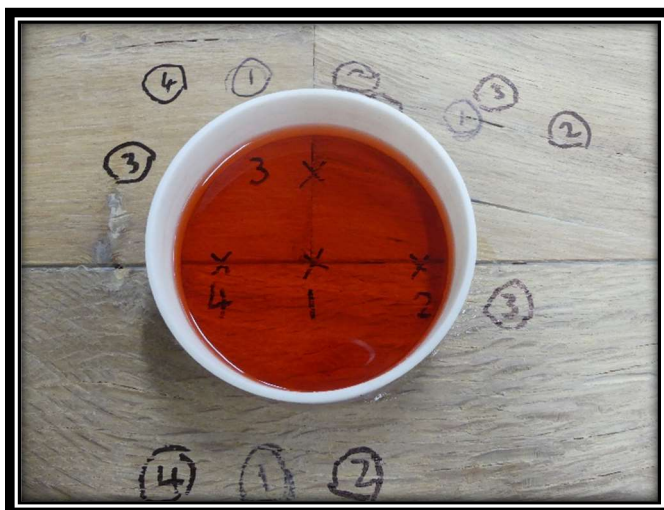
After 24 hrs With Water

100 mls of dye solution was applied onto the sample surface. It was poured into a cylinder 100mm diameter placed in the centre of the sample at the "T joint." Sealant was used at the plank/cylinder interface to avoid leakage.

The sample was left at 20°C, 65% Relative Humidity room conditions for 24 hours after the dye was added and then examined for dye penetration through the backing (not 23°C, 50% RH as stated in the method).

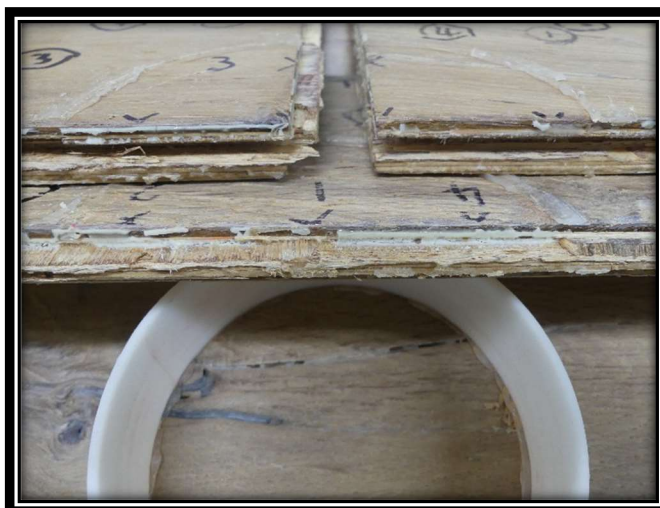
Recovered Swell (Disassembled)
