Case Study: Viking Dec-K-ing

DEC-K-ING ENJOYS THE SEA VIEWS – APARTMENT, MT MAUNGANUI

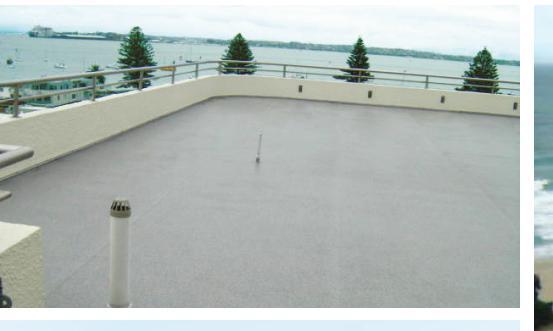
VIEW THE OCEAN ON A ROBUST, BUT MORE IMPORTANTLY, WATERTIGHT MEMBRANE.

CHALLENGE: THE ROOF OF AN UPMARKET MOUNT MAUNGANUI APARTMENT SERVES AS A WONDERFUL VIEWING PLATFORM OVERLOOKING THE PACIFIC OCEAN FROM 6 FLOORS UP. BUT BY EARLY 2009, THE APARTMENT'S TIRED BUTYL RUBBER MEMBRANE ROOF WAS BEGINNING TO OXIDIZE - A CONDITION MORE COMMONLY KNOWN AS "CHALKING-OFF".

Not only was this old butyl struggling with the intense UV, the membrane (being black) had a propensity to become extremely hot; putting undue pressure on the air-conditioning requirements (and therefore energy costs) of the building. Additionally, the messy, black butyl powder from this chalking-off was beginning to rub off onto the apartment owners (and their guests) feet when they went onto the roof to enjoy the view.

The Viking Approved Applicator faced several challenges. The first one being the weather. Being winter time, Viking's Technical Specialist insisted that once the butyl rubber had been removed and disposed of, the porous concrete substrate would need to be coated with Aquaguard 101 to seal its surface. This would prevent the need for expensive down-time to dry out the substrate after each rainfall during the installation period.

Once the substrate had been diamondground and then sealed with Aquaguard 101, the application team successfully installed approximately 500 m2 of Viking Dec-K-ing (between periods of appalling weather).

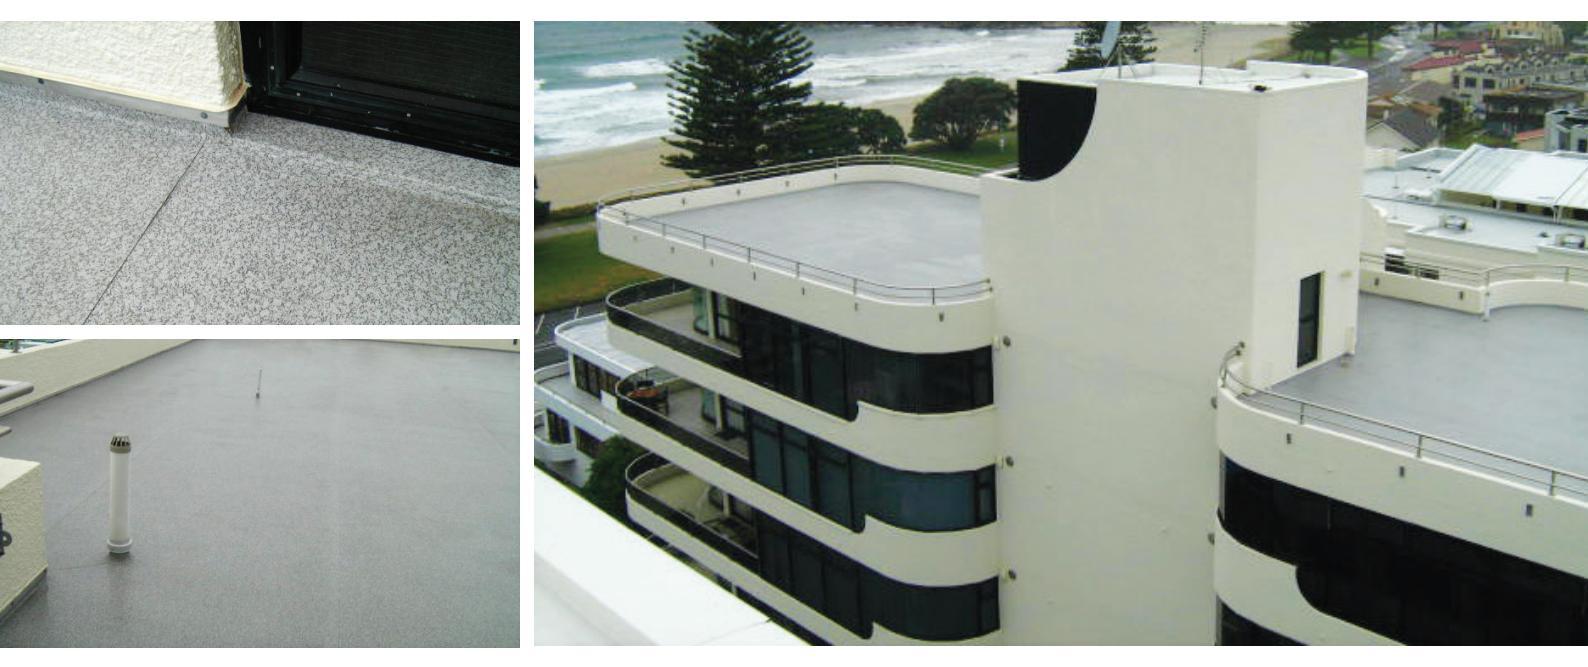
extremely rough texture of the concrete. If not dealt with prior to laying, this rough texture would show through the surface of the membrane.

them to entertain guests and view the ocean on a robust, but more importantly, watertight membrane; the aesthetics of which are inkeeping with the quality and location of the building.
