Case Study: Viking Epiclad

KIDZ FIRST CHILDREN'S HOSPITAL - MIDDLEMORE HOSPITAL, AUCKLAND

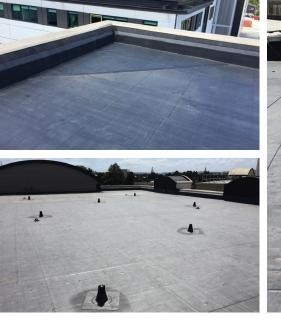
THE BUILDING RECEIVED ITS SECOND SUCCESSFUL VIKING EPICLAD INSTALLATION, WHICH THE TEAM WERE VERY HAPPY WITH.

After several consultations with Viking Roofspec Technical staff, the successful applicator installed exactly to Viking's robust specification for this roof being: fully-adhered 6m wide x 15.2m long rolls of 1.5mm thick Epiclad membrane, to minimise the number of joins.
