COMMERCIAL TRIMRIB ROOFING PENETRATION FLASHING WATERSHED TO UNDER RIDGE

CTRO18A

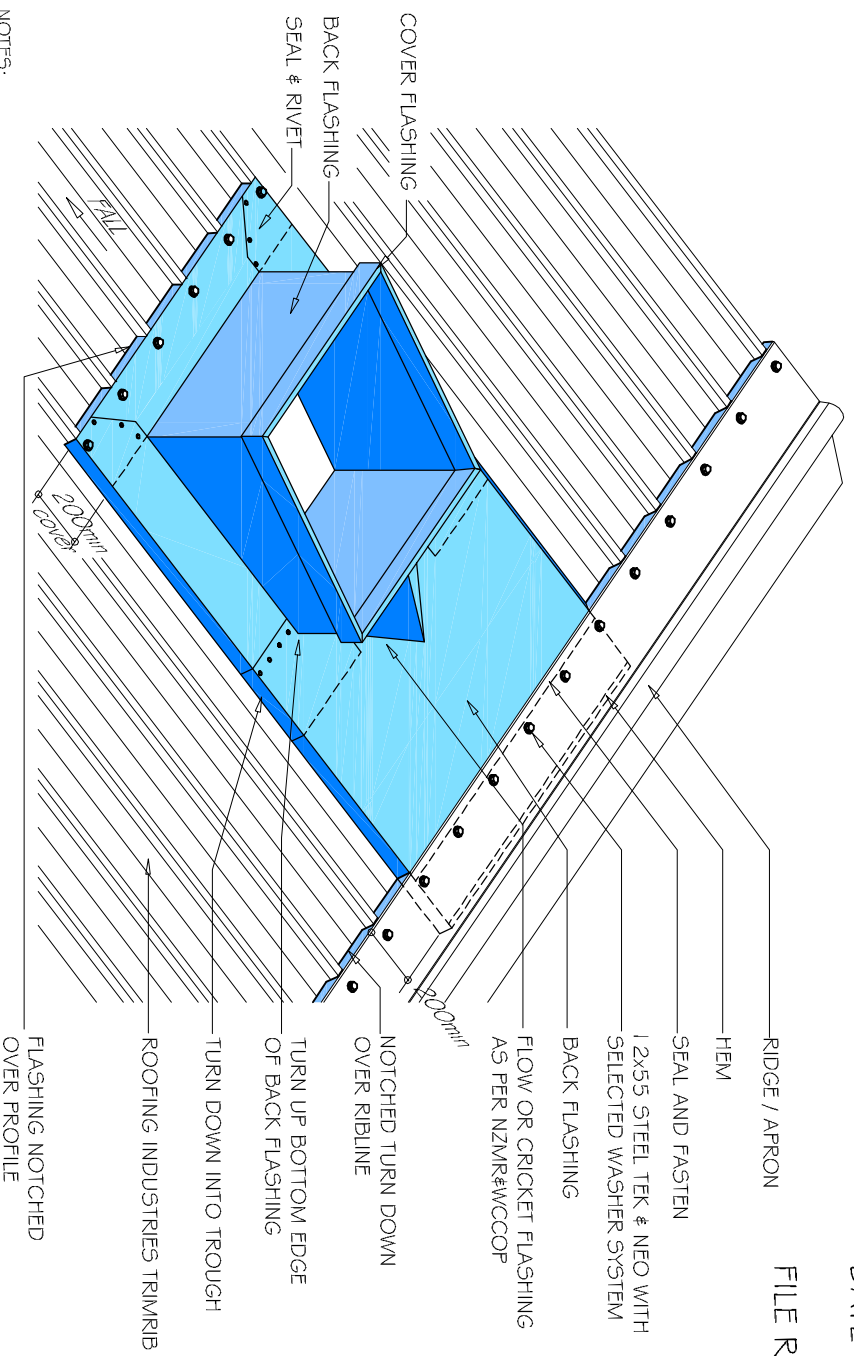
NOTE:
 (1) ADDITIONAL SUPPORT FRAMING MAYBE REQUIRED WHEN PENETRATION EXCEEDS 200mm THROUGH ROOF.
 (2) REFER TO SECTION 6 OF NZMRM CODE OF PRACTICE FOR CATCHMENT AREA LIMITATIONS.
