CRT7RO3 I A

75 BOX GUTTER RT7 PROFILE

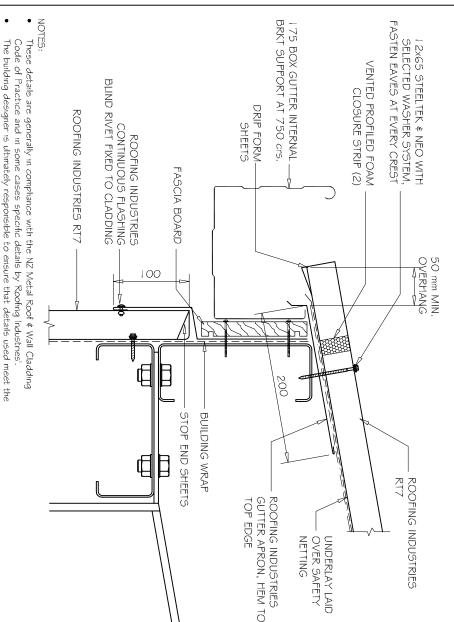
- (2) FOAM CLOSURE STRIP ONLY REQUIRED IN HIGH RISK (1) MINIMUM PITCH 3° SITUATIONS OF WIND BLOWN MOISTURE ENTERING OR IF
- BIRD OR VERMIN PROOFING IS REQUIRED.
 (3) FOR CAPACITY CALCULATION REFER TO NZMRM CODE OF PRACTICE.
- (4) EXTERNAL BRACKETS ARE RECOMMENDED TO ALL GUTTERS IN AREAS SUBJECT TO SNOW.
