CMRR004B

RI-CMRRO04B.DWG

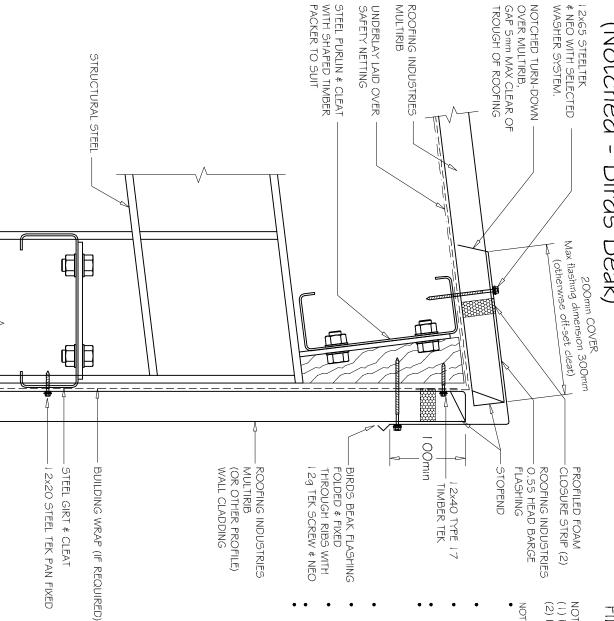
(1) MINIMUM PITCH 3°

(2) FOAM CLOSURE STRIP ONLY REQUIRED IN HIGH RISK SITUATIONS OF WIND BLOWN MOISTURE ENTERING

may vary between Bird's beak dimension manufacturing locations
