# COMMERCIAL MULTIRIB ROOFING 125 BOX GUTTER DETAIL (Internal Bracket)

CMRRO30A

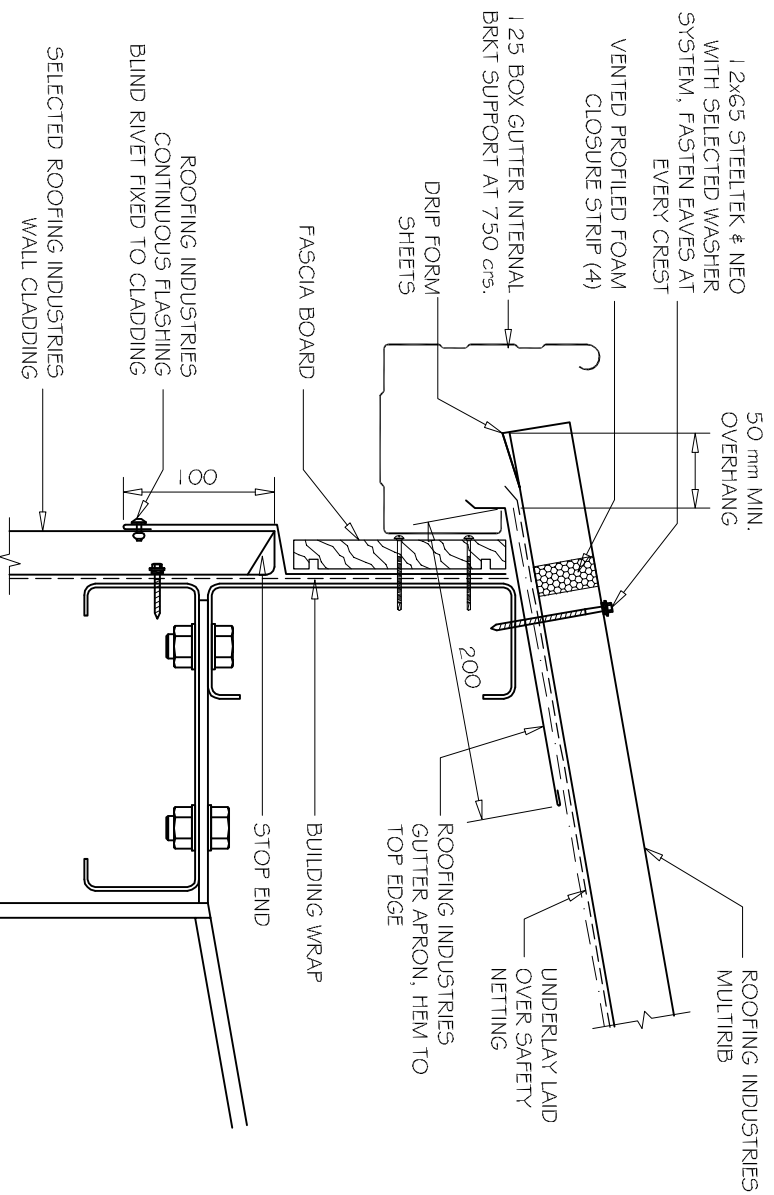
125 BOX GUTTER MULTIRIB PROFILE  
1:5

- (1) MINIMUM PITCH 3°
- (2) FOR CAPACITY CALCULATION REFER TO NZMRM CODE OF PRACTICE.
- (3) EXTERNAL BRACKETS ARE RECOMMENDED TO ALL GUTTERS IN AREAS SUBJECT TO SNOW. REFER DWG CMRRO30B
- (4) FOAM CLOSURE STRIP ONLY REQUIRED IN HIGH RISK SITUATIONS OF WIND BLOWN MOISTURE ENTERING OR IF BIRD OR VERMIN PROOFING IS REQUIRED.
