CMRRO3 I B

75 BOX GUTTER MULTIRIB PROFILE

TOO TITE roof.co.nz

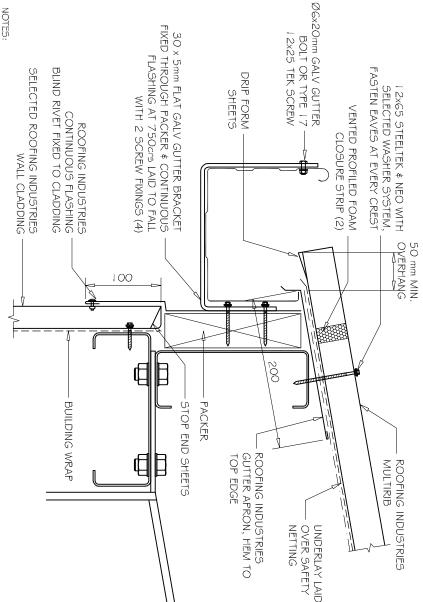
- (1) MINIMUM PITCH 3°
- (2) FOAM CLOSURE STRIP ONLY REQUIRED IN HIGH RISK SITUATIONS OF WIND BLOWN MOISTURE ENTERING OR IF BIRD OR VERMIN PROOFING IS REQUIRED.
- (3) FOR CAPACITY CALCULATION REFER TO NZMRM CODE OF PRACTICE.
- (4) SNOW STRAPS & BRACKETS TO BE FITTED AT 600crs TO ALL GUTTERS IN AREAS SUBJECT TO SNOW.
