COMMERCIAL MAXISPAN ROOFING HEAD APRON - CHASED

DETAIL NO. CMSR00GA
DATE DRAWN 02/03/12
FILE REFERENCE R1-CMSR00GA.DWG

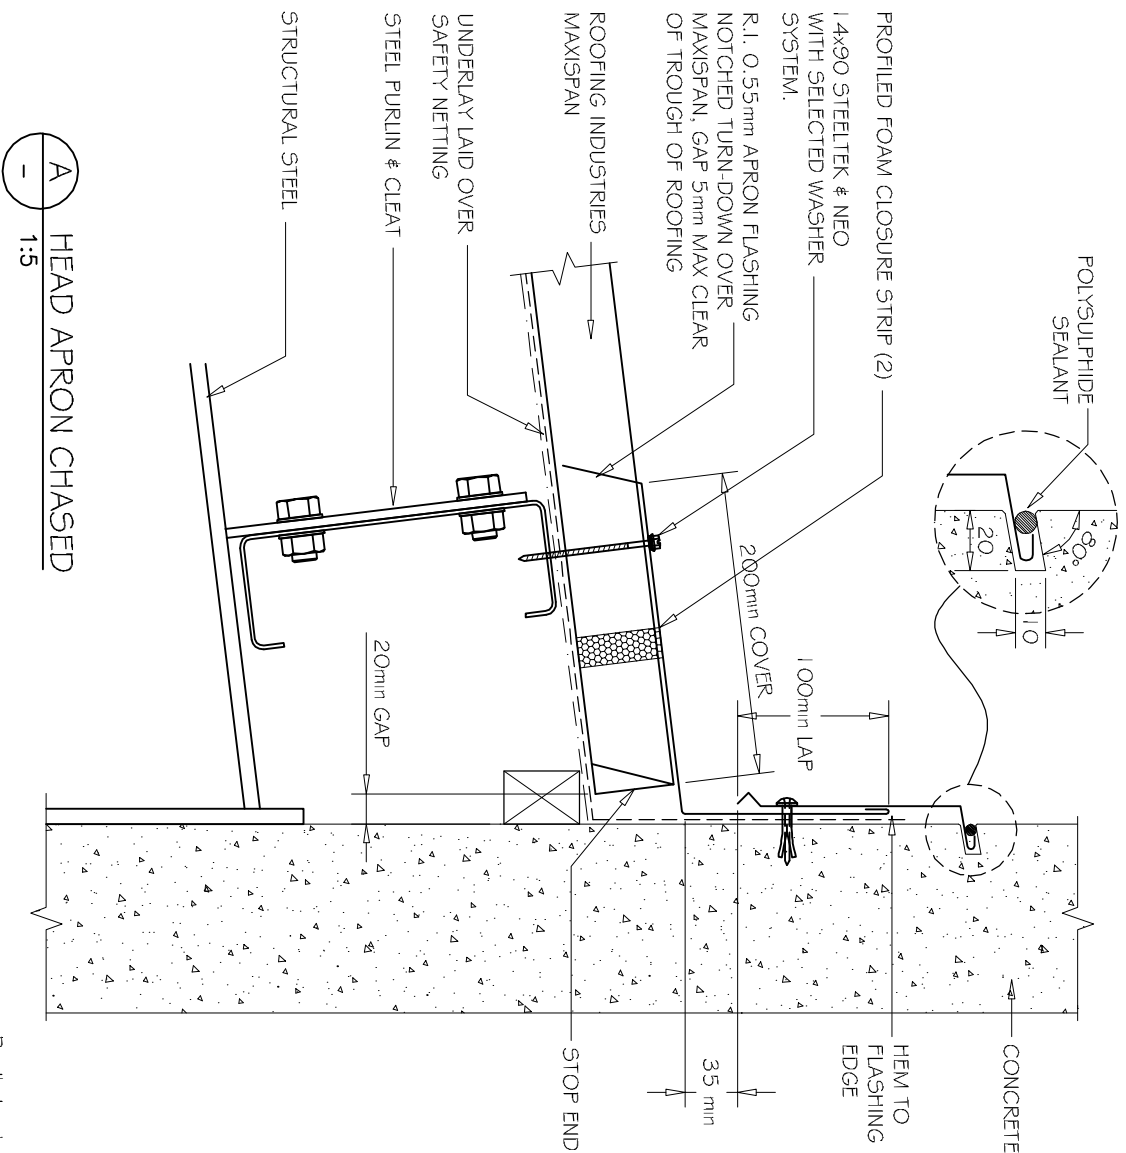
NOTE:
(1) MINIMUM PITCH 3°
(2) FOAM CLOSURE STRIP ONLY REQUIRED IN HIGH RISK SITUATIONS OF WIND BLOWN MOISTURE ENTERING.

Birds beak dimension may vary between manufacturing locations.
