# COMMERCIAL MAXISPAN ROOFING TYPICAL WALL/ROOF JUNCTION (At Head of Roof)

DETAIL NO. CMSR010A  
DATE DRAWN 02/03/12  
FILE REFERENCE R1-CMSR010A.DWG

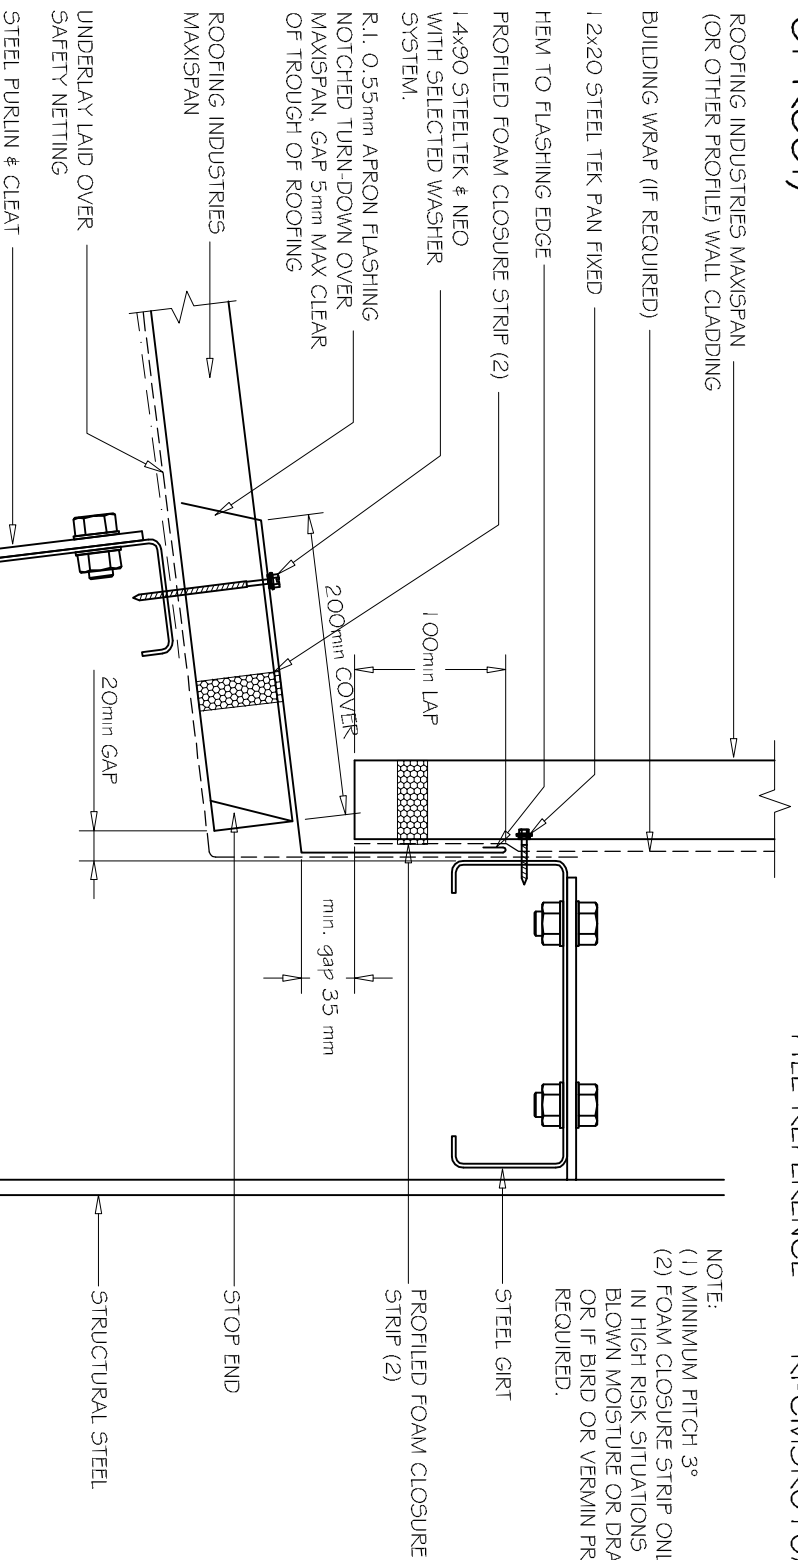
TYPICAL WALL/ROOF JUNCTION  
1:5

NOTE:  
(1) MINIMUM PITCH 3°  
(2) FOAM CLOSURE STRIP ONLY REQUIRED IN HIGH RISK SITUATIONS OF WIND BLOWN MOISTURE OR DRAFTS ENTERING OR IF BIRD OR VERMIN PROOFING IS REQUIRED.
