COMMERCIAL CORRUGATE ROOFING

TYP BOX GUTTER DETAIL

Detail Number: RI-CCR012A

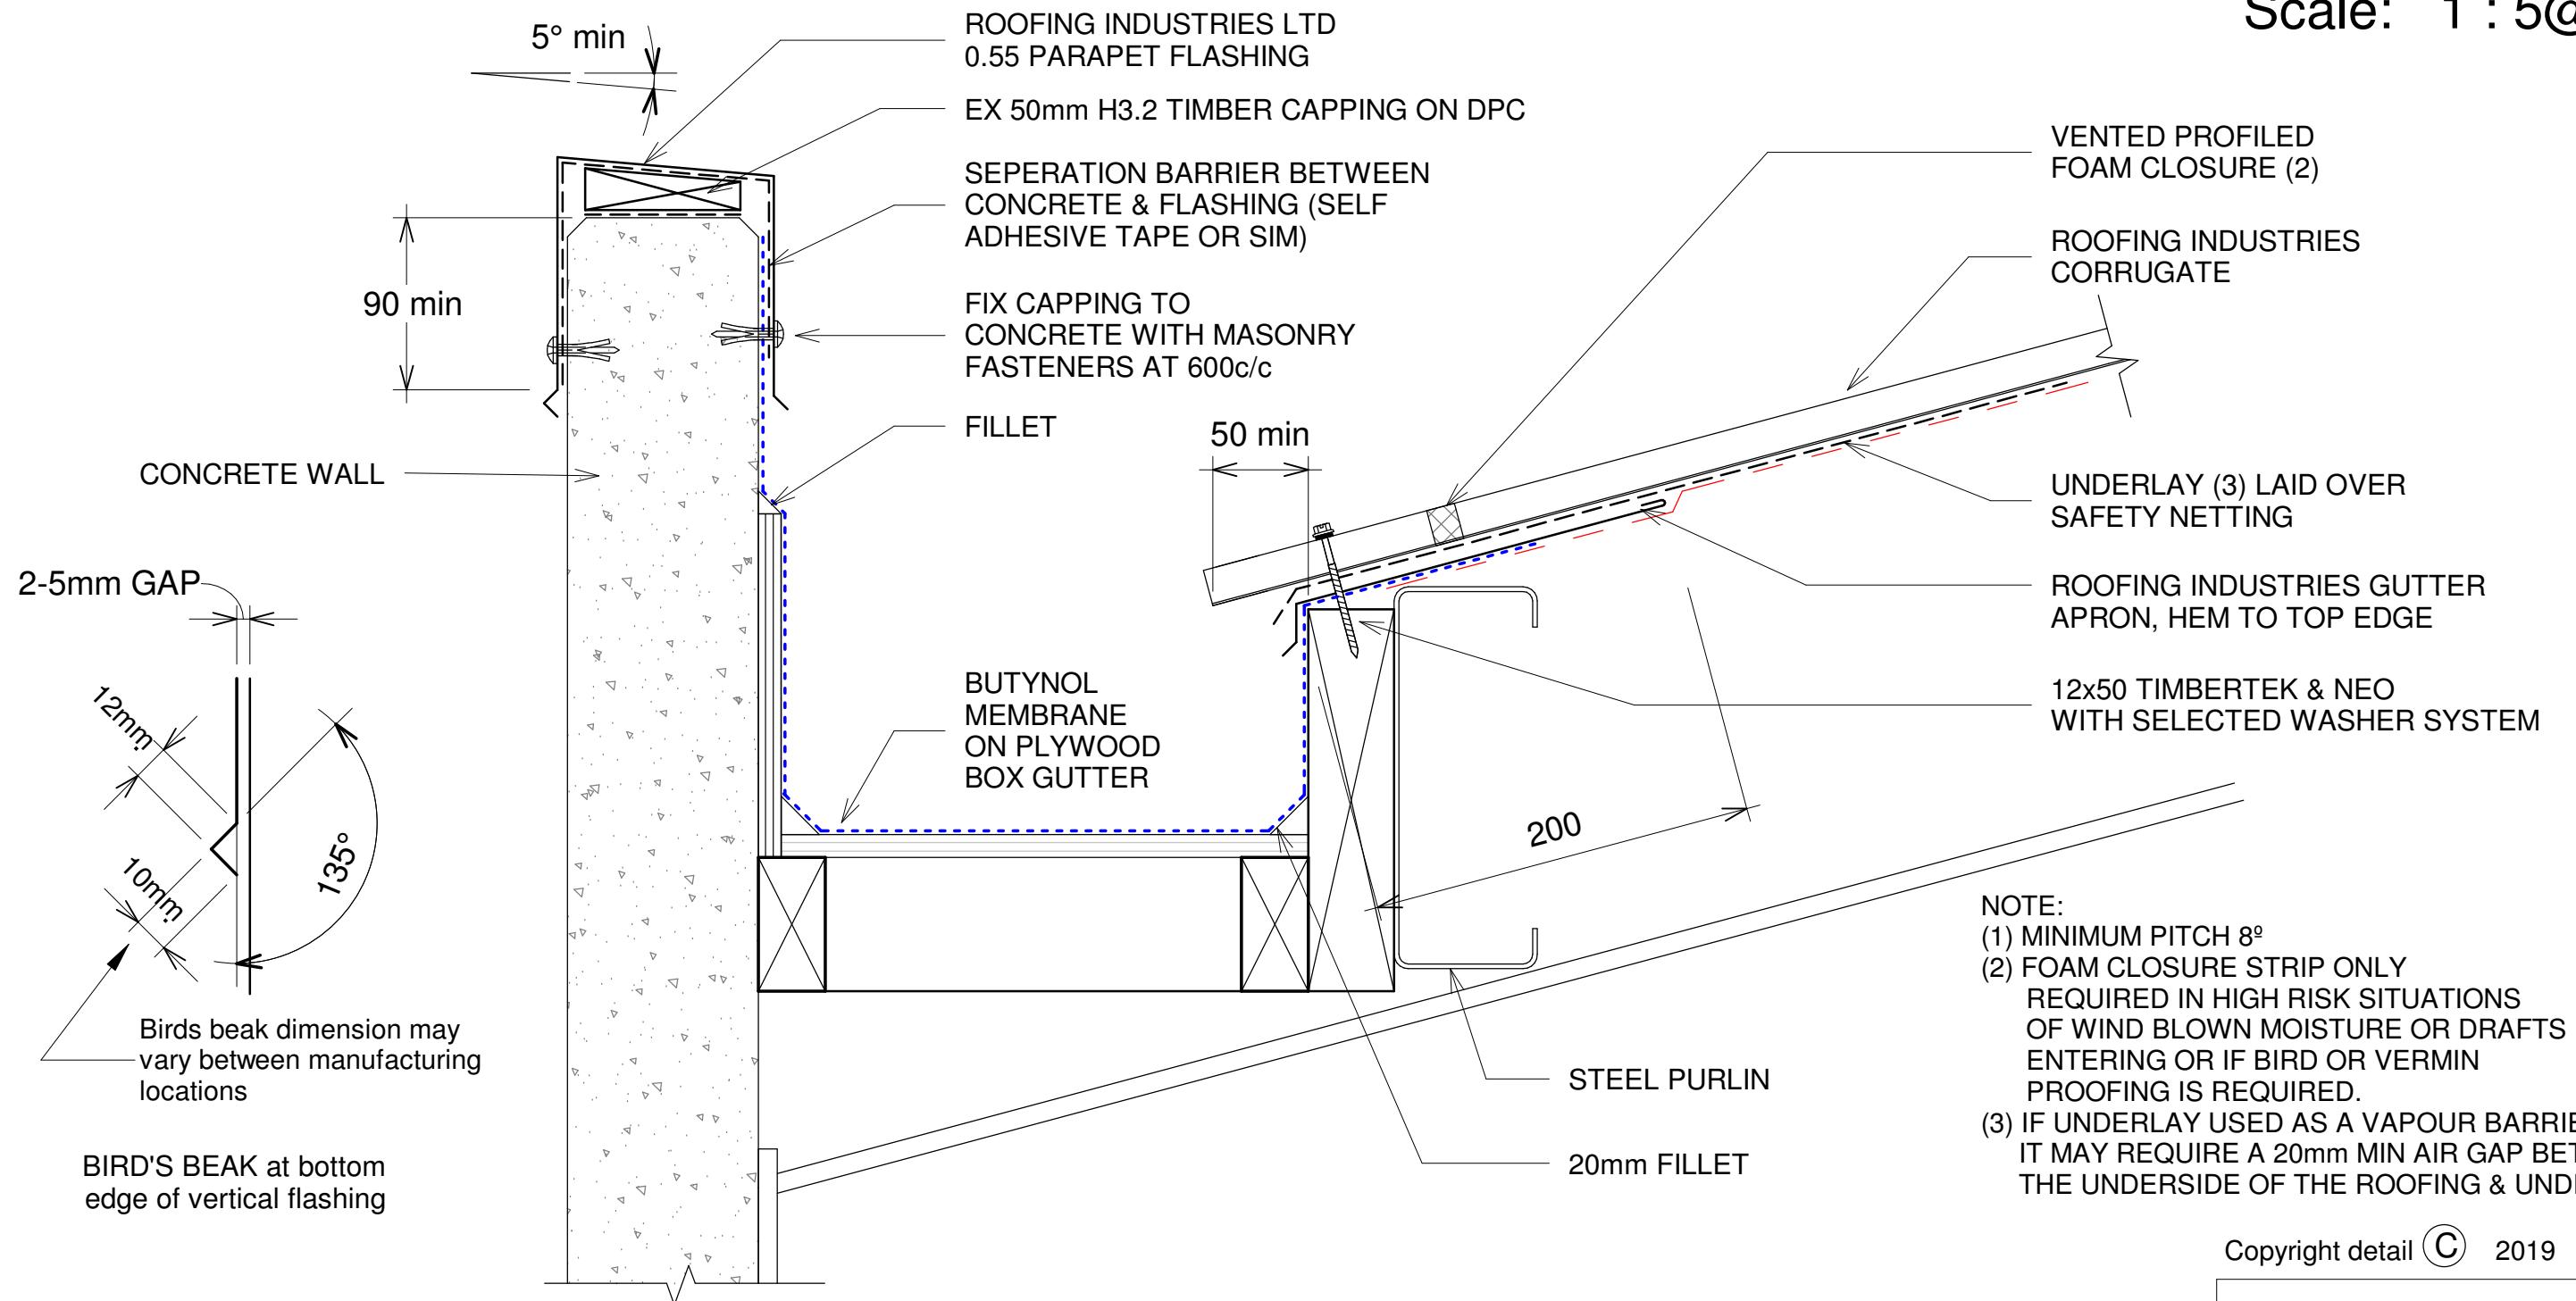
- NOTE:
- (1) MINIMUM PITCH 8°
 - (2) FOAM CLOSURE STRIP ONLY REQUIRED IN HIGH RISK SITUATIONS OF WIND BLOWN MOISTURE OR DRAFTS ENTERING OR IF BIRD OR VERMIN PROOFING IS REQUIRED.
 - (3) IF UNDERLAY USED AS A VAPOUR BARRIER IT MAY REQUIRE A 20mm MIN AIR GAP BETWEEN THE UNDERSIDE OF THE ROOFING & UNDERLAY.
