# BRANZ **Type Test**

## FH 5551-TT [2014]

### CONE CALORIMETER TEST AND NZBC VERIFICATION METHOD C/VM2 APPENDIX A PERFORMANCE OF KAPO BOARD

Enviro Square Ltd  
80 Prince Regent Drive  
Half Moon Bay  
Auckland 2012  
New Zealand

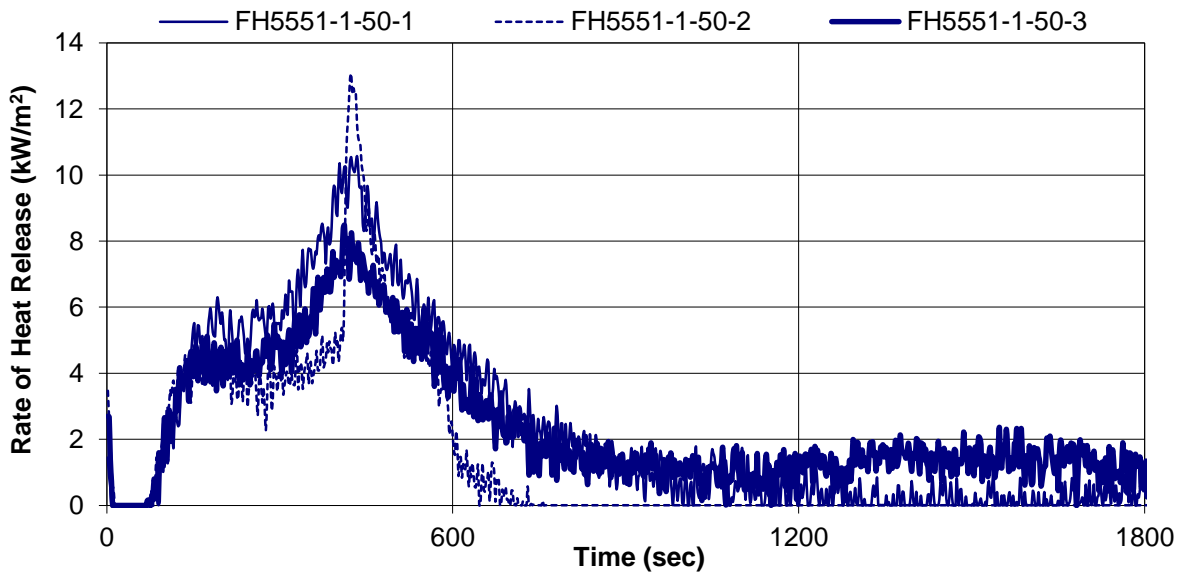
**Figure 2: Rate of heat release versus time**

The report summary for the specimens as described in Section 1, exposed to an irradiance of 50 kW/m<sup>2</sup> is given in table below with rates of heat release illustrated in Figure 2.

| Material | Test specimens as described in Section 1<br>(in accordance with ISO 5660) | | | Mean |
|--|---|---|---|---|
| peak, $\dot{q}_{max}''$ | kW/m <sup>2</sup> | 10.6 | 13.1 | 8.5 |

The test standards requires that the mean heat release rate (HRR) readings over the first 180 s from ignition for the three specimens should differ by no more than 10% of the arithmetic mean of the three readings. In the event of this criterion not being met, a further three specimens are required to be tested.
