# RESIDENTIAL TRUE OAK® DEEP CORRUGATE WALL CLADDING VERTICAL BUTT JOINT - VERTICAL CLADDING WITH CLADDING CHANGE (CAVITY)

Detail No. RI-RTDW009B  
Date drawn: 01/02/2020  
Scale: 1 : 5 @ A4  
Version: 01

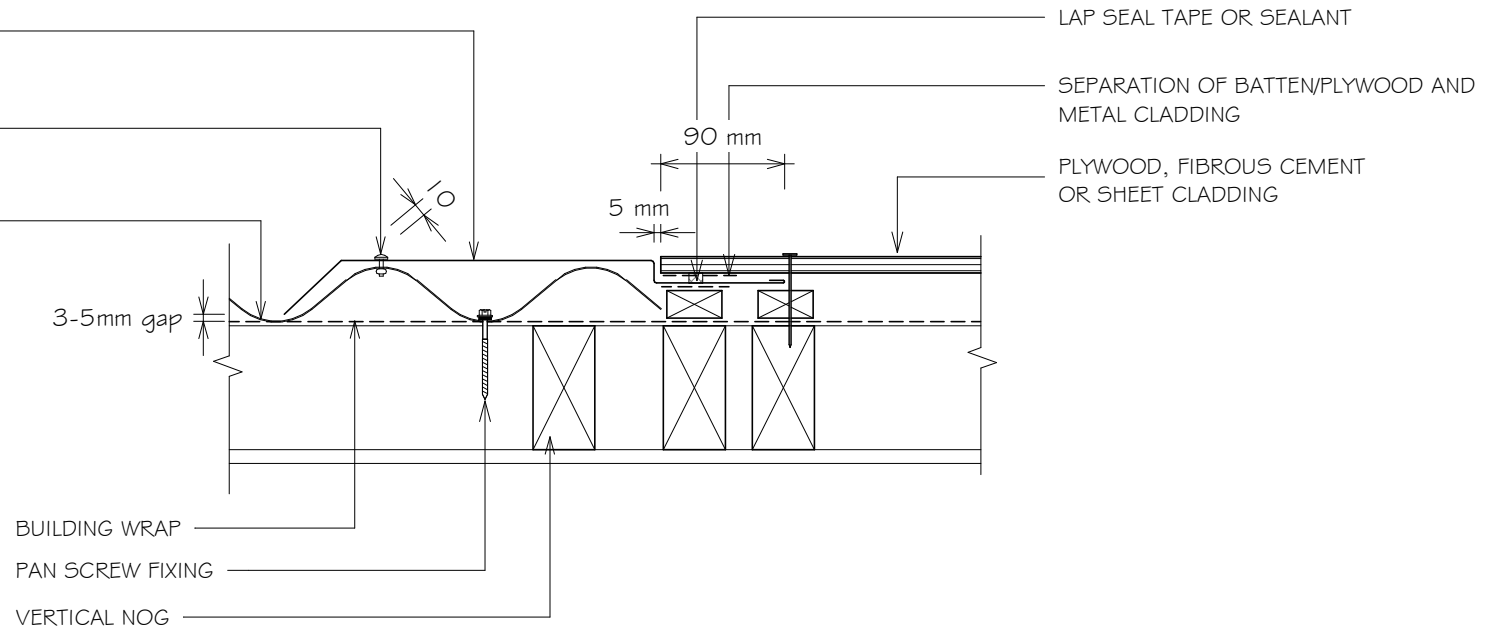
VERTICAL FLASHING TO COVER  
MINIMUM OF 2 CREST AND FINISH  
3-5mm GAP FROM PAN OF CLADDING

FLASHING RIVET  
FIXED TO CLADDING

ROOFING INDUSTRIES 'TRUE OAK' DEEP  
CORRUGATE
