# RESIDENTIAL TRUE OAK® DEEP CORRUGATE WALL CLADDING EXTERNAL CORNER FLASHING FOR HORIZONTAL CLADDING

Detail No. RI-RTDW023A  
Date drawn: 01/02/2020  
Scale: 1 : 5@ A4  
Version: 01

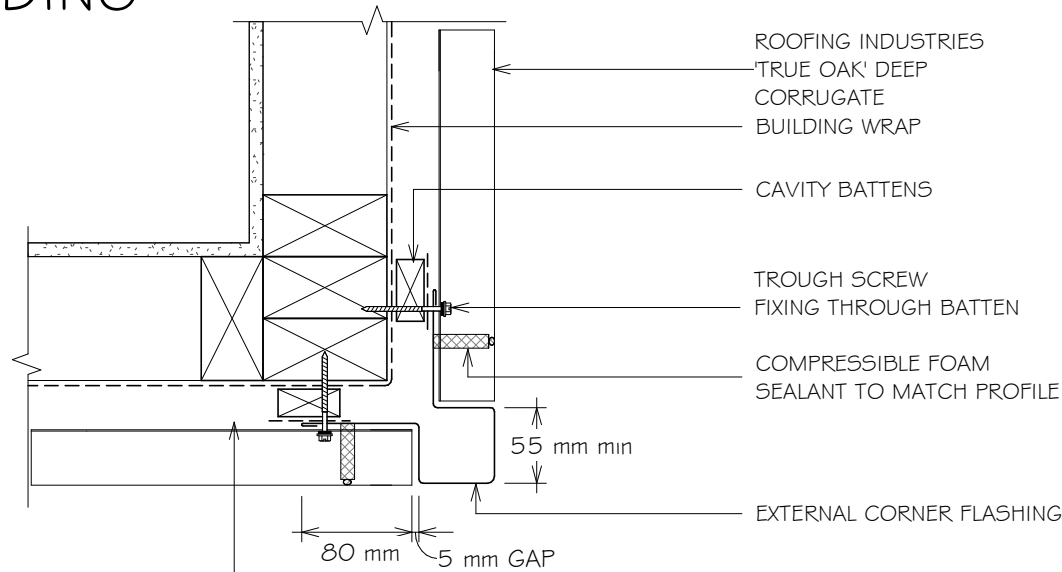
SEPARATION OF BATTEN  
AND METAL CLADDING

FLASHING TO COVER END  
OF METAL PROFILE CLADDING

1. MINIMUM 12 GAUGE WITH 30mm PENETRATION INTO FRAMING TIMBER TEKSCREW WITH NEO. (USE STEELTEK FOR STEEL FRAMING)
2. CAVITY BATTENS CONTAINING CORROSIVE MATERIAL MUST BE SEPARATED FROM METAL CLADDING BY DPC, BUILDING WRAP, PVC OR PAINTING.
