## RESIDENTIAL TRUE OAK® DEEP CORRUGATE WALL CLADDING METER BOX SIDE FLASHING FOR HORIZONTAL CLADDING

Detail No. RI-RTDW04 | A Date drawn: 01/02/2020

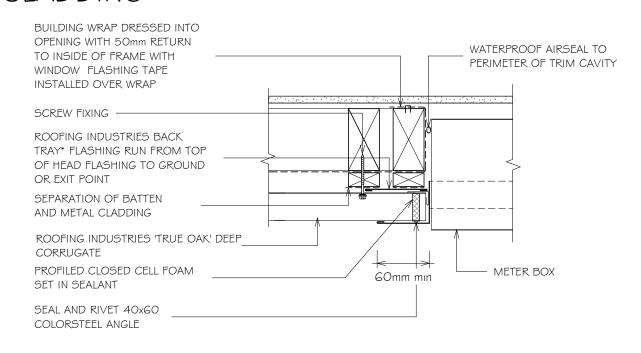
\*Back tray size may require to increase to ensure coverage at ends of head flashing. (Dimensions are indicative only) Turn down end of head flashing
