# TEST REPORT

**SLIP RESISTANCE CLASSIFICATION OF  
NEW PEDESTRIAN SURFACE MATERIALS  
AS/NZS.4586:2004**

**Balterio Grande, Laminate Flooring**

**11-09-2017**

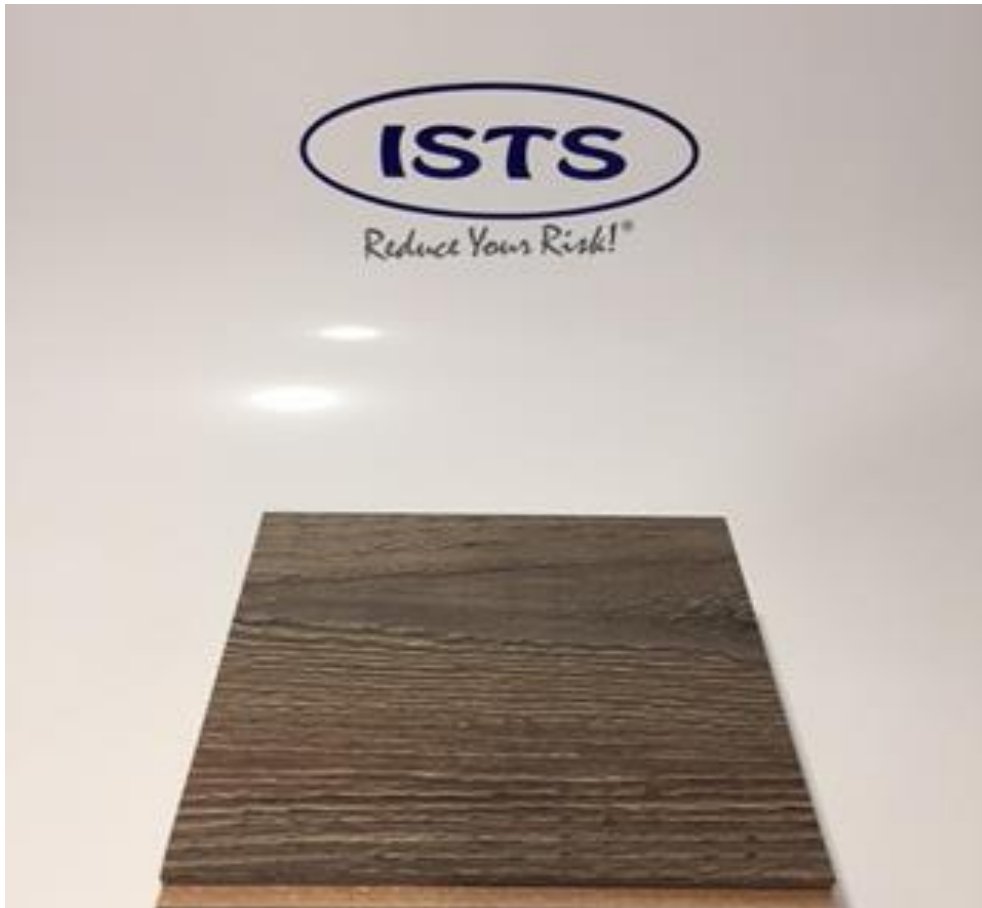
## TEST PRODUCT IMAGE

**Product Description:** Balterio Grande, Laminate Flooring
