INSTALLATION DETAIL - FIRST RESIDENTIAL BIFOLD DOOR OPEN IN ON RUSTICATED WEATHERBOARD CAVITY CONSTRUCTION

INSTALLATION DETAIL - FIRST RESIDENTIAL BIFOLD DOOR OPEN IN ON RUSTICATED WEATHERBOARD DIRECT FIXED CLADDING

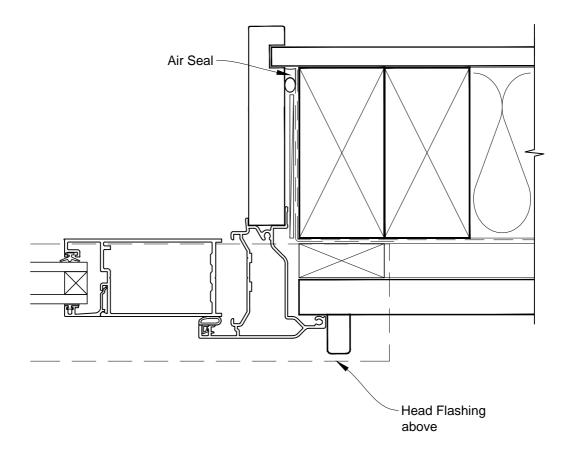
Scale: 1:2 CAD Ref.: FRBIRW-CJ

INSTALLATION DETAIL - FIRST RESIDENTIAL BIFOLD DOOR OPEN IN ON RUSTICATED WEATHERBOARD CAVITY CONSTRUCTION

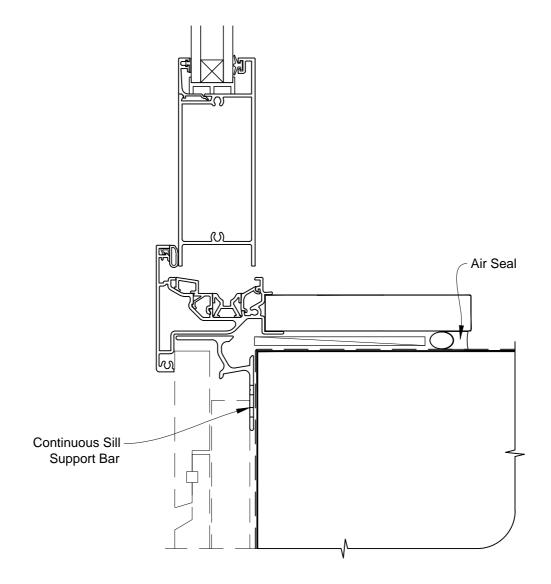
Date: 01.03.14 Scale: 1:2 CAD Ref.: FRBIRW-CS

INSTALLATION DETAIL - FIRST RESIDENTIAL BIFOLD DOOR OPEN IN ON RUSTICATED WEATHERBOARD CAVITY CONSTRUCTION

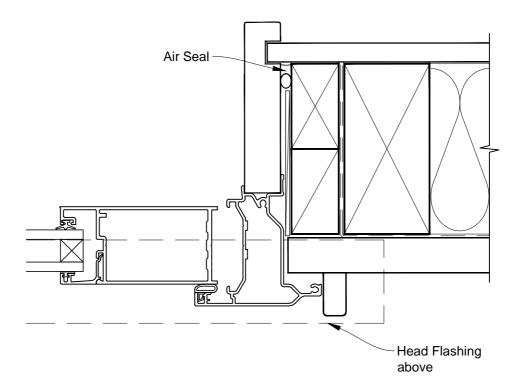
Scale: 1:2 CAD Ref.: FRBIRW-DJ

INSTALLATION DETAIL - FIRST RESIDENTIAL BIFOLD DOOR OPEN IN ON RUSTICATED WEATHERBOARD DIRECT FIXED CLADDING
