**AWNING WINDOW, BEADED SASH
AND ESPAGNOLETTE SASH OPTION**

**AWNING WINDOW, DOUBLE GLAZED
VENTED SASH AND AEROVENT**

**AWNING WINDOW, DOUBLE GLAZED
VENTIENT**

**AWNING WINDOW
REPLACEMENT FRAME AND CHAIR FRAME**

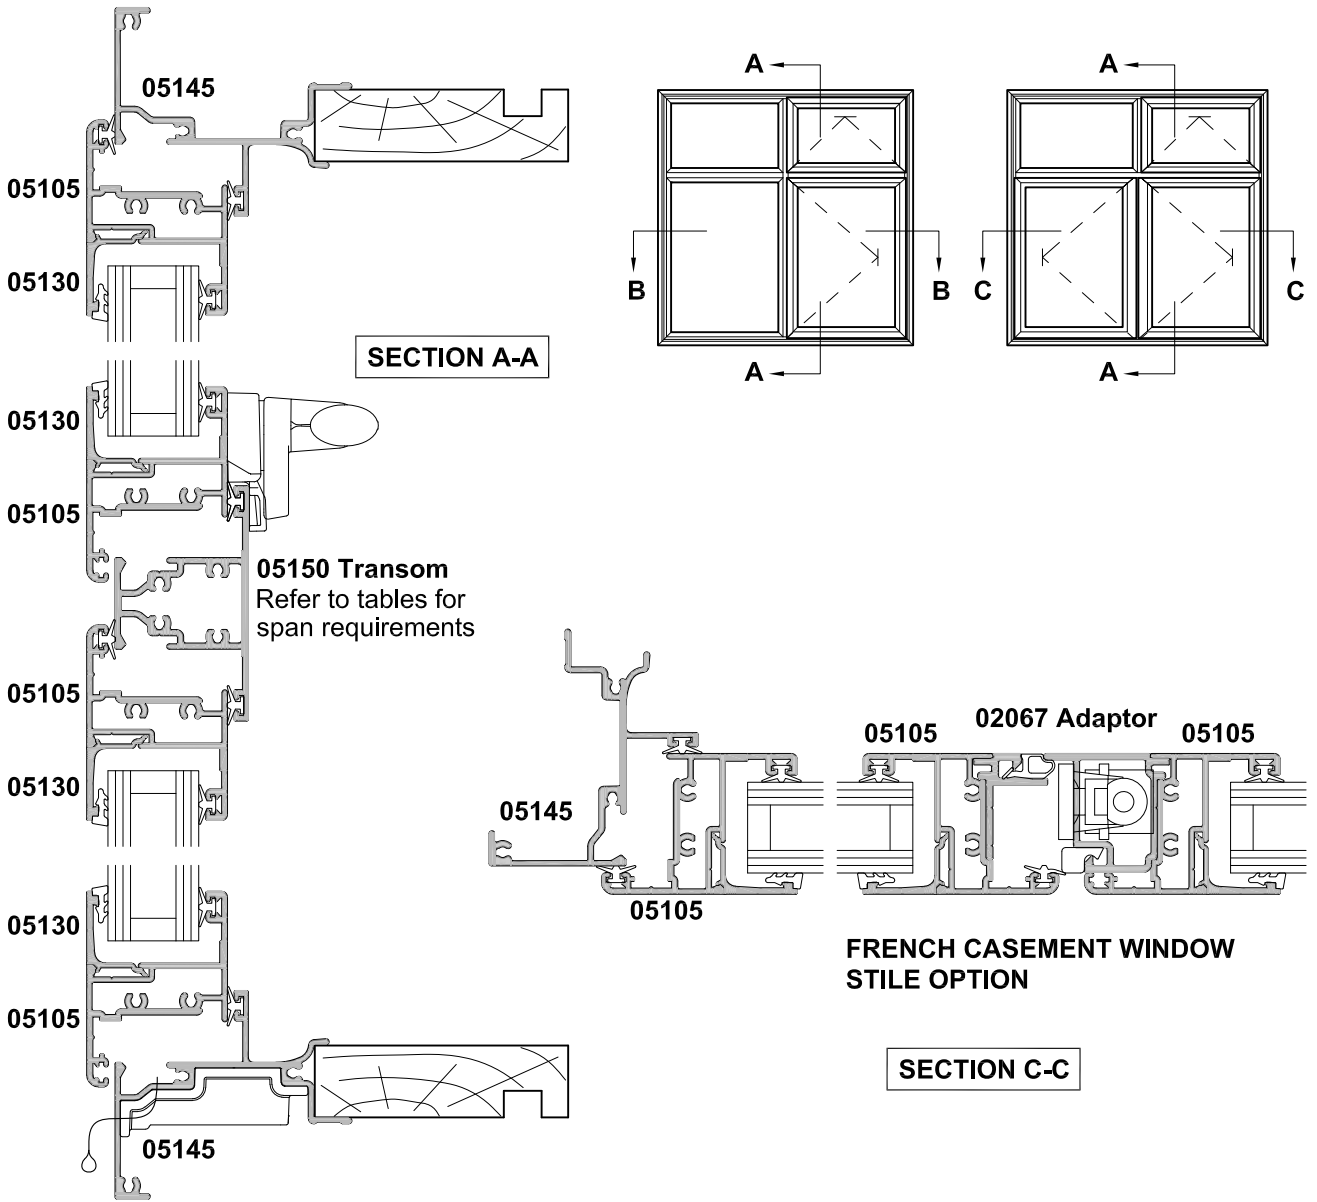
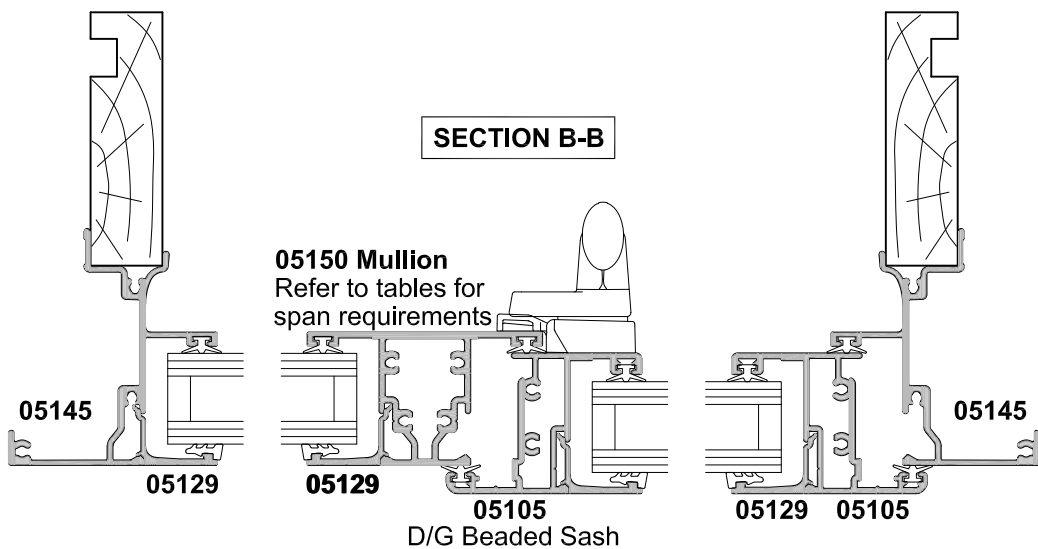
**CASEMENT WINDOW AND
FRENCH CASEMENT WINDOW, D/G SASH & FIXED LIGHT
CROSS SECTION**
