Laboratory measurements of the reduction of transmitted impact sound by floor coverings on a heavyweight reference floor (According to ISO 10140-3)

Reduction of impact sound pressure level according to ISO 10140-3
Laboratory measurements of the reduction of transmitted impact sound by floor coverings on a heavyweight reference floor

Client: Jacobsen Creative Surfaces and Nordic Built Pty Ltd.

No. of test report: **T1638-1**

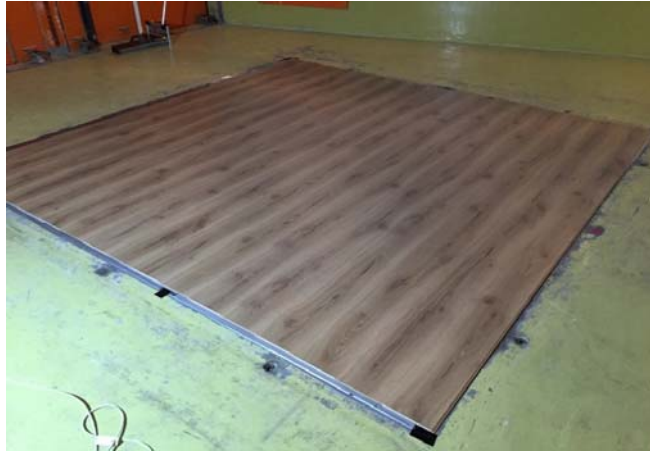
Source chamber side: 3240 x 3175mm of *Pergo Mansion Oak, Plank PerfectFold 3.0* laminate flooring (71.5kg) loose laid on *Silent Shield* underlay (2.95kg) loose laid on a concrete slab.

Figure 1: Boards in place on underlay.
