**Our Ref: T1741 A**

**LABORATORY MEASUREMENT OF  
THE REDUCTION OF  
TRANSMITTED IMPACT SOUND OF  
LAMINATE FLOORING  
(ACCORDING TO ISO 10140-3)**

Jacobsen Creative Surfaces Ltd.  
41 Morrin Road  
Mt Wellington  
Auckland

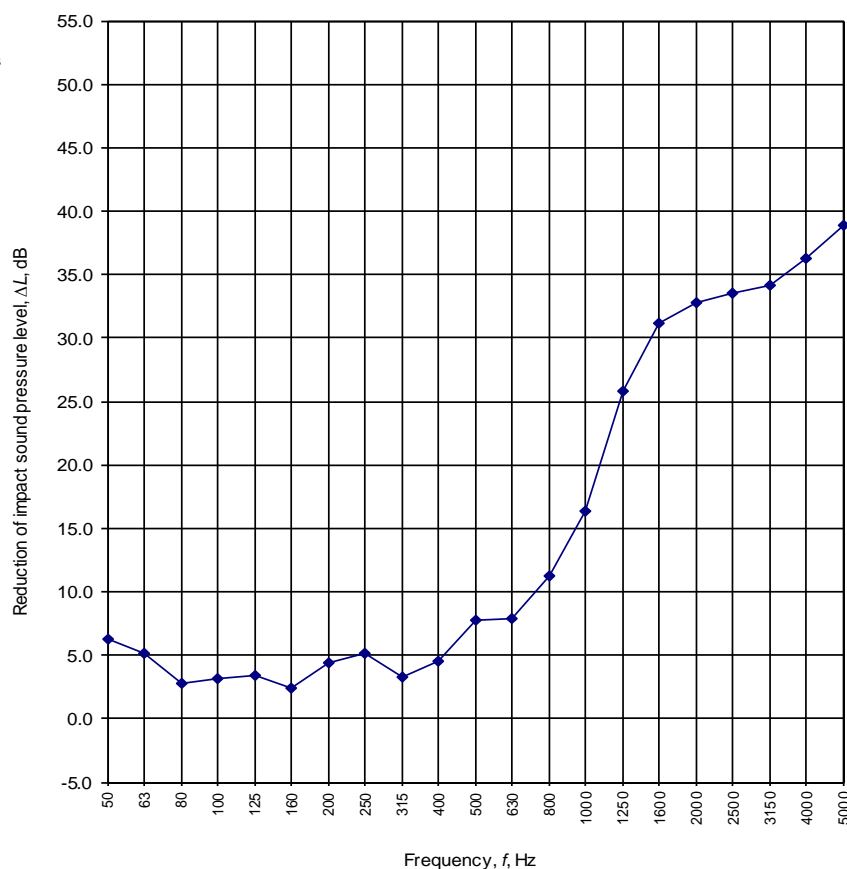
No. of test report: T1741-1

Flooring: 5 mm Decotile LVT Vinyl flooring  
 Flooring adhesive: Uzin KE 2000S adhesive  
 Underlay: 4.5 mm Regupol 4515 Rubber/Cork mix underlay  
 Underlay Adhesive: Uzin KE 2000S adhesive  
 Concrete Slab

Frequency <i>f</i> Hz	$L_{n,0}$ One-third octave dB	$\Delta L$ One-third octave dB
50	54.4	6.3
63	50.0	5.2
80	56.8	2.8
100	<b>63.7</b>	<b>3.2</b>
125	<b>65.8</b>	<b>3.4</b>
160	<b>66.1</b>	<b>2.4</b>
200	<b>68.7</b>	<b>4.4</b>
250	<b>72.1</b>	<b>5.2</b>
315	<b>71.3</b>	<b>3.3</b>
400	<b>69.9</b>	<b>4.5</b>
500	<b>74.2</b>	<b>7.8</b>
630	<b>72.0</b>	<b>7.9</b>
800	<b>71.2</b>	<b>11.2</b>
1000	<b>71.3</b>	<b>16.3</b>
1250	<b>71.3</b>	<b>25.8</b>
1600	<b>71.1</b>	<b>31.2</b>
2000	<b>72.0</b>	<b>32.8</b>
2500	<b>72.5</b>	<b>33.5</b>
3150	<b>72.6</b>	<b>34.1</b>
4000	71.1	<b>36.3</b>
5000	68.2	<b>38.9</b>

$\Delta L_w = 18$  dB $C_{I,\Delta} = 10$  dB $C_{I,r} = -1$  dB $C_{I,50-2500} = -1$  dB

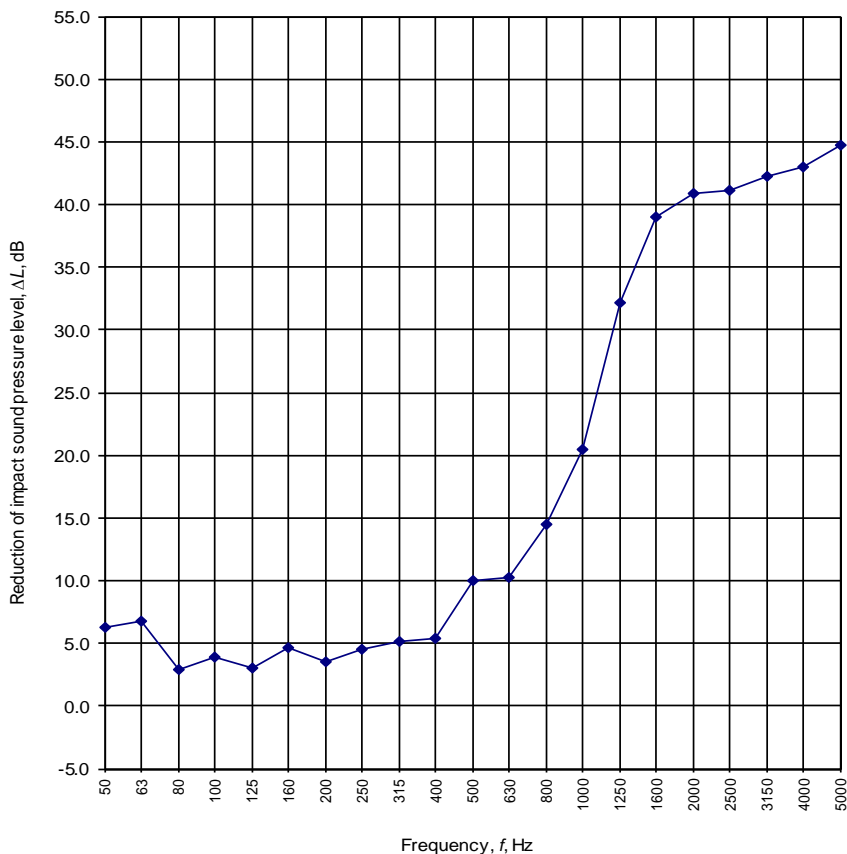
No. of test report: **T1741-3**

Flooring: *LG Easyfix LVT* Vinyl flooring  
 Flooring adhesive: *Uzin KE 2000S* adhesive  
 Underlay: *4.5 mm Regupol 4515* Rubber/Cork mix underlay  
 Underlay Adhesive: *Uzin KE 2000S* adhesive  
 Concrete Slab

Frequency <i>f</i> Hz	$L_{n,0}$ One-third octave dB	$\Delta L$ One-third octave dB
50	54.4	6.3
63	50.0	6.8
80	56.8	2.9
100	<b>63.7</b>	<b>3.9</b>
125	<b>65.8</b>	<b>3.0</b>
160	<b>66.1</b>	<b>4.7</b>
200	<b>68.7</b>	<b>3.5</b>
250	<b>72.1</b>	<b>4.5</b>
315	<b>71.3</b>	<b>5.2</b>
400	<b>69.9</b>	<b>5.4</b>
500	<b>74.2</b>	<b>10.0</b>
630	<b>72.0</b>	<b>10.3</b>
800	<b>71.2</b>	<b>14.5</b>
1000	<b>71.3</b>	<b>20.5</b>
1250	<b>71.3</b>	<b>32.2</b>
1600	<b>71.1</b>	<b>39.0</b>
2000	<b>72.0</b>	<b>40.9</b>
2500	<b>72.5</b>	<b>41.1</b>
3150	<b>72.6</b>	<b>42.3</b>
4000	71.1	43.0
5000	68.2	44.7

$\Delta L_w = 19$  dB $C_{I,\Delta} = 10$  dB $C_{I,r} = -1$  dB $C_{1,50-2500} = -1$  dB

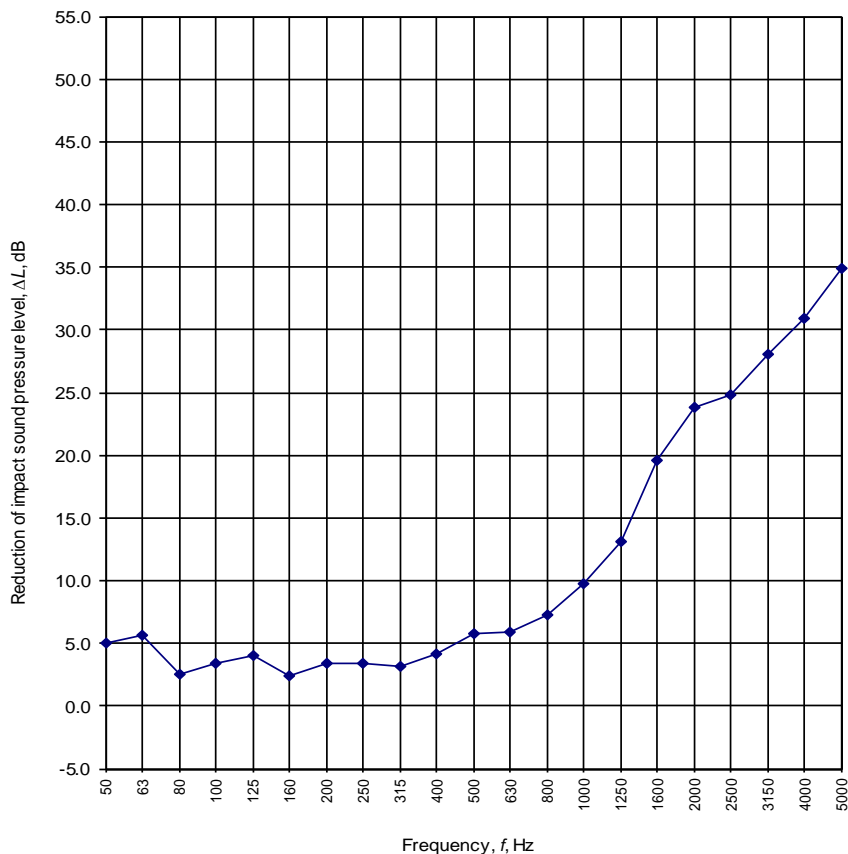
No. of test report: T1741-6

**Flooring:** 14 mm Pergo UNICLIC Oak timber laminate flooring (14 mm x 190 mm x 1820 mm planks)**Flooring adhesive:** Uzin KE 2000S adhesive**Underlay:** 4.5 mm Regupol4515 Rubber/Cork mix underlay**Underlay Adhesive:** Uzin KE 2000S adhesive

Frequency <i>f</i> Hz	<i>L</i> <sub><i>n,0</i></sub> One-third octave dB	$\Delta L$ One-third octave dB
50	54.4	5.0
63	50.0	5.7
80	56.8	2.5
100	<b>63.7</b>	<b>3.4</b>
125	<b>65.8</b>	<b>4.0</b>
160	<b>66.1</b>	<b>2.4</b>
200	<b>68.7</b>	<b>3.4</b>
250	<b>72.1</b>	<b>3.4</b>
315	<b>71.3</b>	<b>3.2</b>
400	<b>69.9</b>	<b>4.1</b>
500	<b>74.2</b>	<b>5.8</b>
630	<b>72.0</b>	<b>5.9</b>
800	<b>71.2</b>	<b>7.2</b>
1000	<b>71.3</b>	<b>9.8</b>
1250	<b>71.3</b>	<b>13.1</b>
1600	<b>71.1</b>	<b>19.6</b>
2000	<b>72.0</b>	<b>23.8</b>
2500	<b>72.5</b>	<b>24.8</b>
3150	<b>72.6</b>	<b>28.0</b>
4000	71.1	30.9
5000	68.2	34.9

$\Delta L_w = 16$  dB*C*<sub>1,Δ</sub> = 9 dB*C*<sub>1,r</sub> = -2 dB*C*<sub>1,50-2500</sub> = -2 dB

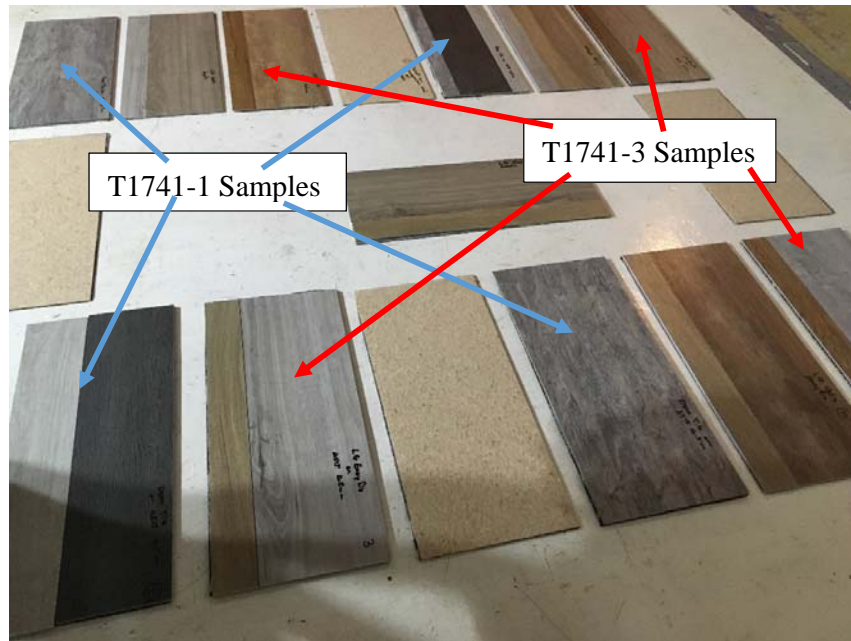
Figure 1: Samples on concrete floor

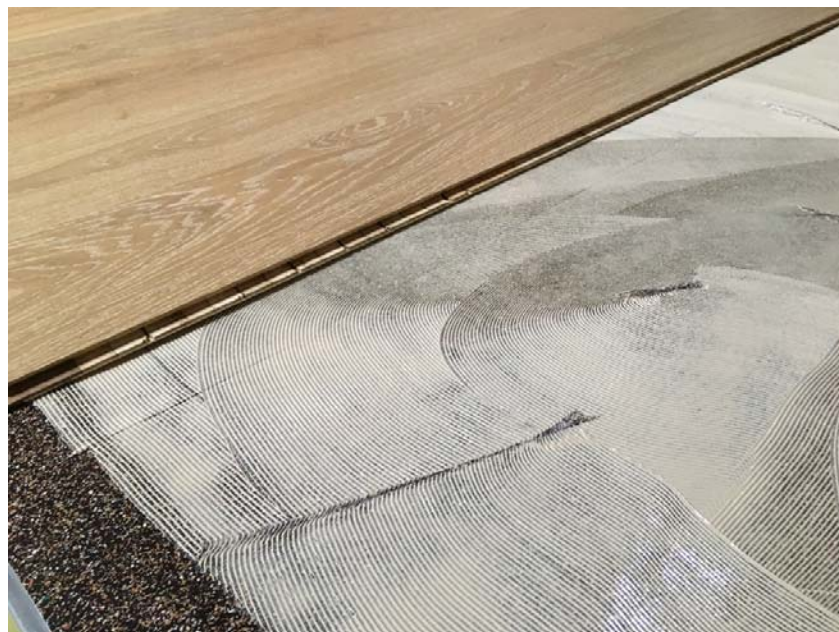
Figure 2: Applying Uzin adhesive to the Regupol 4515 underlay

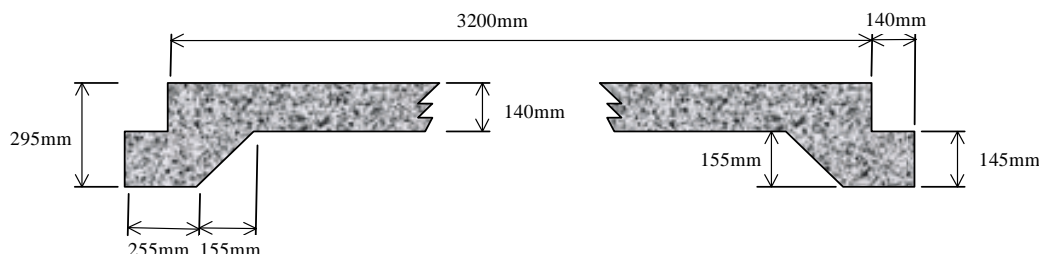
Figure 4: Concrete slab

Deviation from standard: The bare test floor used is of uniform thickness for an area of only 2.6m x 2.6m. The description of the bare test floor is given in the full report.

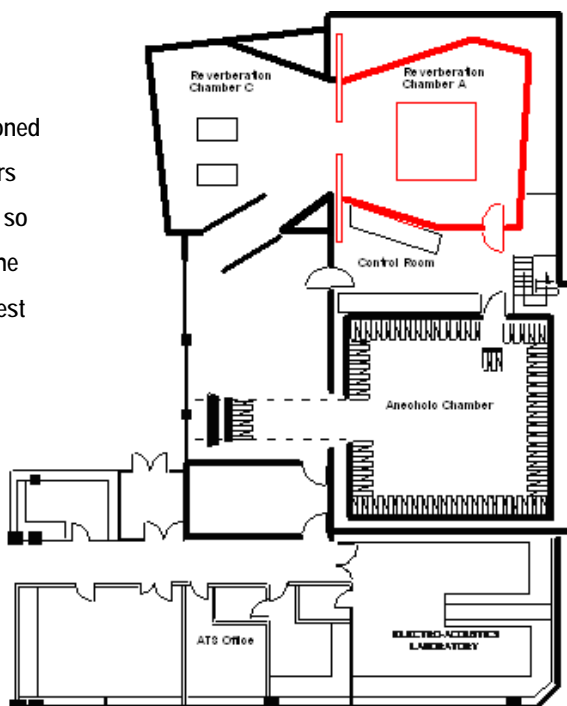
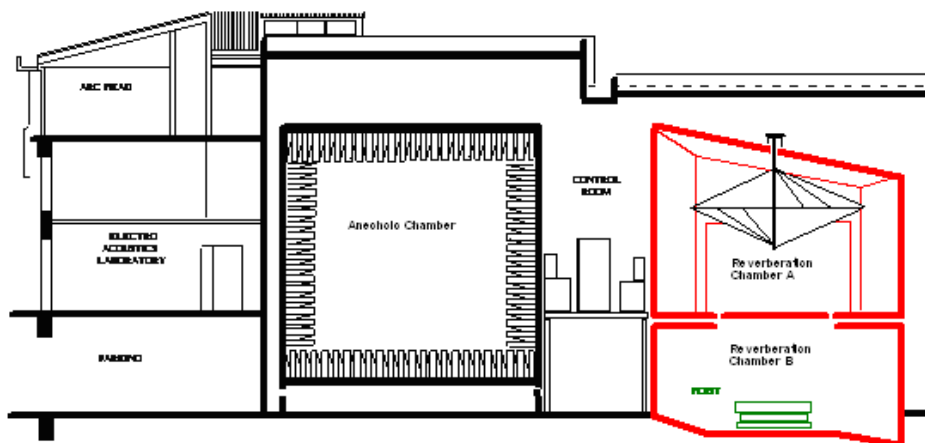
There are three large interconnected reverberation chambers at the Acoustics Research Centre, two at ground level (Chambers C and A) and the third (Chamber B) below A.

VOLUME (m <sup>3</sup> )	SURFACE AREA (m <sup>2</sup> )
Chamber A	202 ± 3	203.6 ± 0.9
Chamber B	153 ± 2	173 ± 1
Chamber C	209 ± 4	214 ± 0.9

The three Reverberation Chambers are linked by heavy steel doors and a removable Standard Industrial Floor Section which is removed and repositioned by a hydraulic hoist. The three chambers are vibration isolated from one another so that sound can only pass from one to the other via the intervening Test Wall or Test
