**Our Ref: T1741-2**

**LABORATORY MEASUREMENT OF  
THE REDUCTION OF  
TRANSMITTED IMPACT SOUND OF  
LAMINATE FLOORING  
(ACCORDING TO ISO 10140-3)**

**Reduction of impact sound pressure level according to ISO 10140-3**  
**Laboratory measurements of the reduction of transmitted impact sound by floor coverings on a heavyweight reference floor**

**Flooring:** 2 mm Tarkett Homogeneous Vinyl flooring  
**Flooring adhesive:** Uzin KE 2000S adhesive  
**Underlay:** 3 mm Regupol 4515-S Rubber/Cork mix underlay  
**Underlay Adhesive:** Uzin KE 2000S adhesive  
 Concrete Slab

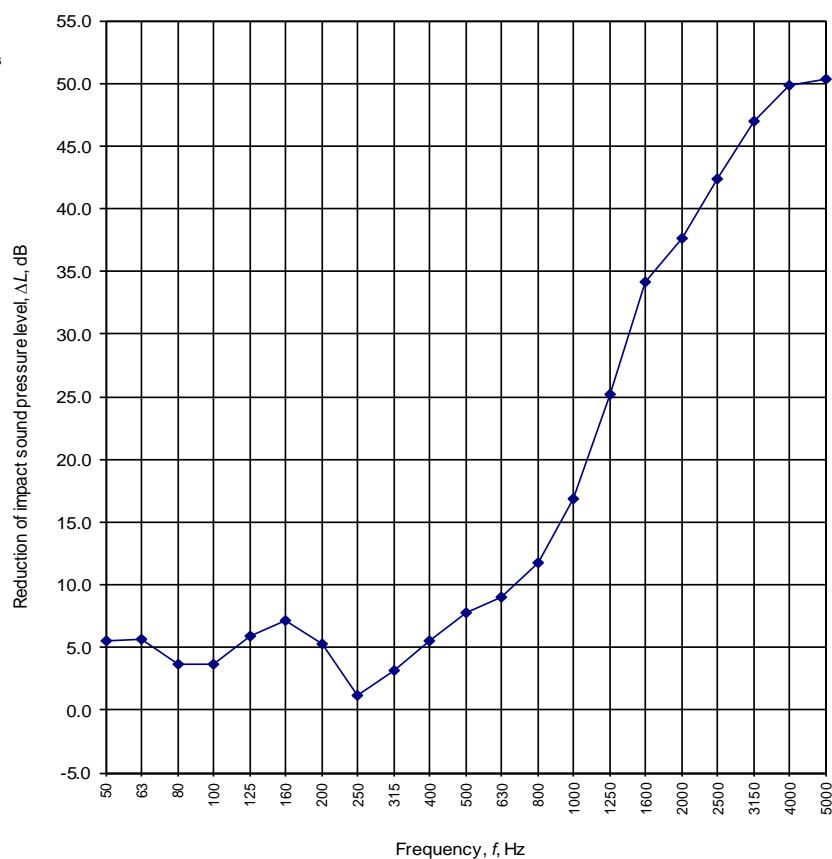
Frequency <i>f</i> Hz	$L_{n,0}$ One-third octave dB	$\Delta L$ One-third octave dB
50	54.4	5.5
63	50.0	5.6
80	56.8	3.7
100	<b>63.7</b>	<b>3.7</b>
125	<b>65.8</b>	<b>5.9</b>
160	<b>66.1</b>	<b>7.1</b>
200	<b>68.7</b>	<b>5.3</b>
250	<b>72.1</b>	<b>1.1</b>
315	<b>71.3</b>	<b>3.2</b>
400	<b>69.9</b>	<b>5.5</b>
500	<b>74.2</b>	<b>7.7</b>
630	<b>72.0</b>	<b>9.0</b>
800	<b>71.2</b>	<b>11.7</b>
1000	<b>71.3</b>	<b>16.8</b>
1250	<b>71.3</b>	<b>25.2</b>
1600	<b>71.1</b>	<b>34.2</b>
2000	<b>72.0</b>	<b>37.6</b>
2500	<b>72.5</b>	<b>42.4</b>
3150	<b>72.6</b>	<b>47.0</b>
4000	71.1	49.8
5000	68.2	50.3

Notes: #N/A = Value not available. **Bold** values are used to calculate  $\Delta L_w$ .  
 < indicates that the true value is lower.  
 $L_{n,0}$  are the bare floor impact sound levels.

$\Delta L_w = 18$  dB $C_{I,\Delta} = 10$  dB $C_{I,r} = -1$  dB $C_{1,50-2500} = -1$  dB

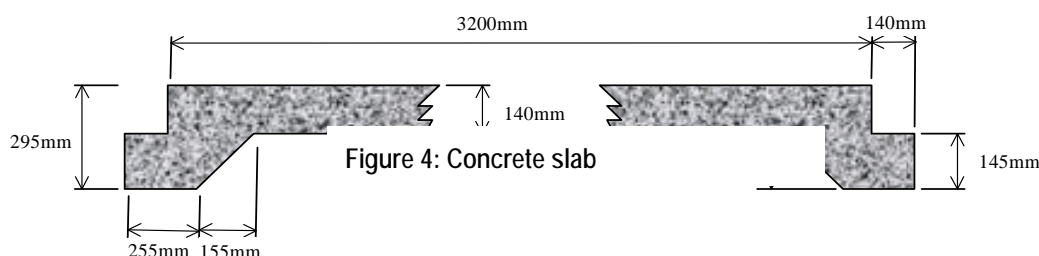
Figure 4: Concrete slab

The floor/ceiling system under test is installed in the opening between the two large reverberation chambers – chambers B and A. These chambers are vibration isolated from each other which results in a structural discontinuity at the middle of the test opening. This gap is covered over by a wooden collar, which seals the gap and provides for ease of fixing of samples

The sample is constructed by the client following the techniques normally used in practice for that type of floor/ceiling system, and is sealed into the test opening with perimeter seals of acoustic sealant.
